Reference: Removal of Coal Bins and B-14 Area, Camp Stanley Storage
Activity (CSSA), Solid Waste Registration Number 69026, EPA
Identification Number TX2210020739

This letter respectfully serves as notification of the removal of the coal bin area and B-14 area from the CSSA Solid Waste Management Unit (SWMU) list. These areas were previously thought to be possible SWMUs and were included in the Environmental Assessment (EA)¹ SWMU list. In 1992 and 1993, Parsons identified many potential SWMUs through historical waste management records, site maps, aerial photographs, and interviews with CSSA personnel. In some cases, file data and interviews dealing with past waste handling practices were very speculative. All identified potential SWMUs were included in the EA, but a field survey following the SWMU identification process failed to identify any waste management activities at the coal bin area or the SWMU B-14 area. These field survey results for the coal bin area and the B-14 area were documented in the EA and were also presented in the CSSA RL17 Work Plan (Parsons ES, 1996). Further details associated with these areas are provided below.

COAL BIN AREA

B-14 AREA

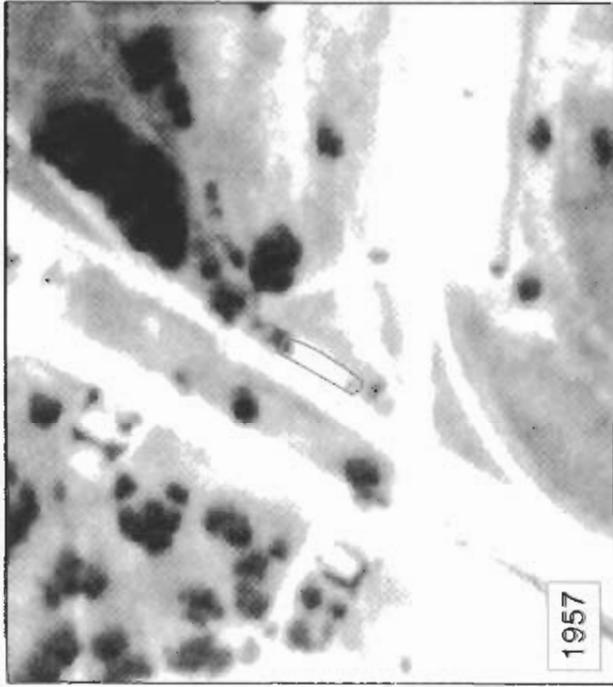
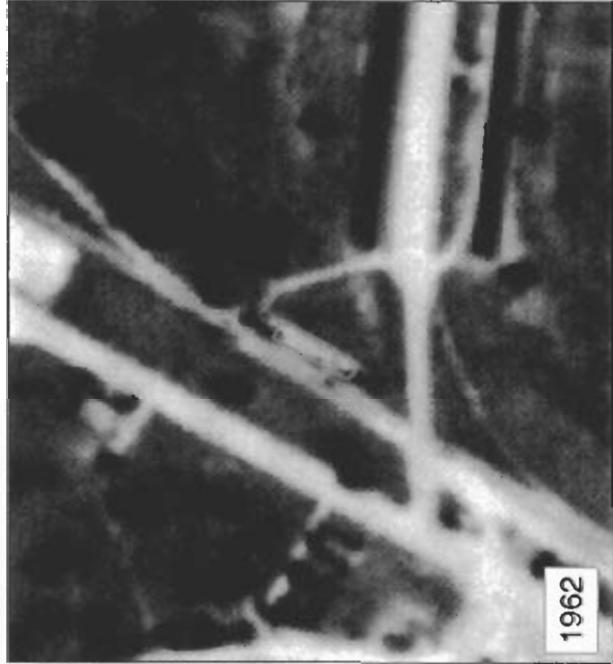
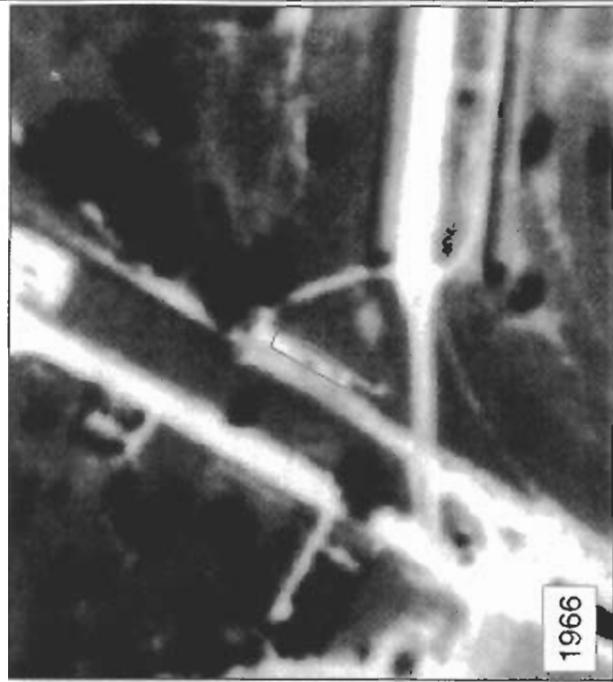
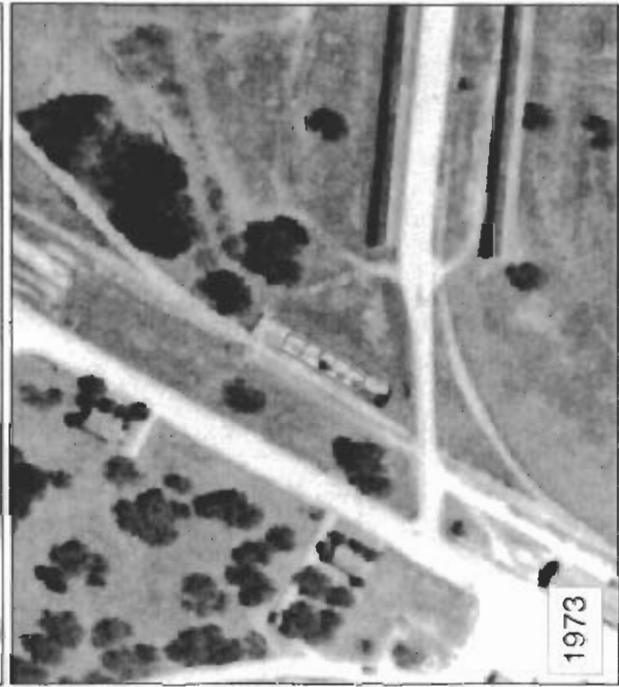
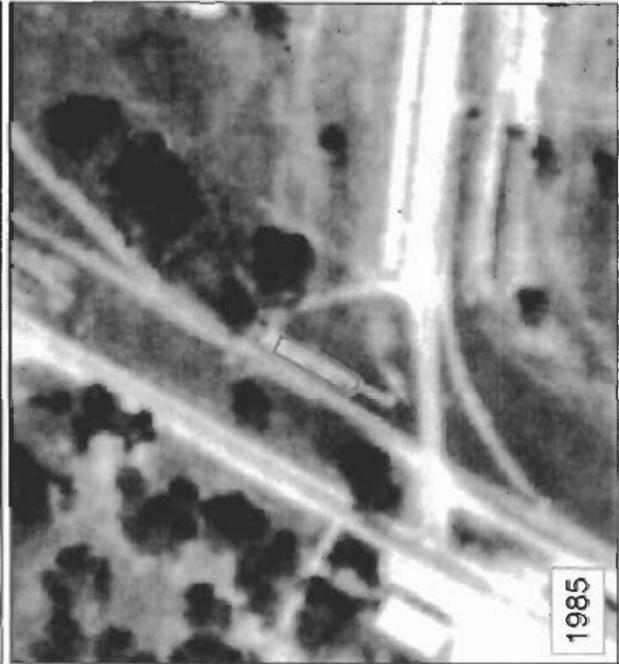
Figure 1
Coal Bin Area
Aerial Photographs
Camp Stanley Storage Activity

The former coal bin area is located northwest of the headquarters building (Figure 1). The bins are concrete structures as shown in Photograph 1. This area was used for bulk coal storage, according to CSSA records. The structural integrity remained intact for the duration of its operation.

Aerial photos do not show waste management activities in 1957, 1962, 1966, 1973, or 1985, as shown in Figure 1. In addition, historical file records and interviews with present installation employees did not indicate historical waste management in this area. Field surveys completed in September 1992 and March 1996 did not indicate any evidence of waste management activity. Neither the bins nor the surrounding area show any evidence of waste management activities.

The coal bin and B-14 areas, previously thought to be SWMUs, show no evidence of solid waste or solid waste management activity and have no records of solid waste management activity. Therefore, the areas do not require further investigation. Although both areas are listed as SWMUs in the EA and RL17 Work Plan, neither are considered SWMUs since field investigations found no evidence of past waste management activities at either area.

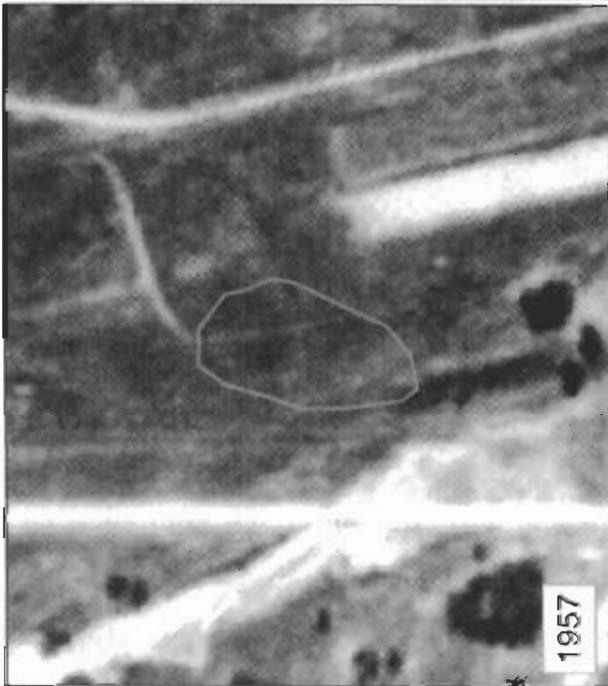
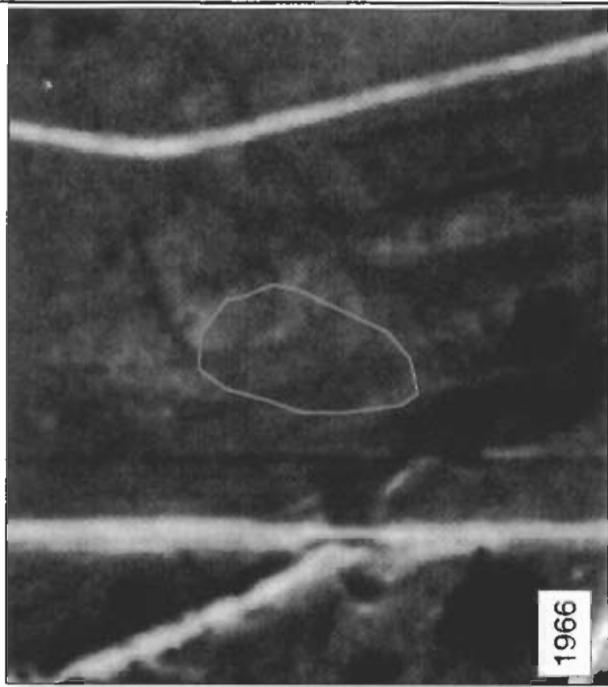
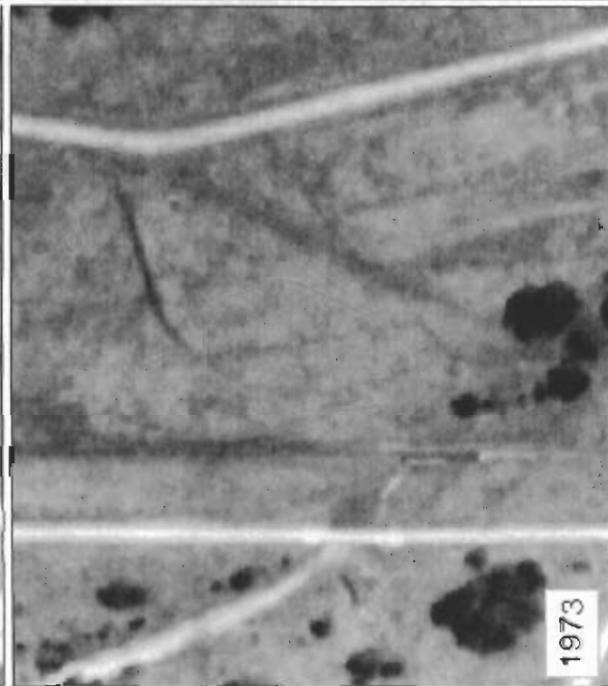
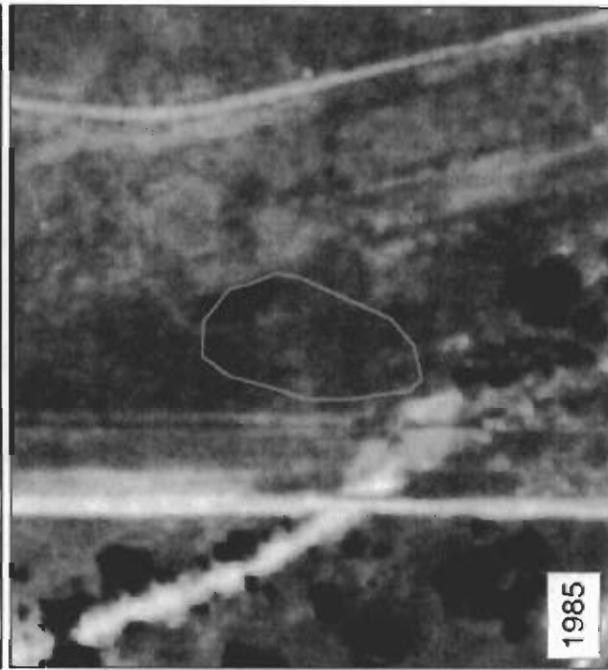
Figure 2

The approximate location of the B-14 area is shown in Figure 2. A photograph of the area where the site may have been located is shown in Photograph 2. According to the EA, this area was supposedly a fired brass area located in the east pasture at CSSA. Fired brass areas are typically characterized by spent brass casings at the surface.

Aerial photos do not show waste management activities in 1957, 1962, 1966, 1973, or 1985, as shown in Figure 2. During the initial (1992) field survey, the reported B-14 area could not be located, even with the area cleared for fence repair operations. No spent casings were identified. No evidence of solid waste management activities was found in a subsequent field survey in 1996.

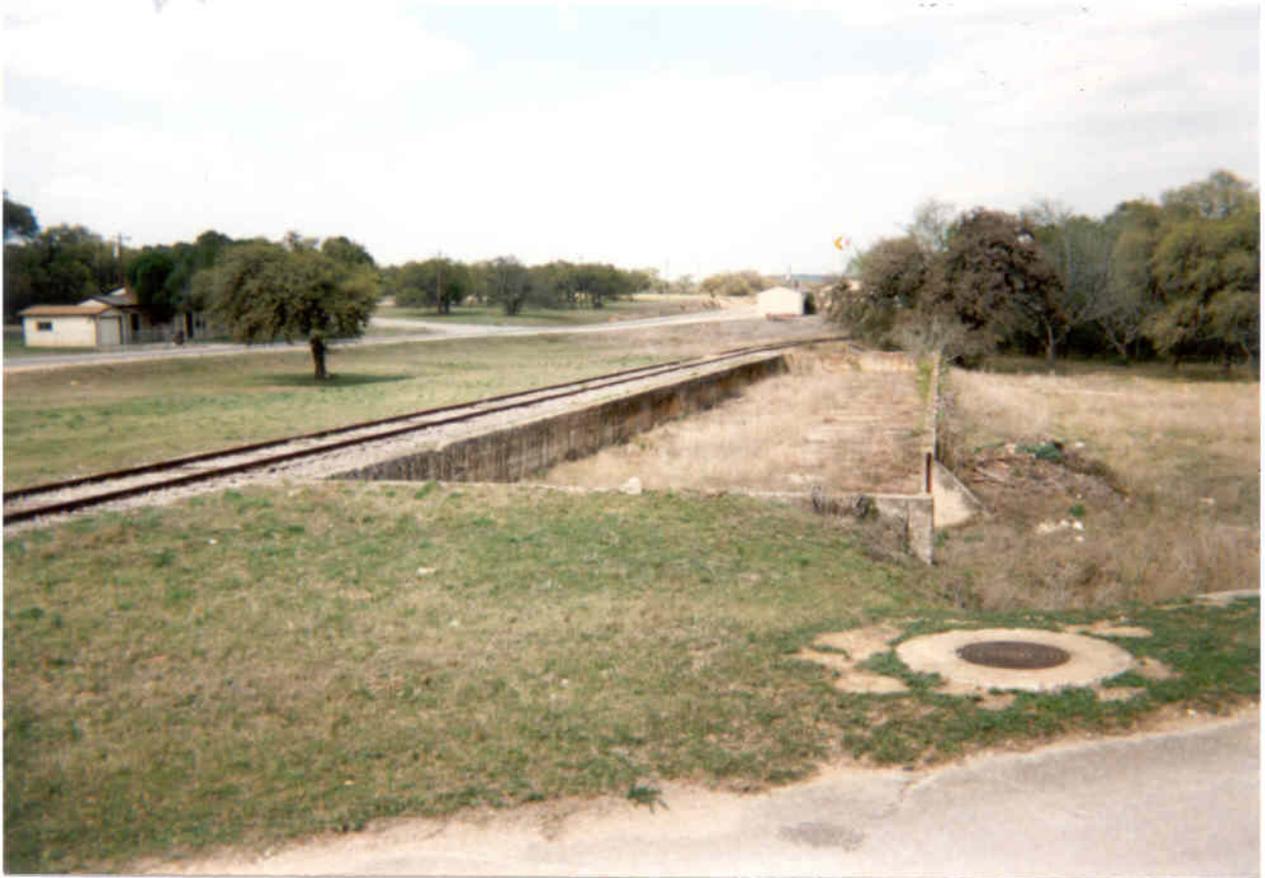
Photograph 1: Coal Bin concrete structures.

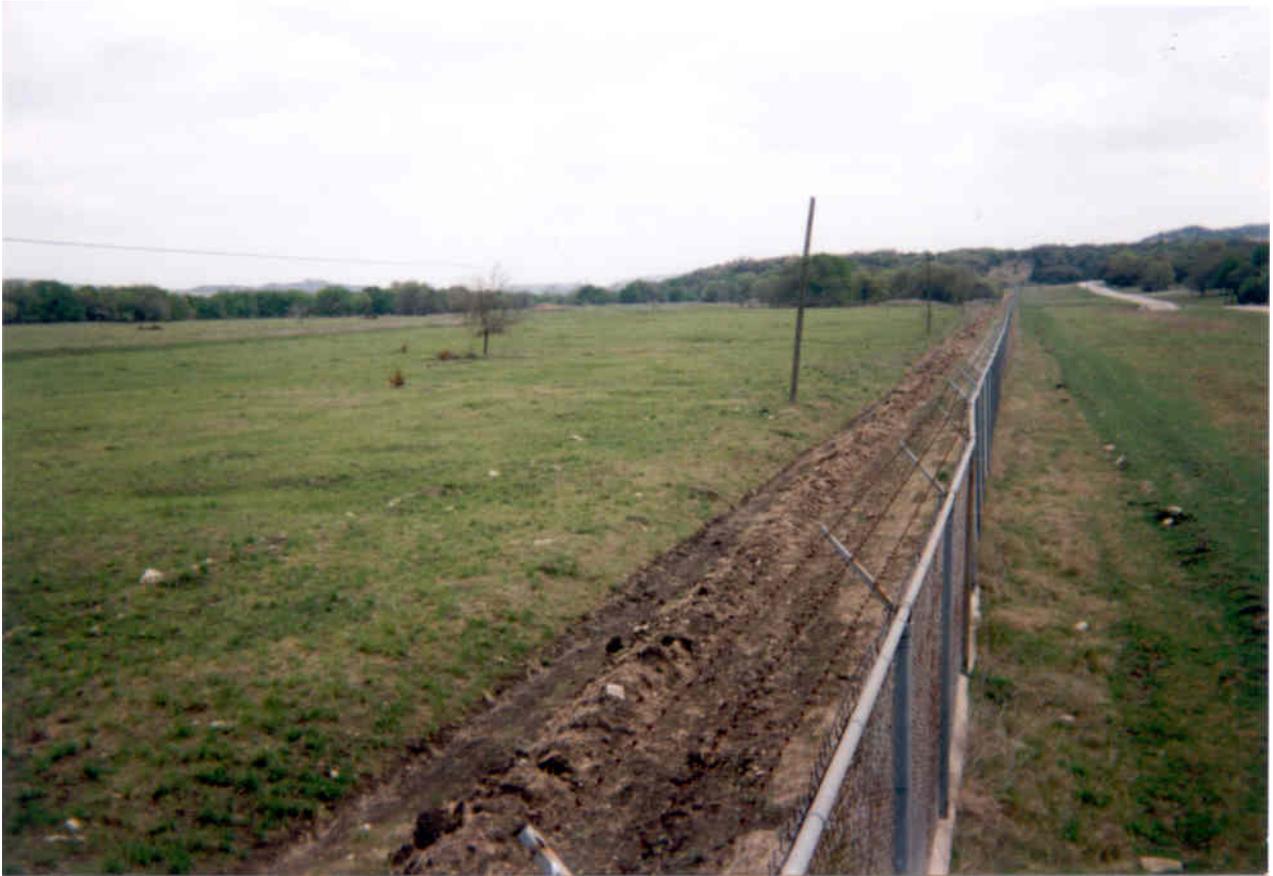
Photograph 2: Presumed location of SWMU B-14.
