CSSA Regulator Meeting

Camp Stanley Storage Activity Status Update

June 13, 2011

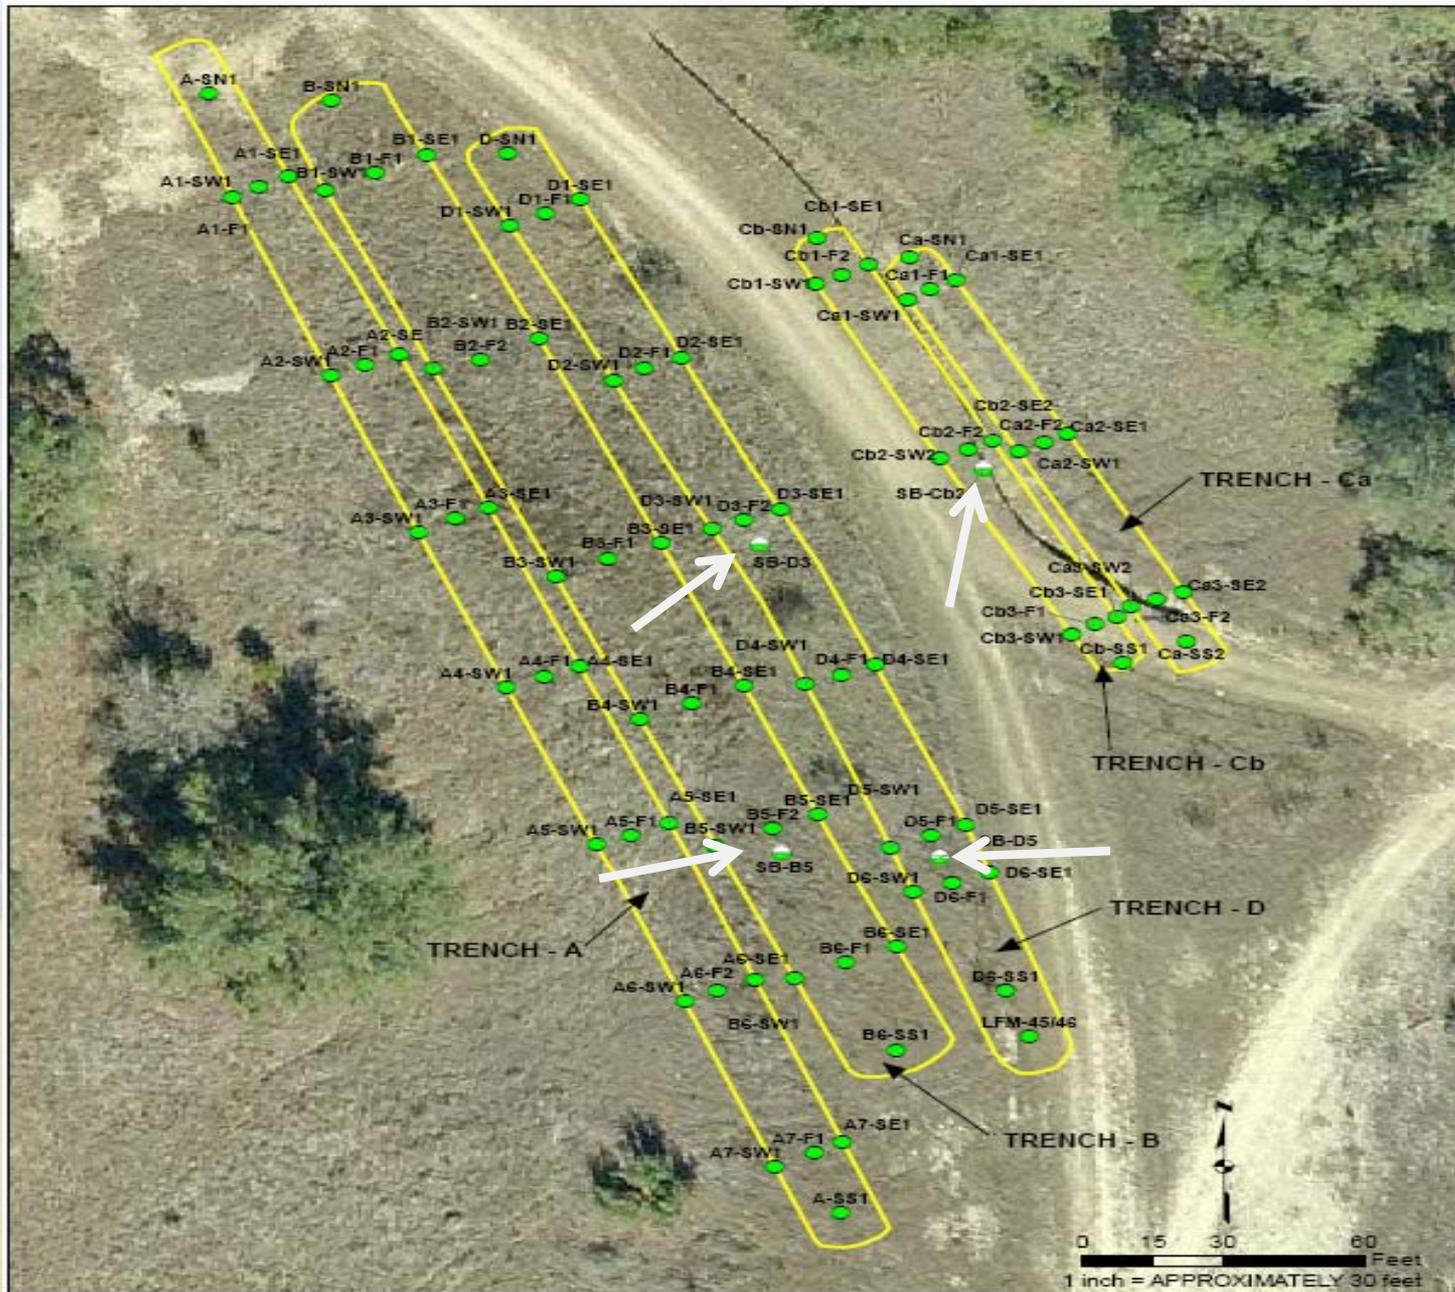
Residual COCs in SWMU B-4 Trenches

Legend

- Excavation Confirmation sample location with COC concentrations less than Tier 1 and Tier 2 critical PCLs
- Vertical delineation soil boring with COC concentrations less than camp Stanley site specific back ground concentration

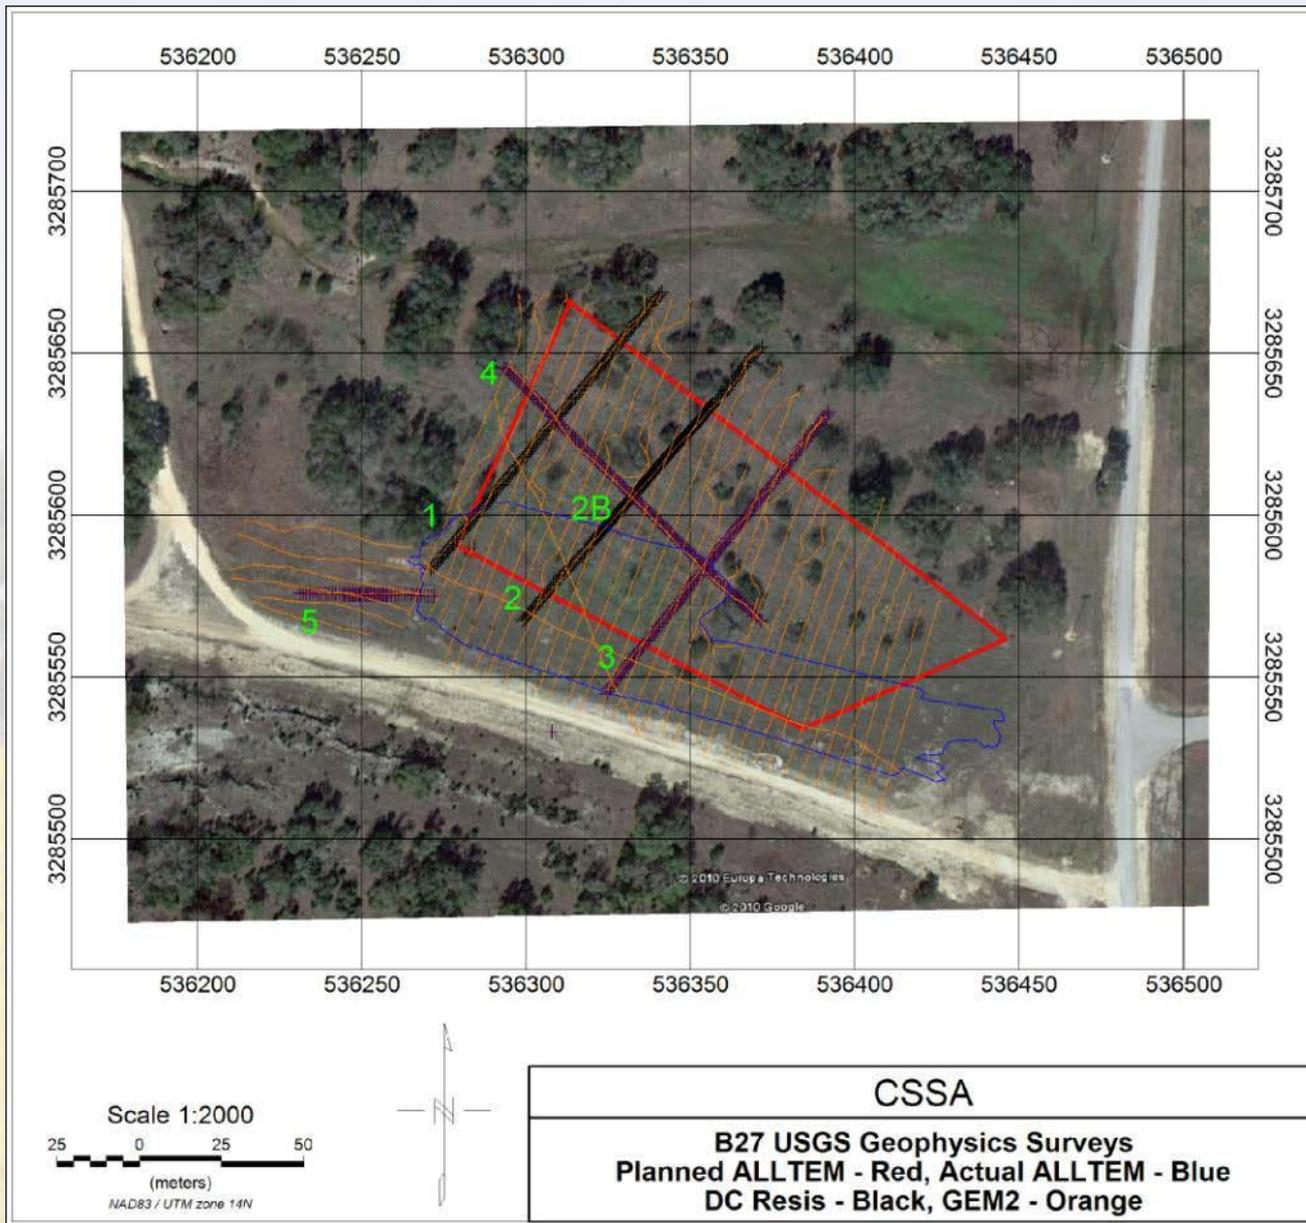
B-27 Geophysical Surveys

EXPLANATION

- Red polygon = planned ALLTEM survey area
- Irregular blue line = actual ALLTEM area surveyed
- Orange lines = GEM2 survey
- Thick black lines = Earth Resistivity (dc) transects (numbered in green)

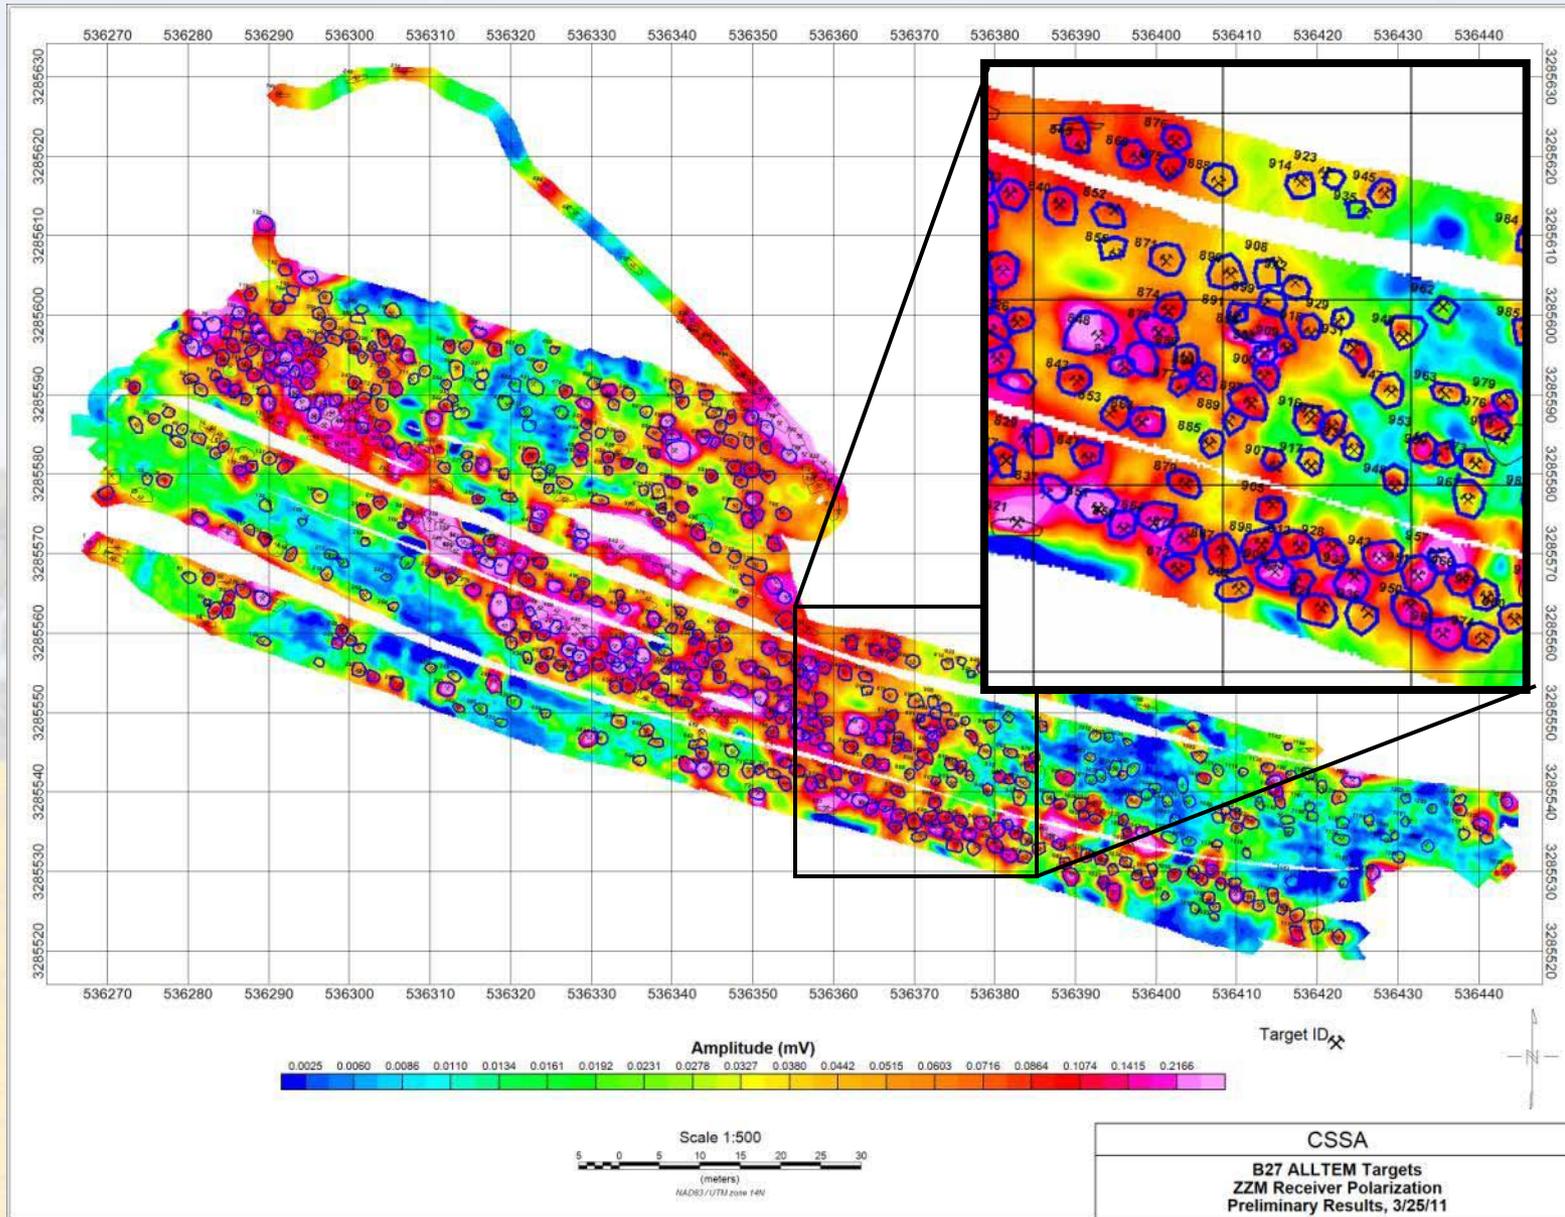
ALLTEM Target Map B-27

The automatic target picker draws a polygon around individual targets, marks the peak, and assigns a target number to each.

Each target will be processed using the inversion program, which estimates target characteristics and generates a dig list.

This is a target map using the ZM polarization, akin to an EM61 configuration.

This is just 1 of 19 polarization maps.

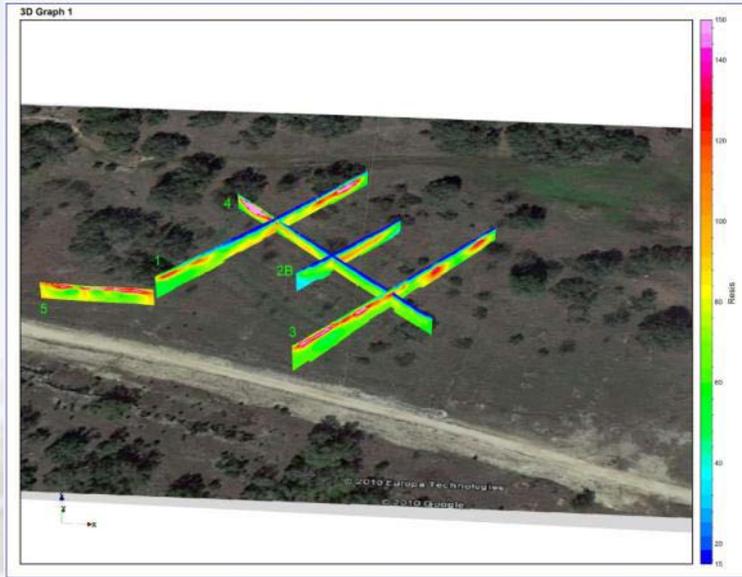
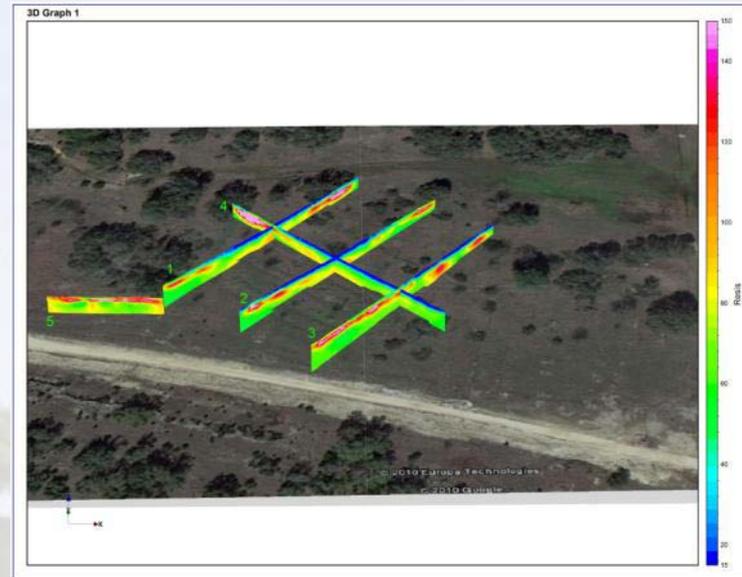
Earth Resistivity Imaging B-27

Trenches are evident as closely-spaced, shallow (<2.5 m), low-resistivity (blue) zones.

Fence diagrams in perspective view against aerial photograph of site.

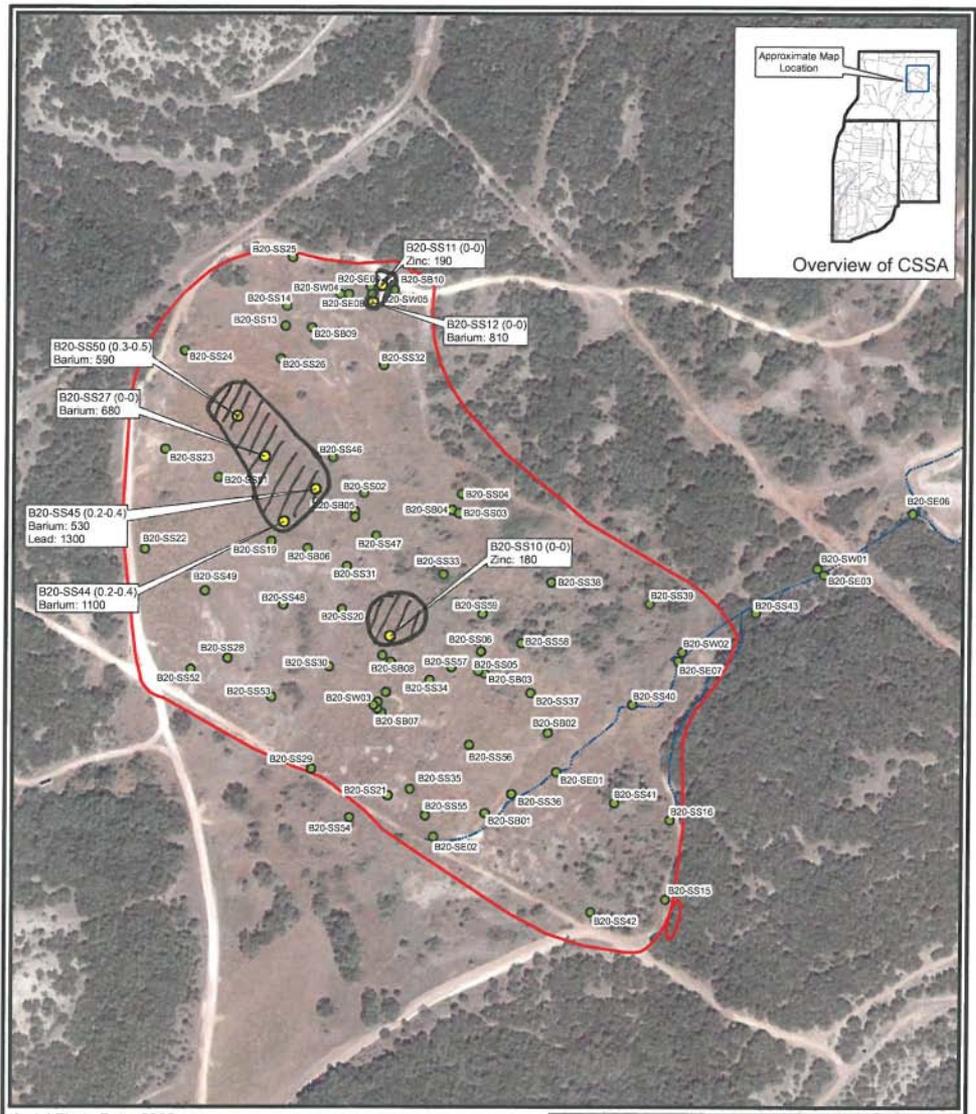
Figure 4A-1
 Surface Soil COC Concentrations
 at SWMU B-20/21
 Camp Stanley Storage Activity
PARSONS

- TENTATIVE excavation extent, surface soils only

Soil sample location with COC concentrations detected above residential assessment levels (results in mg/kg)

Soil sample location with COC concentrations detected below residential assessment levels, or not detected

SWMU B-20/21 Boundary

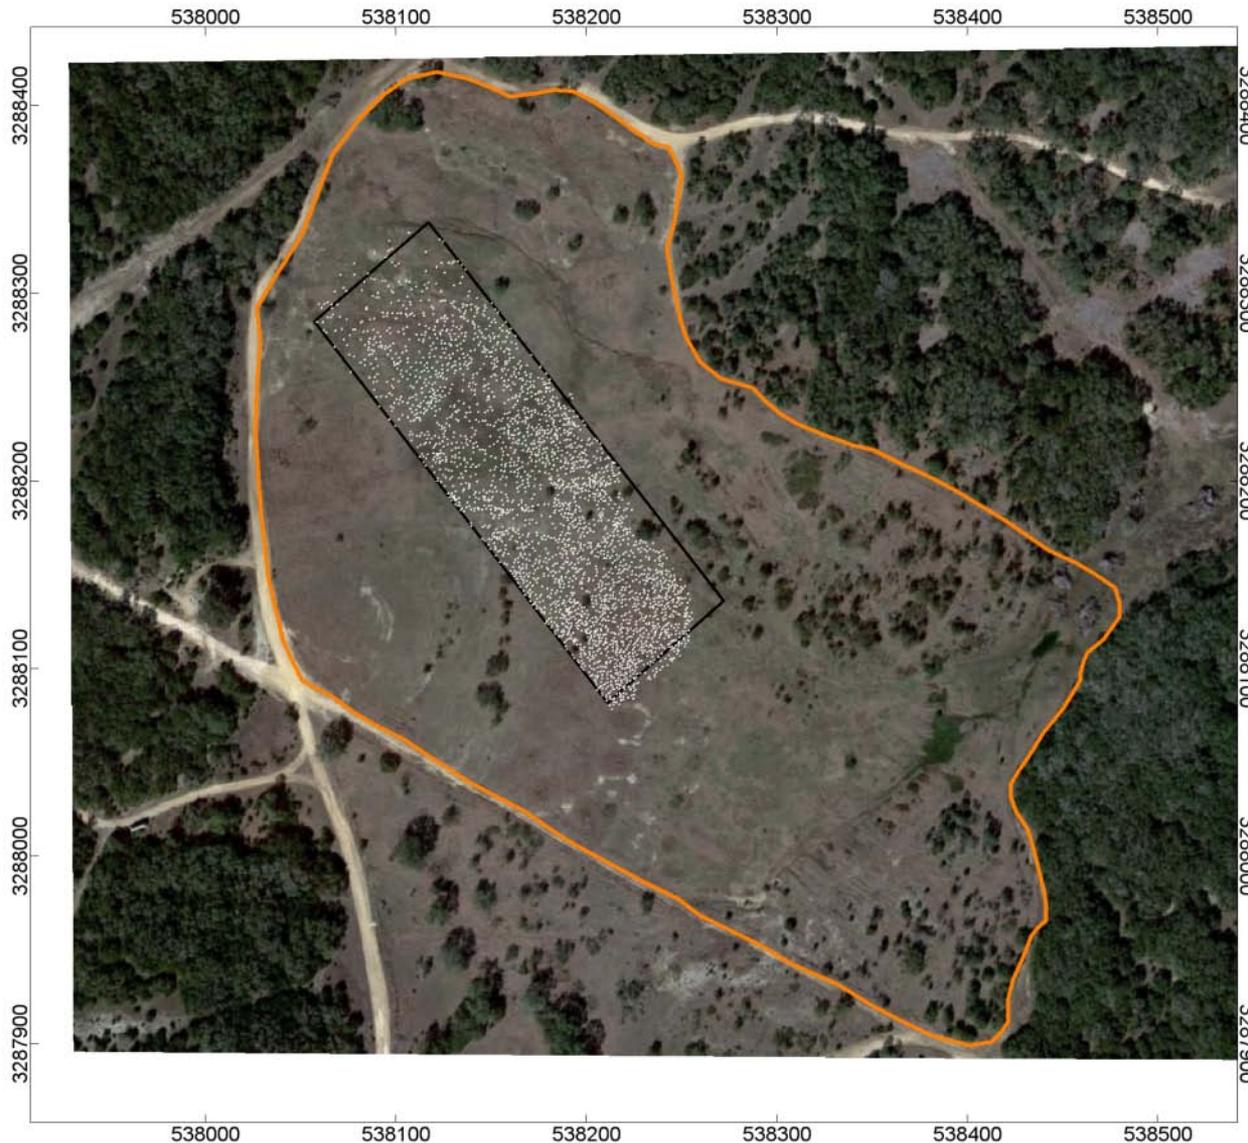
B-20 Target Map

❖ > 2780 targets picked for inversion

❖ Uneven distribution

— ALLTEM
Survey Area
(~5 acres)

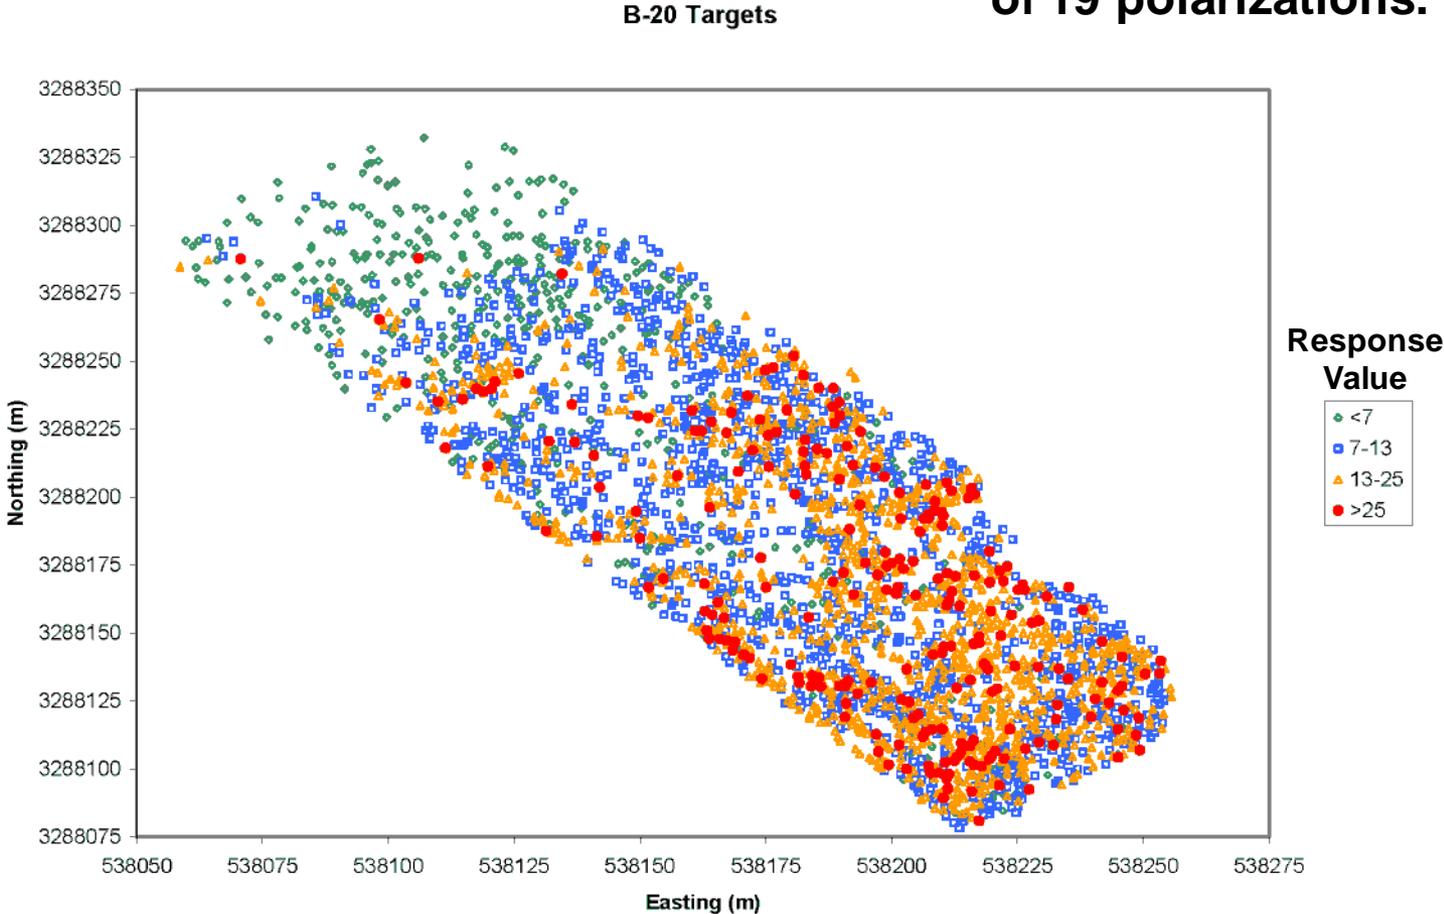
B-20 Target Response-Value Distribution

Targets classed by combined response of 19 polarizations.

Distribution not normal because response-value is not a function of a random process.

Distribution is skewed to smaller response values.

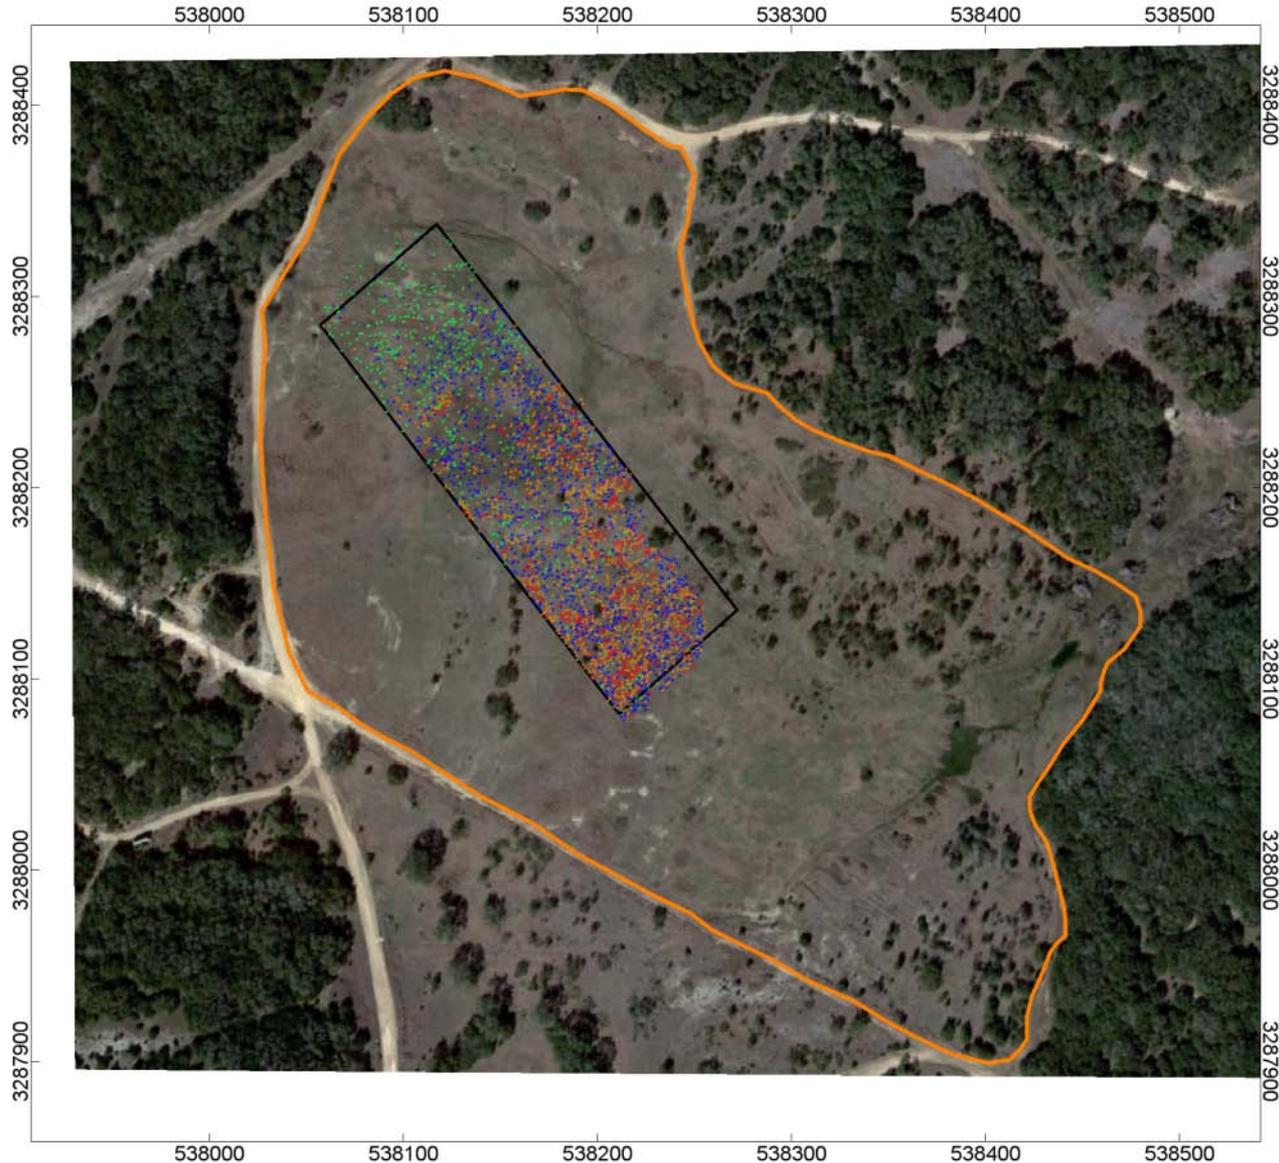
B-20 ALLTEM TARGETS

Targets classed into four categories according to combined response of 19 polarizations.

ALLTEM
Survey Area
(~5 acres)

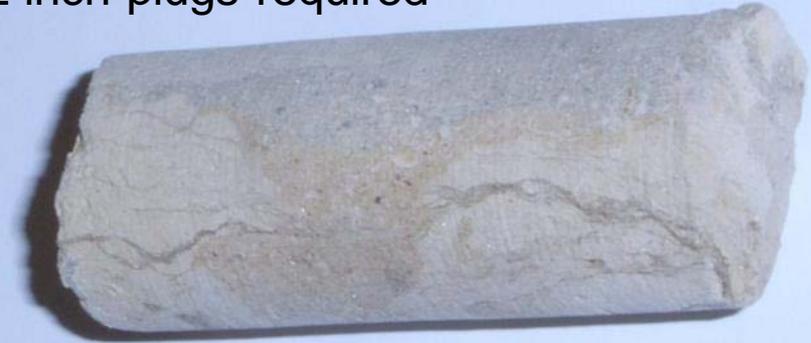
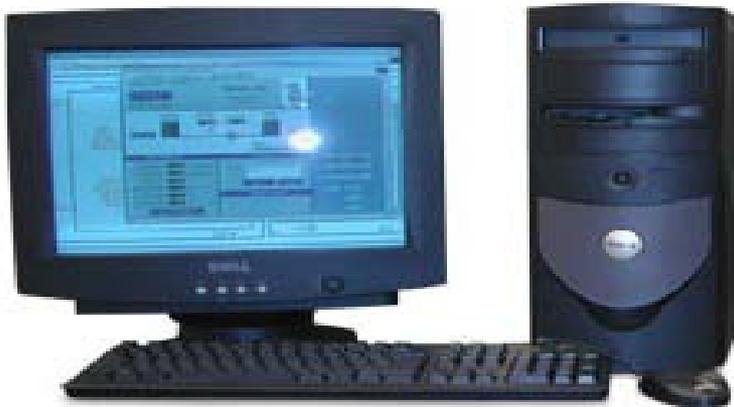
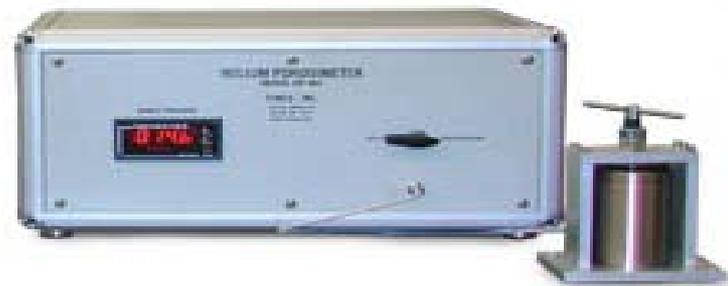
CSSA 3-D EV Model

- HE Gas Injection
- Neutron Well Logs
- 55 plugs collected from
- Well Core MW-5LGR

1 by 2 inch plugs required

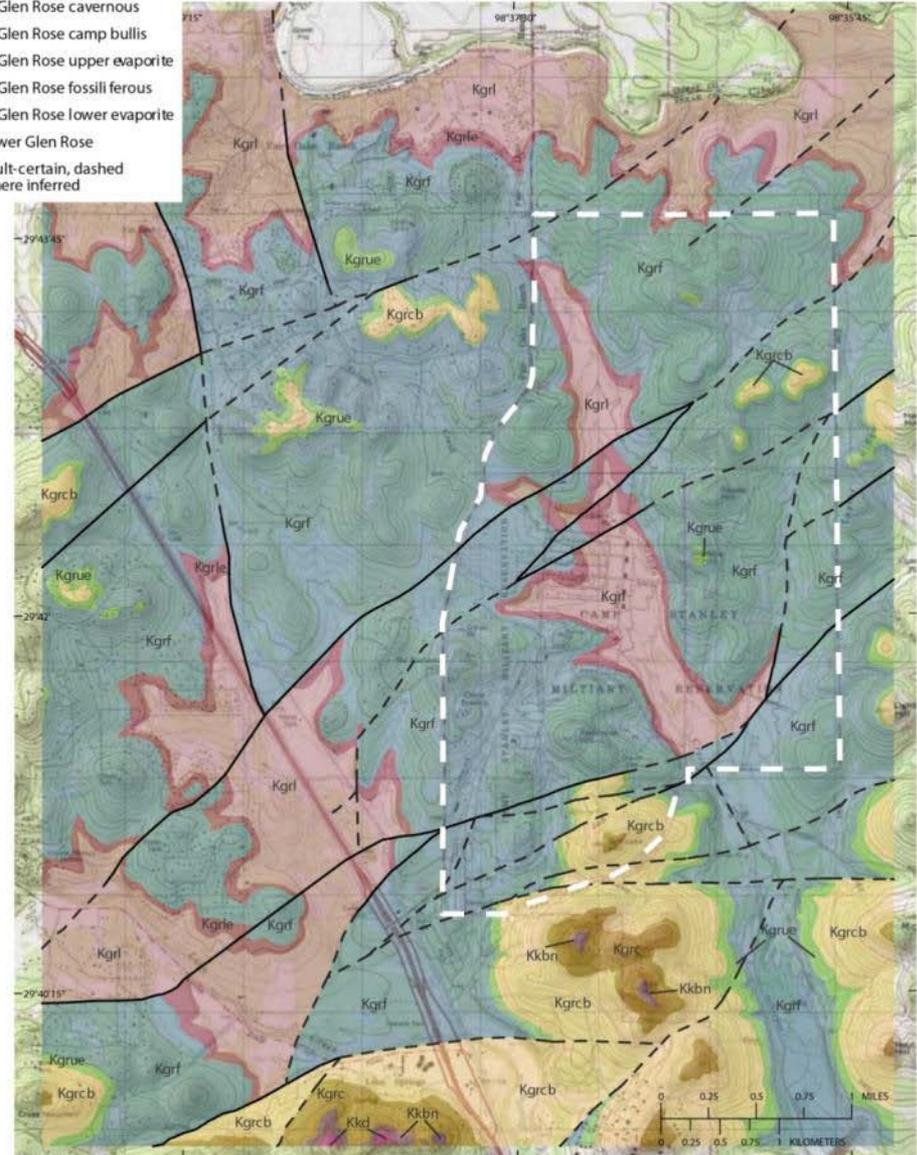
- 102 wells
- 16 model layers
 - 2-Edwards
 - 5-Upper Glen Rose
 - 6-Lower Glen Rose
 - 1-Bexar Shale
 - 1-Cow Creek
 - 1-Pine Is. (Hammett)
- 1 major fault
- 5-6 minor faults

EXPLANATION	
Kkd	Dolomitic
Kkbn	Basal nodular
Karc	U. Glen Rose cavernous
Kgrcb	U. Glen Rose camp bulls
Kgrue	U. Glen Rose upper evaporite
Kgrlf	U. Glen Rose fossiliferous
Kgrle	U. Glen Rose lower evaporite
Kgrf	Lower Glen Rose
---	Fault-certain, dashed where inferred

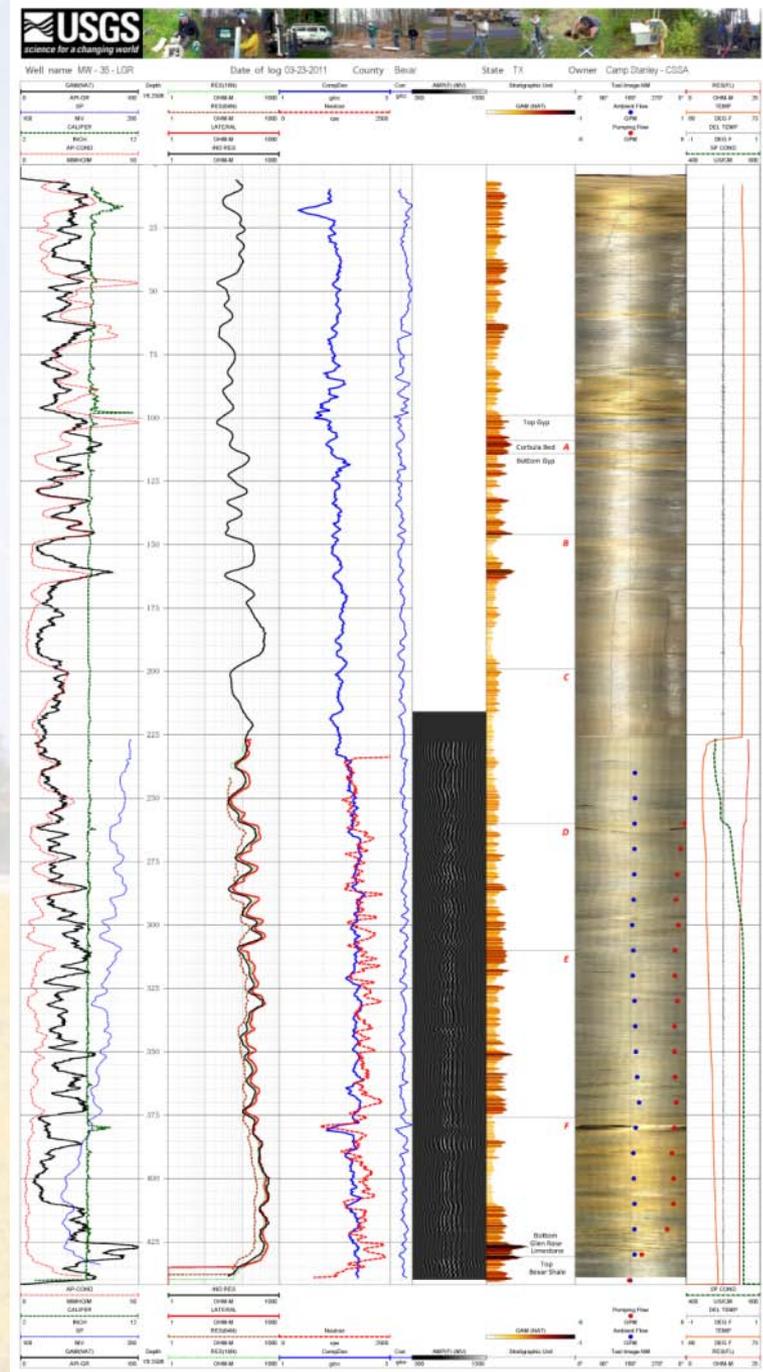
Composite Log MW-35-LGR

- Gamma
- SP
- Caliper
- Temperature
- Resistivity
 - Normal
 - Induction
 - Fluid
- Gamma-Gamma Density
- Neutron
- Full Wave Sonic
- Optical Image
- EM Flowmeter

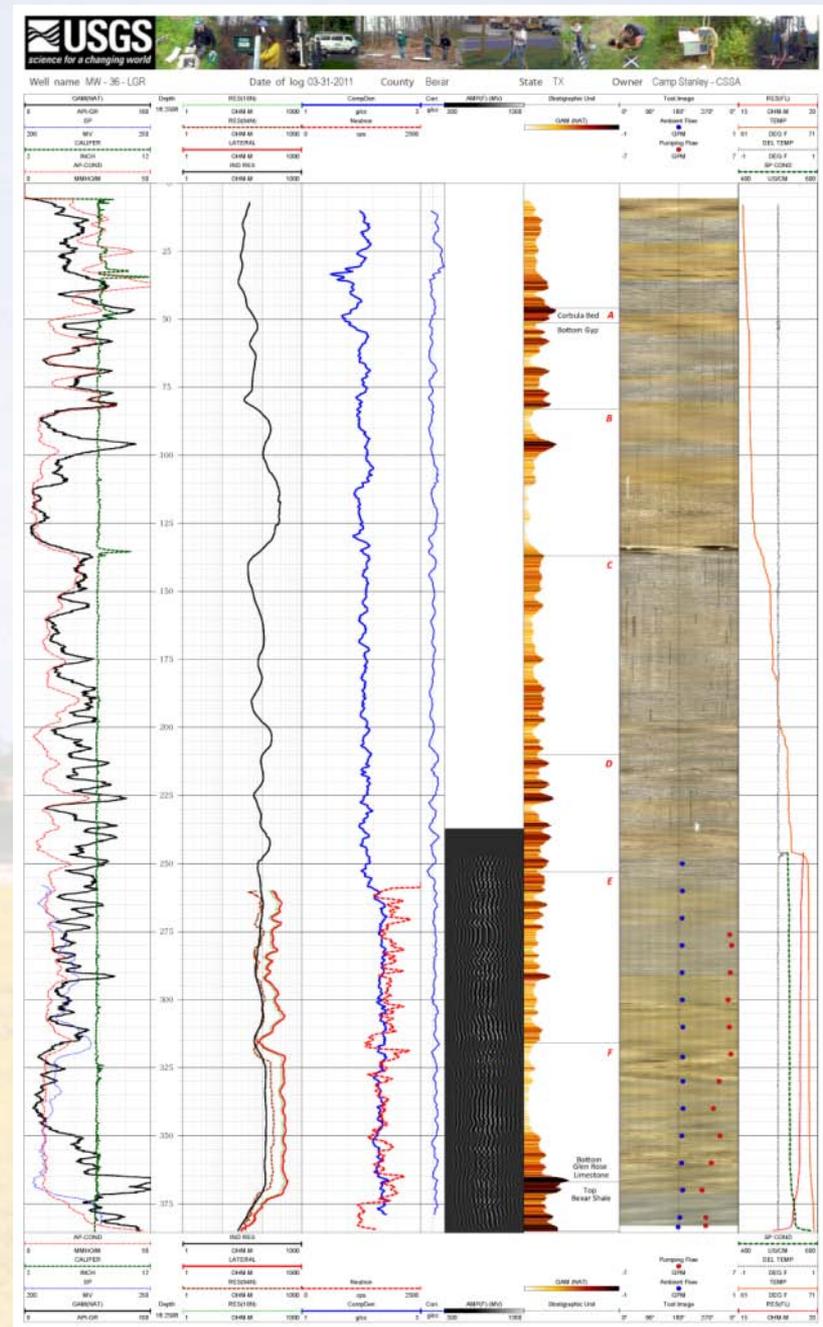
Composite Log MW-36-LGR

- Gamma
- SP
- Caliper
- Temperature
- Resistivity
 - Normal
 - Induction
 - Fluid
- Gamma-Gamma Density
- Neutron
- Full Wave Sonic
- Optical Image
- EM Flowmeter

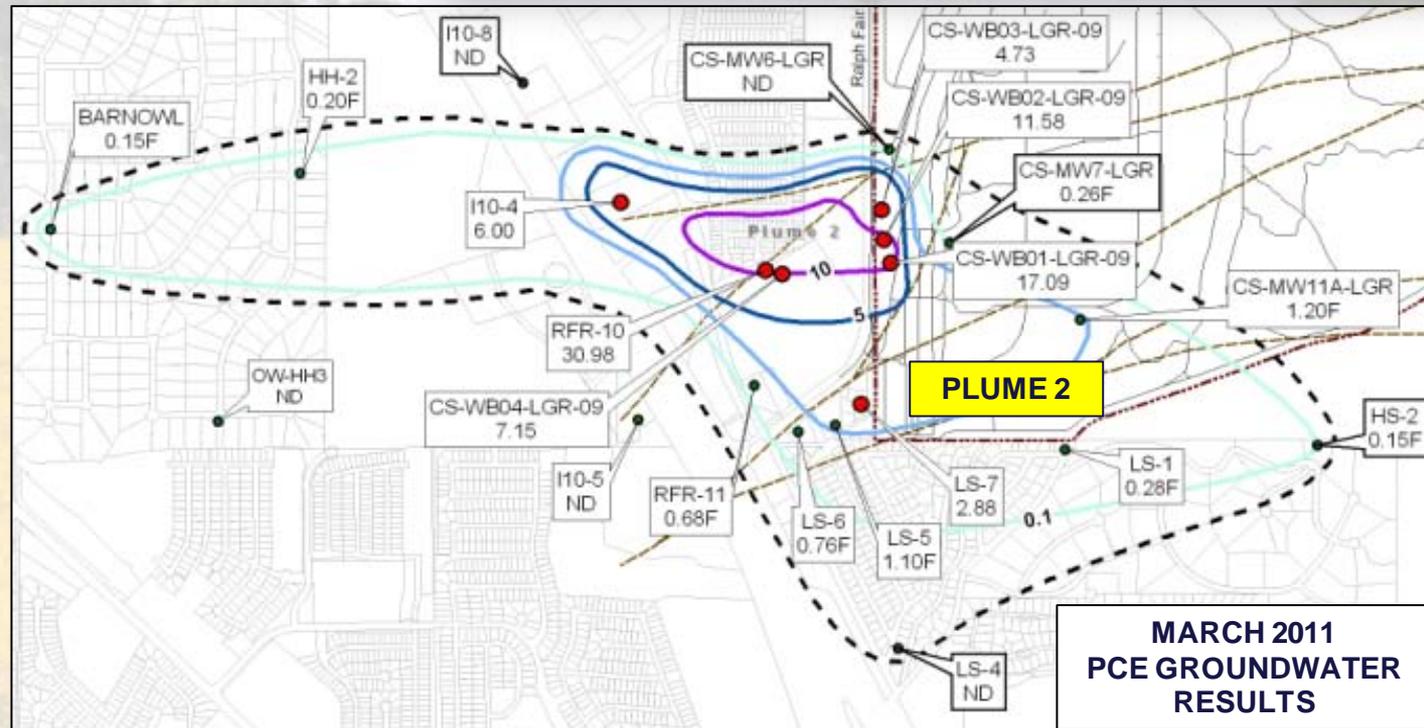
March 2011 Plume 2

- The detection of PCE at The Oaks WSC is significant because it extends the margin of the plume to 1 mile west of I10-4 well.
- PCE contamination now detected 1.5 miles west of CSSA boundary.

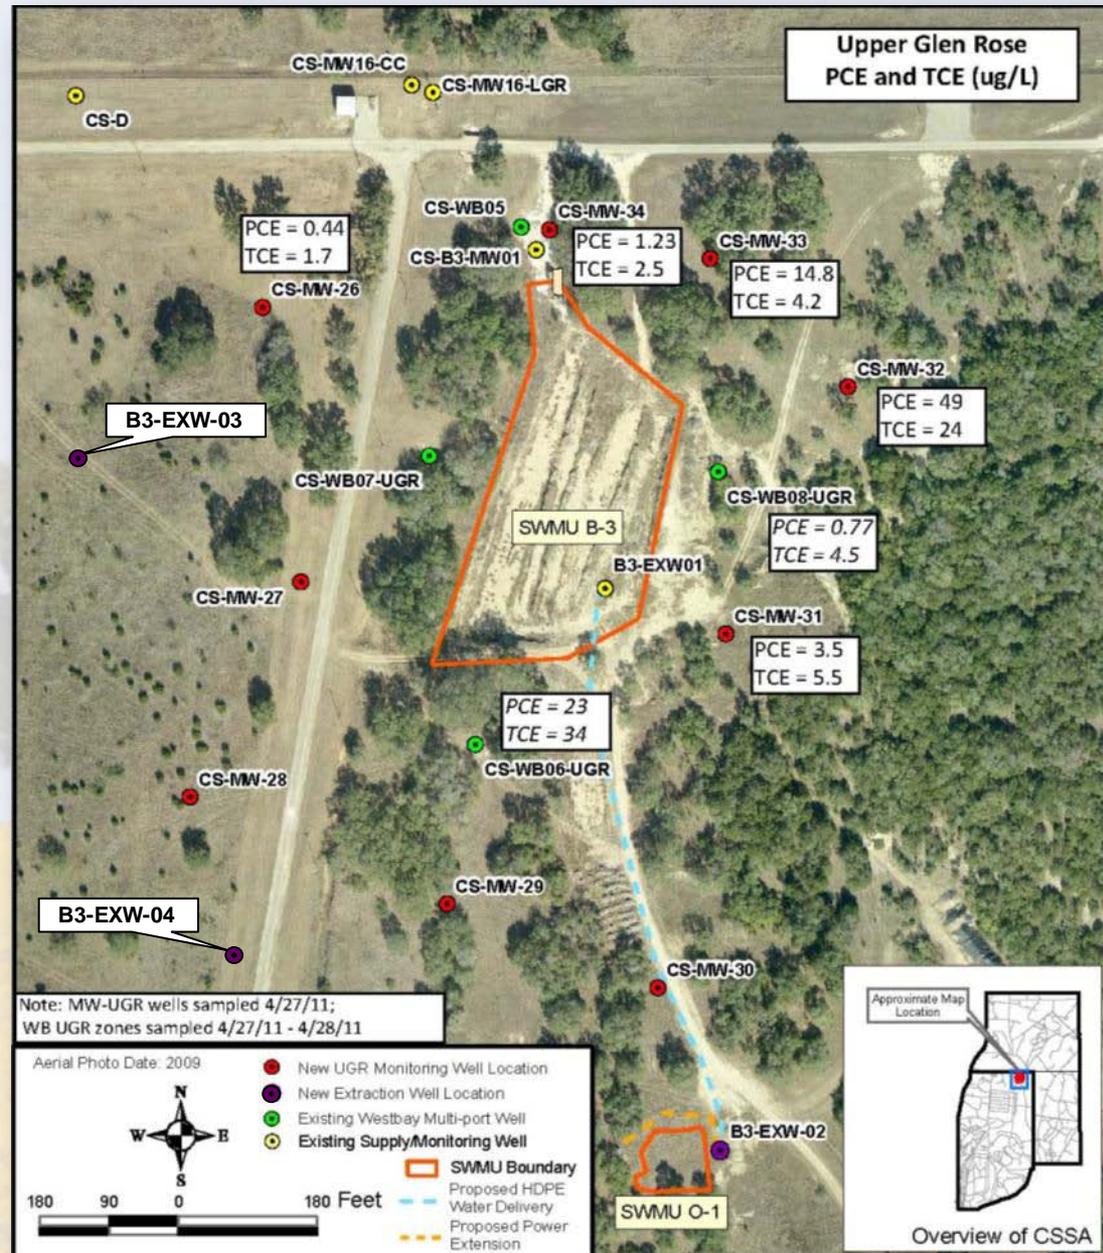
B-3 Bioreactor Pilot Study Observations

- Shallow wells south and east of the bioreactor contain elevated concentrations of PCE and TCE.
- Shallow wells to the west of the bioreactor continue to contain minor concentrations of PCE or TCE approximately equal to concentration levels in bioreactor.

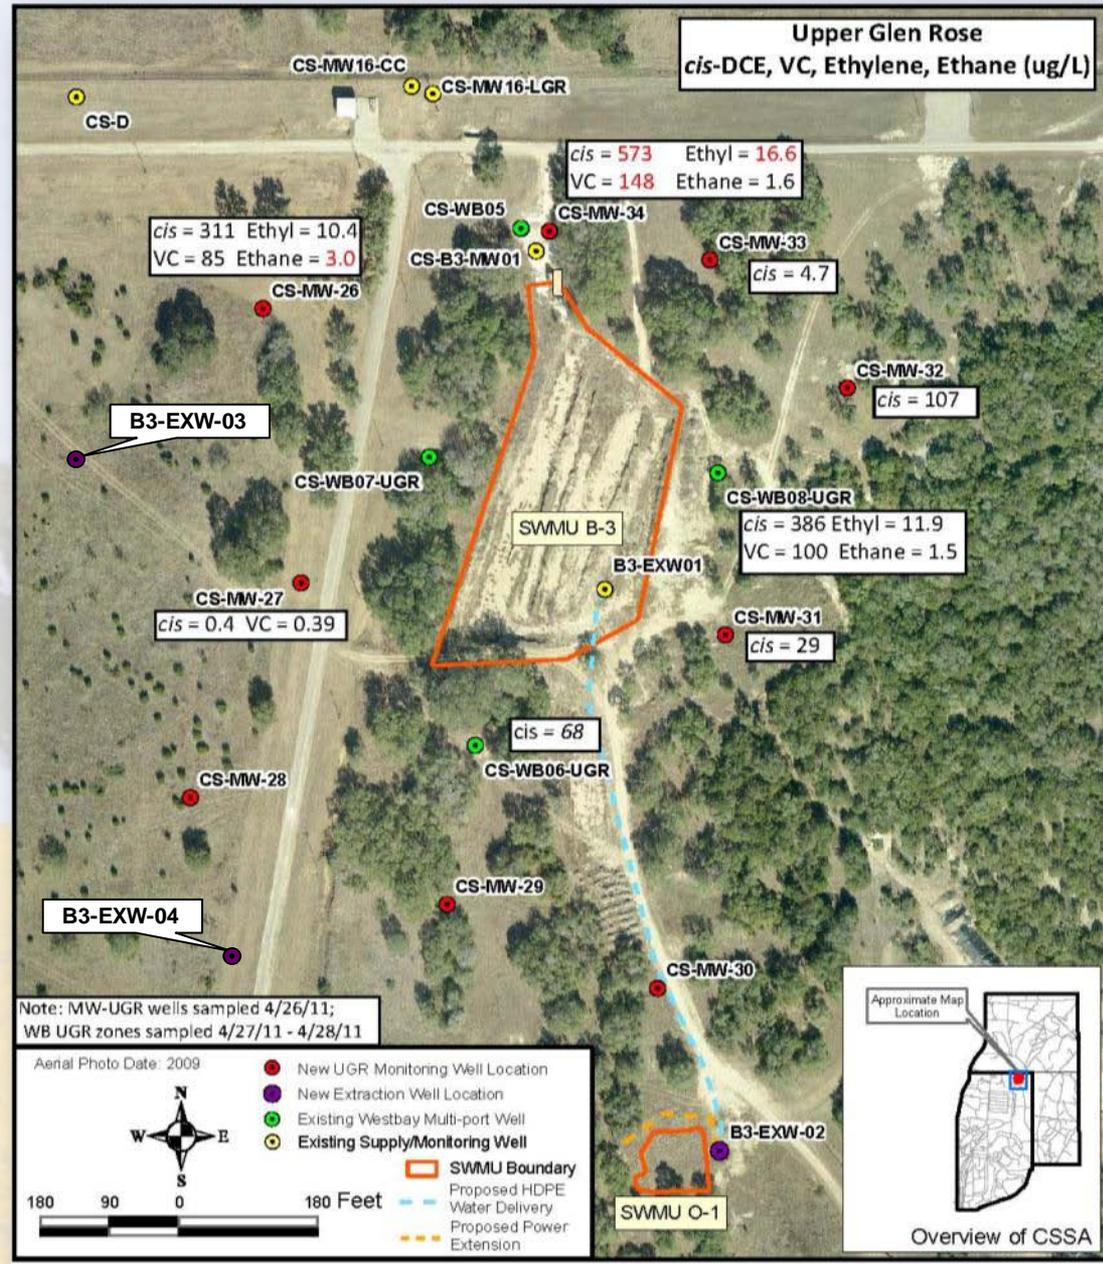
B-3 Bioreactor Pilot Study Observations

- Monitoring wells north and west of the bioreactor contain elevated concentrations of microbial degradation products vinyl chloride (VC) and ethylene (Ethyl) suggesting bioreactor influence.
- Shallow wells to the east of the bioreactor contain degradation compound concentrations of *cis*-DCE.

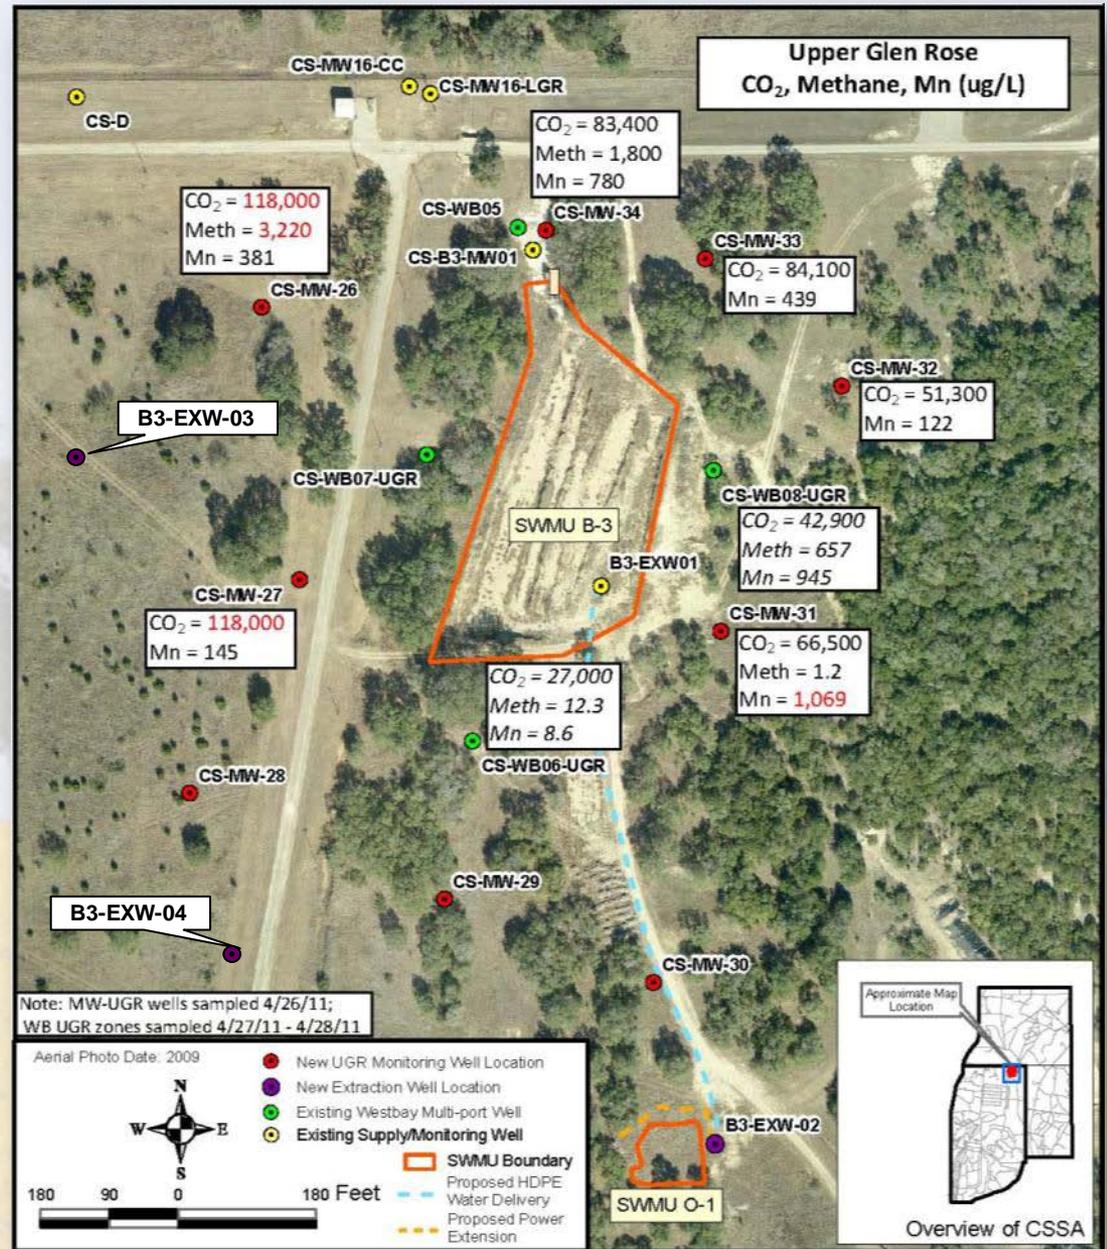
B-3 Bioreactor Pilot Study Observations

- Shallow wells surrounding the bioreactor contain elevated concentrations of other biotic degradation products Carbon Dioxide (CO₂), Methane (Meth) and Manganese (Mn).
- CS-MW-28 continues to be a dry well suggesting potential fault line somewhere southwest of SWMU B-3.
