CSSA Regulator Meeting

Camp Stanley Storage Activity Status Update

June 13, 2011

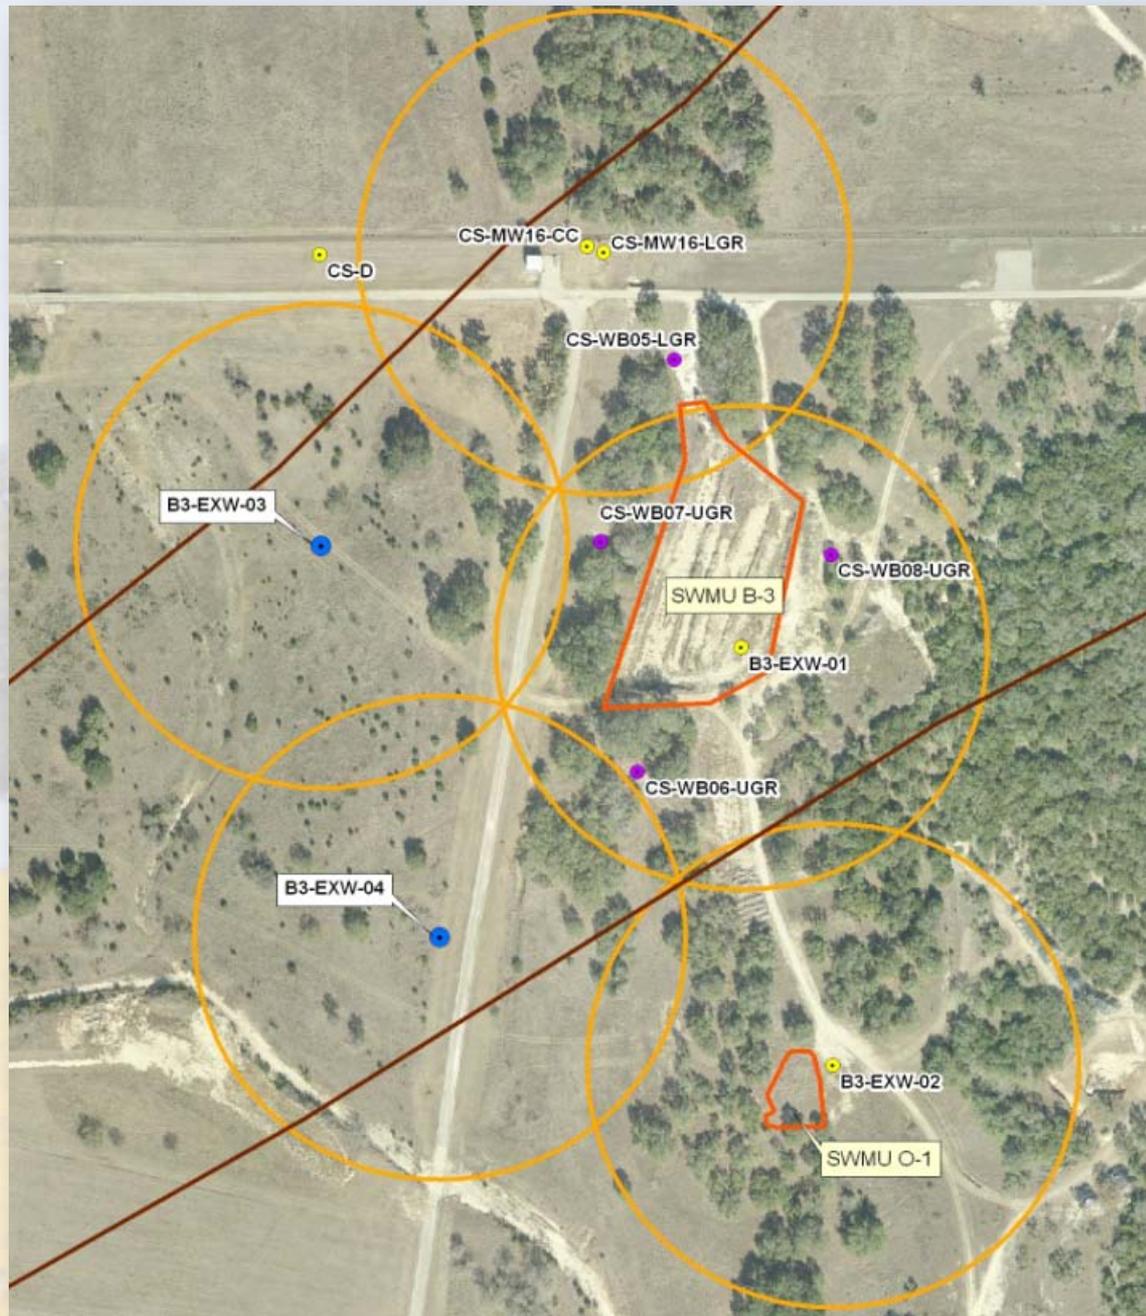
B-3 Bioreactor New Extraction Wells

- Two new LGR extraction wells are being drilled West of the Bioreactor to augment the system.
- **CS-EXW03-LGR** is a cased open hole in highly fractured zone (TD = 340' bgs).
- **CS-EXW04-LGR** is currently being drilled.

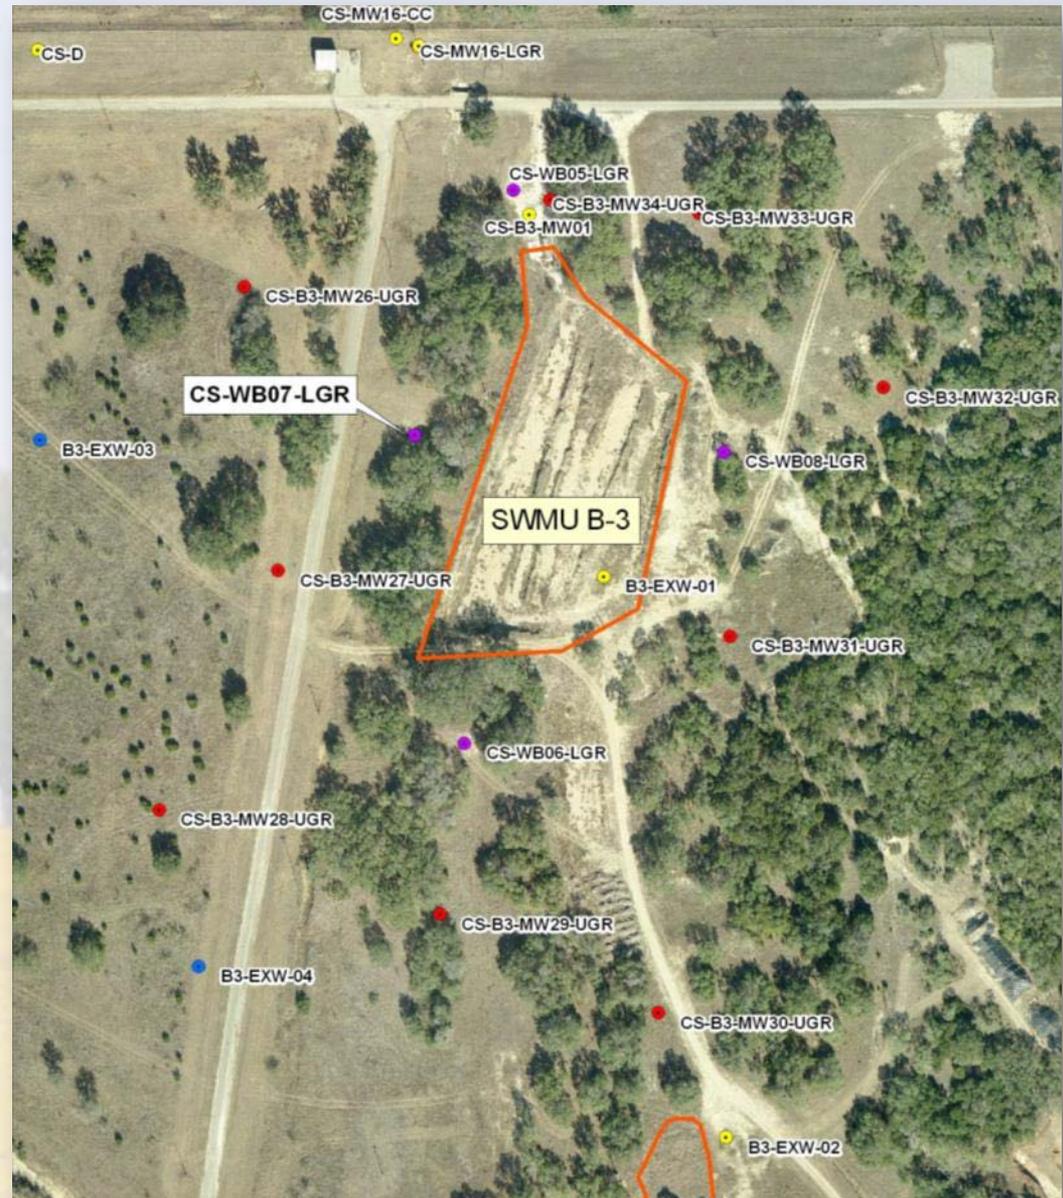
Replacement of CS-WB07

- Westbay well was damaged in March 2011 when probe and samplers broke off the wireline at 245' bgs.
- Probe was stuck, but was successfully extracted.
- Camera survey showed that the casing has been compromised.
- Water level inside the WB well has equilibrated with 03B zone.
- CSSA is funding extraction/replacement of WB07 this month.

- Continue monitoring bioreactor for UIC Permit and Performance parameters.
- Provide design for potential final remedy on SWMU B-3. Design includes new permanent tanks and delivery system with installation of SCADA control systems to allow remote data collection from wells and sumps.
- Repair WB07.

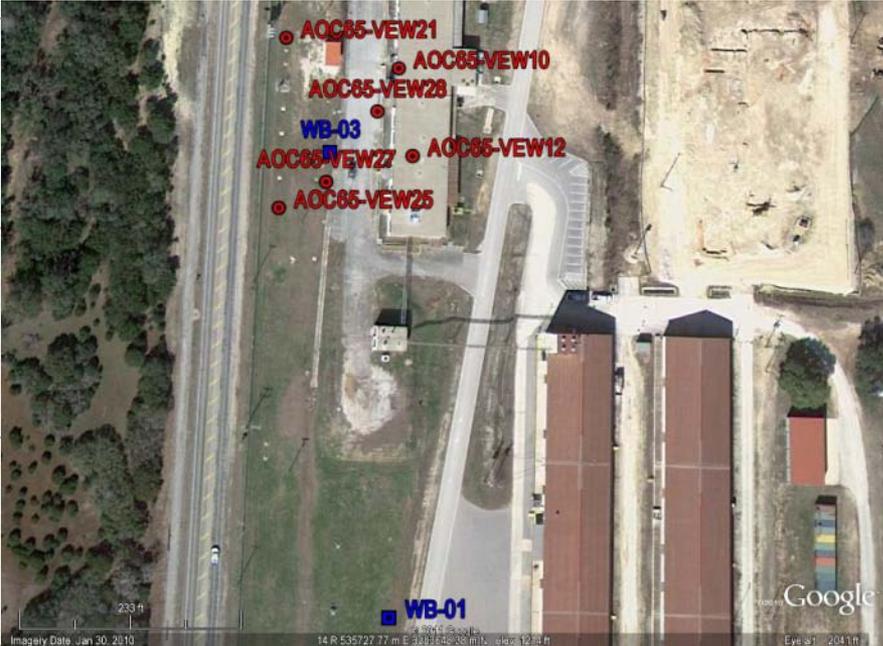
AOC 65 Vapor - CSIA vs Concentration

- ◆ AOC 65 Vapor PCE CSIA
- GW PCE CSIA

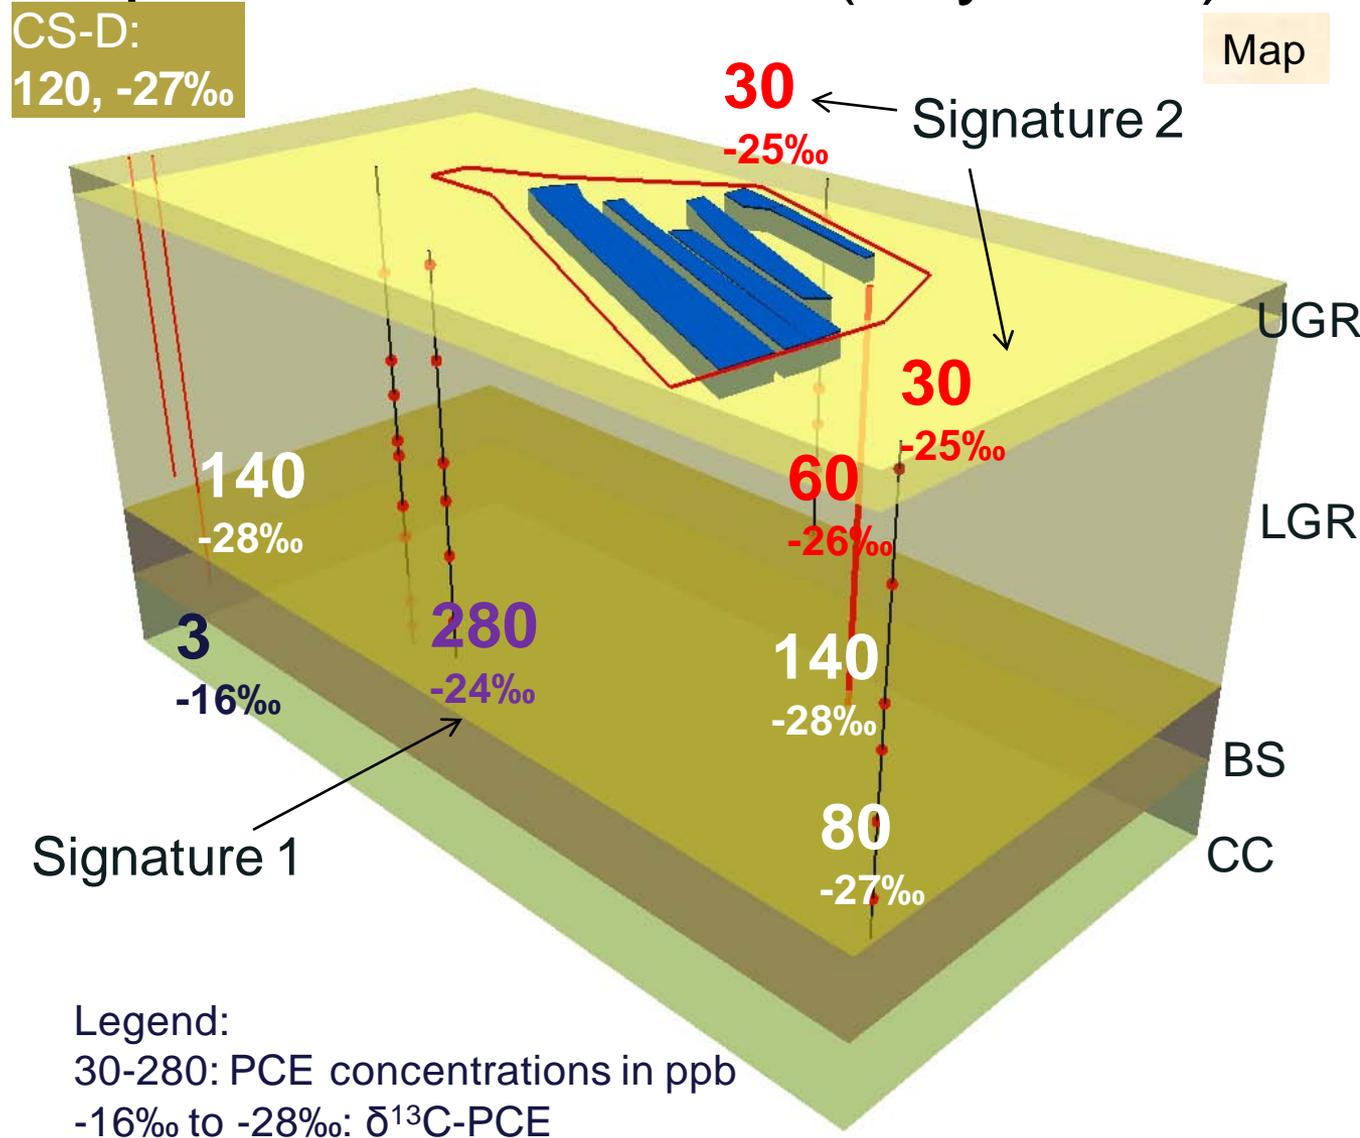
Mixing is shown between Upper Glen Rose (UGR) and Lower Glen Rose (LGR). Water pumped into bioreactor from Cow Creek (CC) infiltrates in LGR. It is not known if there is mixing through the Bexar Shale (BS).

- Concentrations of PCE highest west of the bioreactor just above the BS
- The area with highest PCE concentration (WB07-LGR4) has a $\delta^{13}\text{C}$ -PCE of -24‰ indicating isotopic fractionation, probably due to degradation

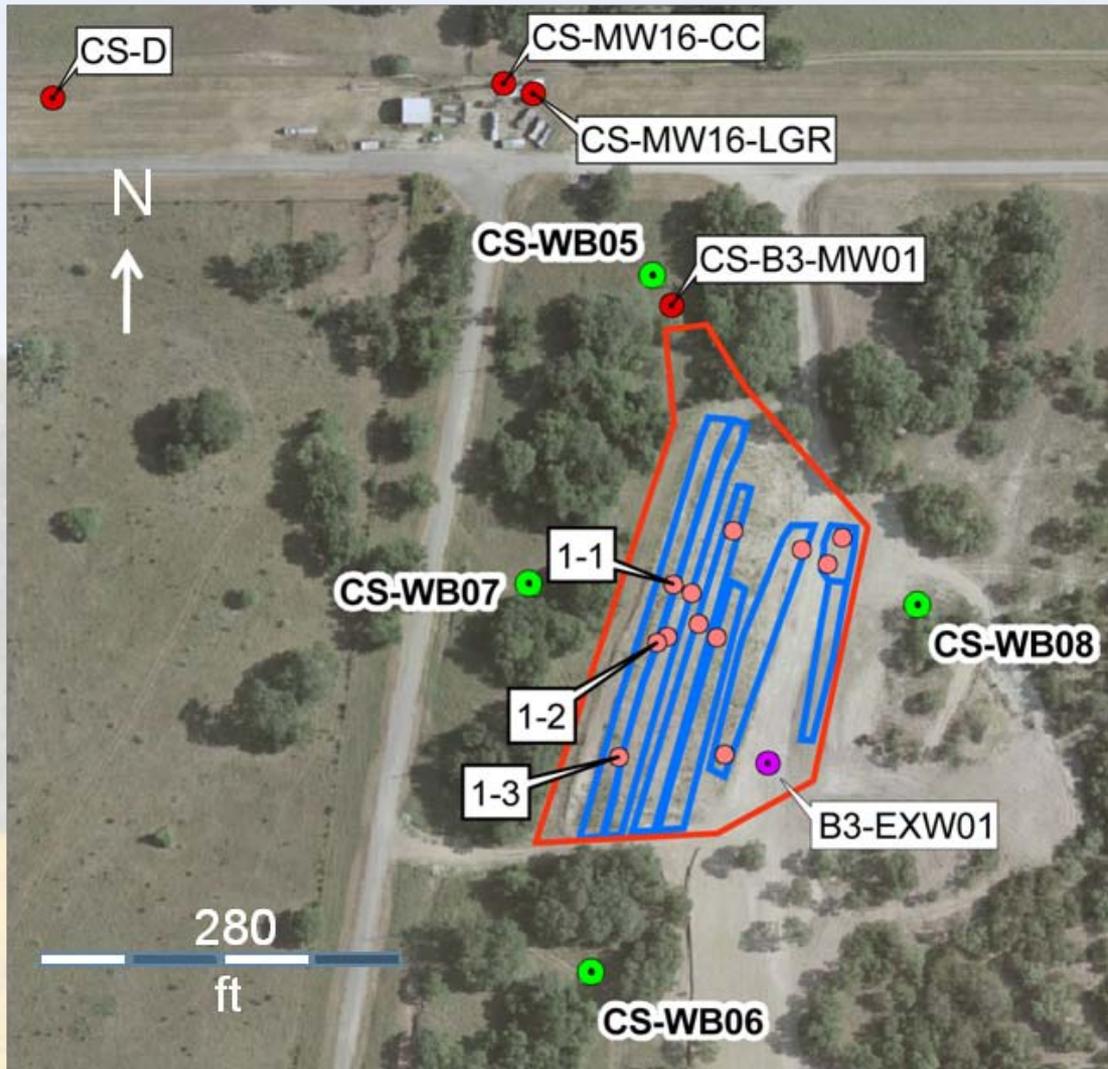
- Bioreactor trenches
- Sampling points in Trench 1
- Monitoring wells
- Extraction wells
