# **Camp Stanley Storage Activity Status Update**

January 24, 2012

## B-3 Bioreactor General Observations

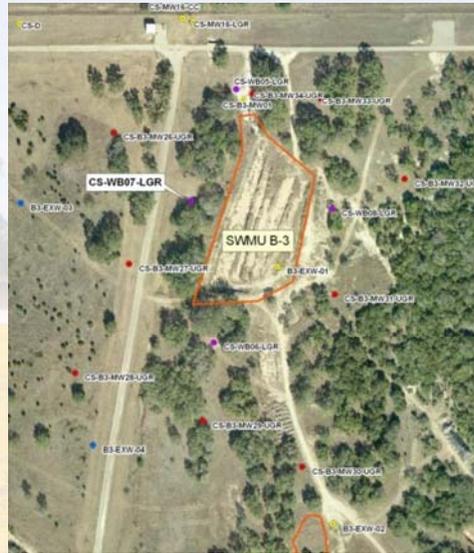
- Westbay well was damaged in March 2011 when monitoring instrument and sampler tubes broke off the wireline.
- The instrument and samplers were successfully extracted.
- Camera survey showed that the casing has been compromised.
- Water level inside the WB well was equilibrated with 03B zone.
- Packers were deflated and all casing material was removed. A damaged coupling was discovered at 247' bgs.
- New well materials were installed and WB07 was returned to service in July 2011.

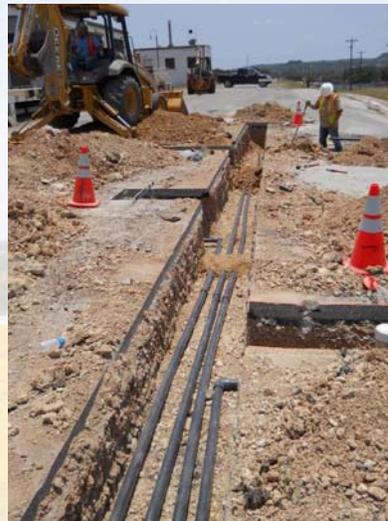
28

### Activities since July 2011 :

- Installed 2 steam injection wells (SIW) and 5 Vapor Extraction Wells (VEW).
- Upgraded existing SVE system (new Building 90 External system blower installed).
- Performed treatability study utilizing thermally enhanced SVE.
- Repaired waterline leaks.

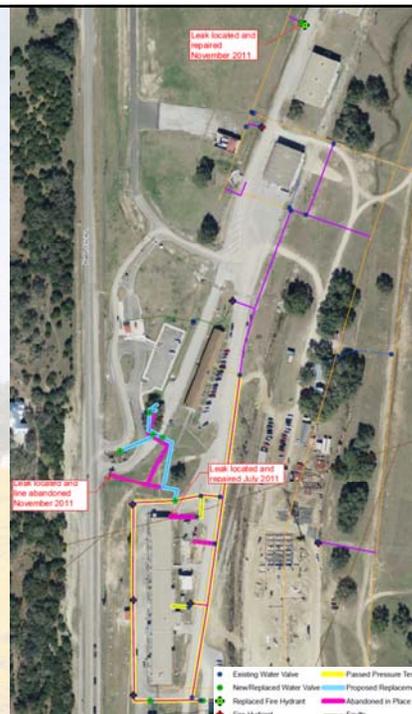
32

## Water Line Repair

- Evidence of water line leak near Building 90 discovered during monitoring and drilling activities.
- Groundwater sample from CS-MW36-LGR showed chlorine disinfection by-products (i.e. chloroform).
- Water lines near Building 90 inspected and pressure tested.
- Water lines determined to be in very poor condition were abandoned in place or repaired as necessary.

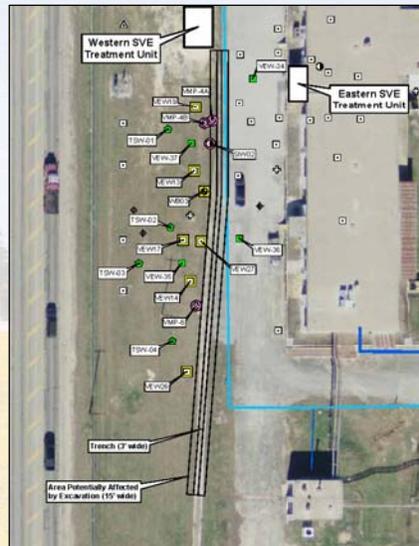
34

## AOC-65 Treatability Study Updates Proposed Interim Removal Action

- IRA removing potentially contaminated soils and bedrock west of Building 90 within the ditch area.
- Approximate dimensions of the trench will be 300 ft long, ~3 ft wide, and up to 15 ft deep.
- The trench will be backfilled with alternating layers of gravel and compacted clay.
- Perforated pipe will be installed within the gravel layers for delivery of an ISCO solution.
- An ISCO solution of sodium persulfate activated with sodium hydroxide will be applied and allowed to infiltrate through fractures intersecting the trench.

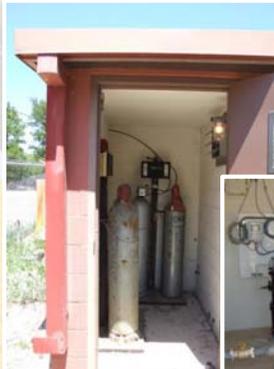
54

## Supply Well CS-1 (cont.)

- CSSA intends to convert all of its potable water supply wells to hypochlorite disinfection systems. This process will begin at well CS-1.
- Parsons submitted an **Engineering Plans and Specifications** document to the TCEQ on September 15, 2011, which included demolishing the existing gas chlorination system, remodeling the facility, and constructing a hypochlorite system.
- The TCEQ approved the modification on November 8, 2011.
- CSSA is currently contracting the construction effort through the USACE.
- Expect that the upgraded well will be operational in Spring 2012.

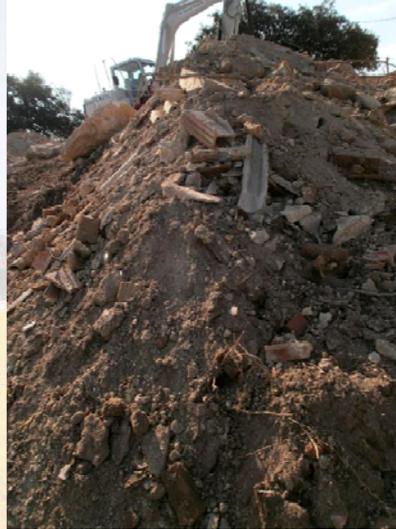
79

## Site Closure Updates AOC-72

- Construction debris landfill, 2 acres
- Previous work:
  - XRF analysis
  - Exploratory excavations
  - Surface soil sampling
- Next Steps:
  - Complete excavation
  - Submit RIR to TCEQ requesting NFA decision

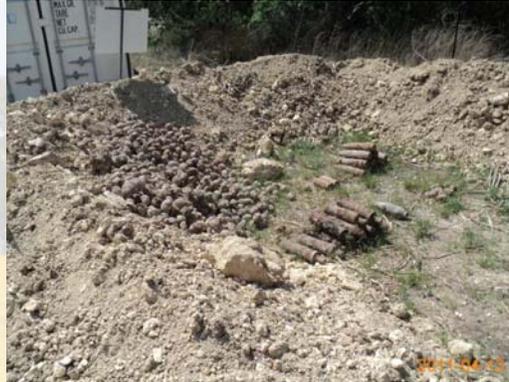
83

## Site Closure Updates SWMU B-4

- Disposal area, 2 acres
- Previous work:
  - Geophysical surveys
  - Soil gas surveys
  - Surface and subsurface soil sampling
  - Excavation of 4 waste trenches (9,110 CY)
  - Sorting and management of 3,000 CY media remaining from excavation
- Next Steps:
  - Excavate one additional trench
  - Submit trench confirmation results to Weston for inclusion in APAR to TCEQ

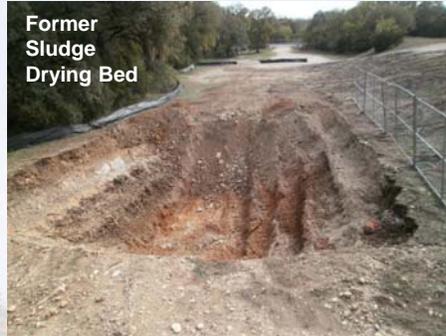
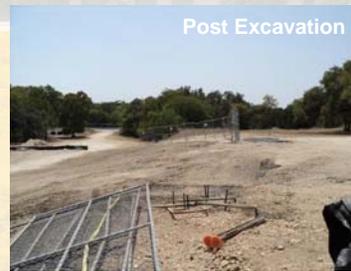
85

## Wastewater Treatment Plant

- CSSA WWTP removed from service June 24, 2011 when CSSA connected to SAWS, 0.6 acre
- Previous work: soil gas survey
- Work Performed:
  - Removal of wastewater and sludge
  - Disinfection of all WWTP components with bleach solution
  - Demolition of WWTP components
  - Excavation and removal of soil media and construction debris
  - Surface and subsurface soil sampling
- Next Steps:
  - Collect samples at ~20 feet bgs within former sludge drying bed for Nitrate/Nitrite analysis
  - Submit RIR to TCEQ requesting NFA decision
