**ENVIRONMENTAL ACTIVITIES AT
CAMP STANLEY STORAGE ACTIVITY
(CSSA)**

MEETING MINUTES

OVERVIEW			
CLIENT	Camp Stanley Storage Activity		
PROJECT	Contract G012		
MEETING DESCRIPTION			
SUBJECT	TO8 Kick-off Meeting	LOCATION	CSSA
MEETING DATE	09/22/2014	REPORT AUTHOR	Shannon Schoepflin
MEETING TIME	10:00 am Central	REPORT DATE	09/25/2014
ATTENDEES			
CSSA		PARSONS	
Gabriel Moreno-Fergusson James Cannizzo		Julie Burdey Laura Arciniaga Scott Pearson Ken Rice Kyle Caskey Brenda Shirley	Shannon Schoepflin Adrien Lindley Julie Bouch Samantha Elliott Richard Fincke Wayne Simoneau
TOPICS			
<p>New Task Order (TO8) Only the CLINs related to the environmental portions of TO8 were discussed at this meeting. CLINs related to the engineering portions of TO8 will be discussed in a separate meeting on October 9, 2014.</p> <p>CLINs 1, 2A, 3, 4, 6, 7 The budget, activities, responsibilities, and task managers were discussed for each of these CLINs. CLIN 1 (FFP) includes project management and administrative duties. CLIN 2A (FFP) covers meetings, data information management, and semi-annual progress reports. CLIN 3 (FFP) includes O&M, compliance, and monitoring. CLIN 4 (FFP) covers groundwater and dr

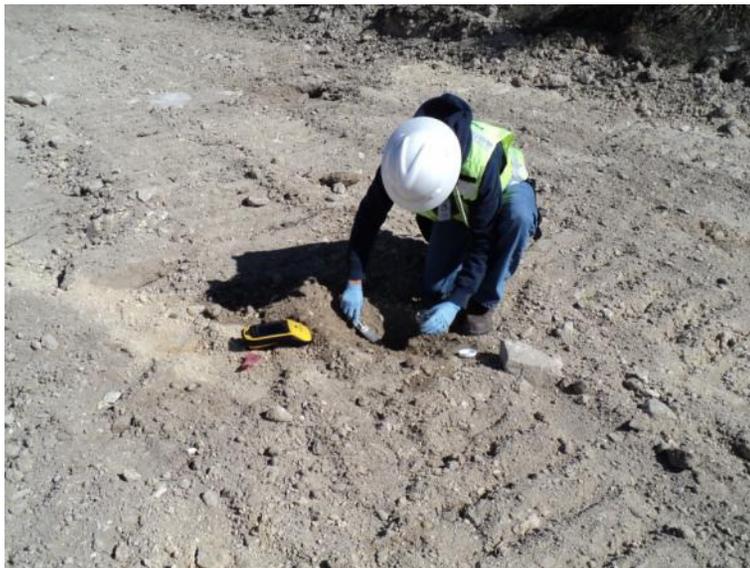
SITE CLOSURE PROCESS

Soil samples were collected to test for contamination and to help delineate the site boundaries.

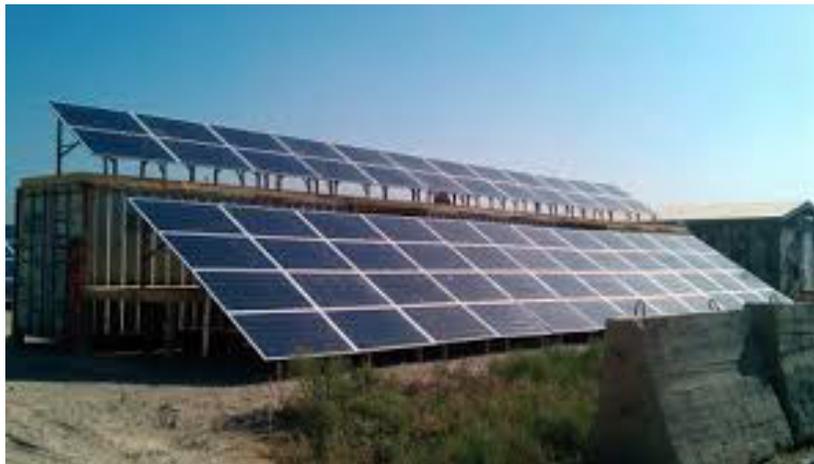
Installation of a 28.2 kW Sundial[®] Military Transportable Solar Power System is expected to be completed by late-2014.

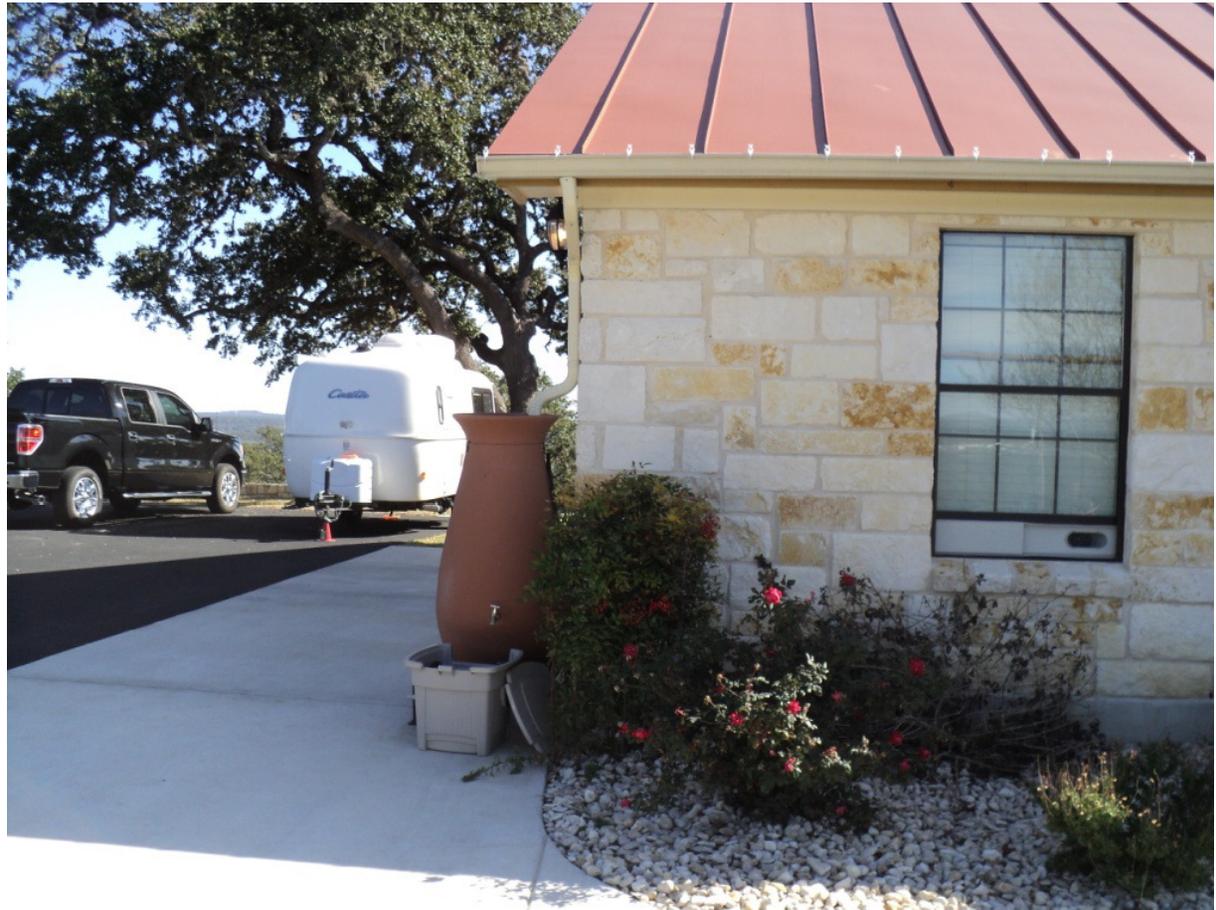
Rainwater harvesting is part of CSSA's Water Management Plan.
