FIGURE 5.14
 MAGNETIC ANOMALIES
 DETECTED IN
 CRATERS 13 & 11
 CAMP STANLEY STORAGE ACTIVITY

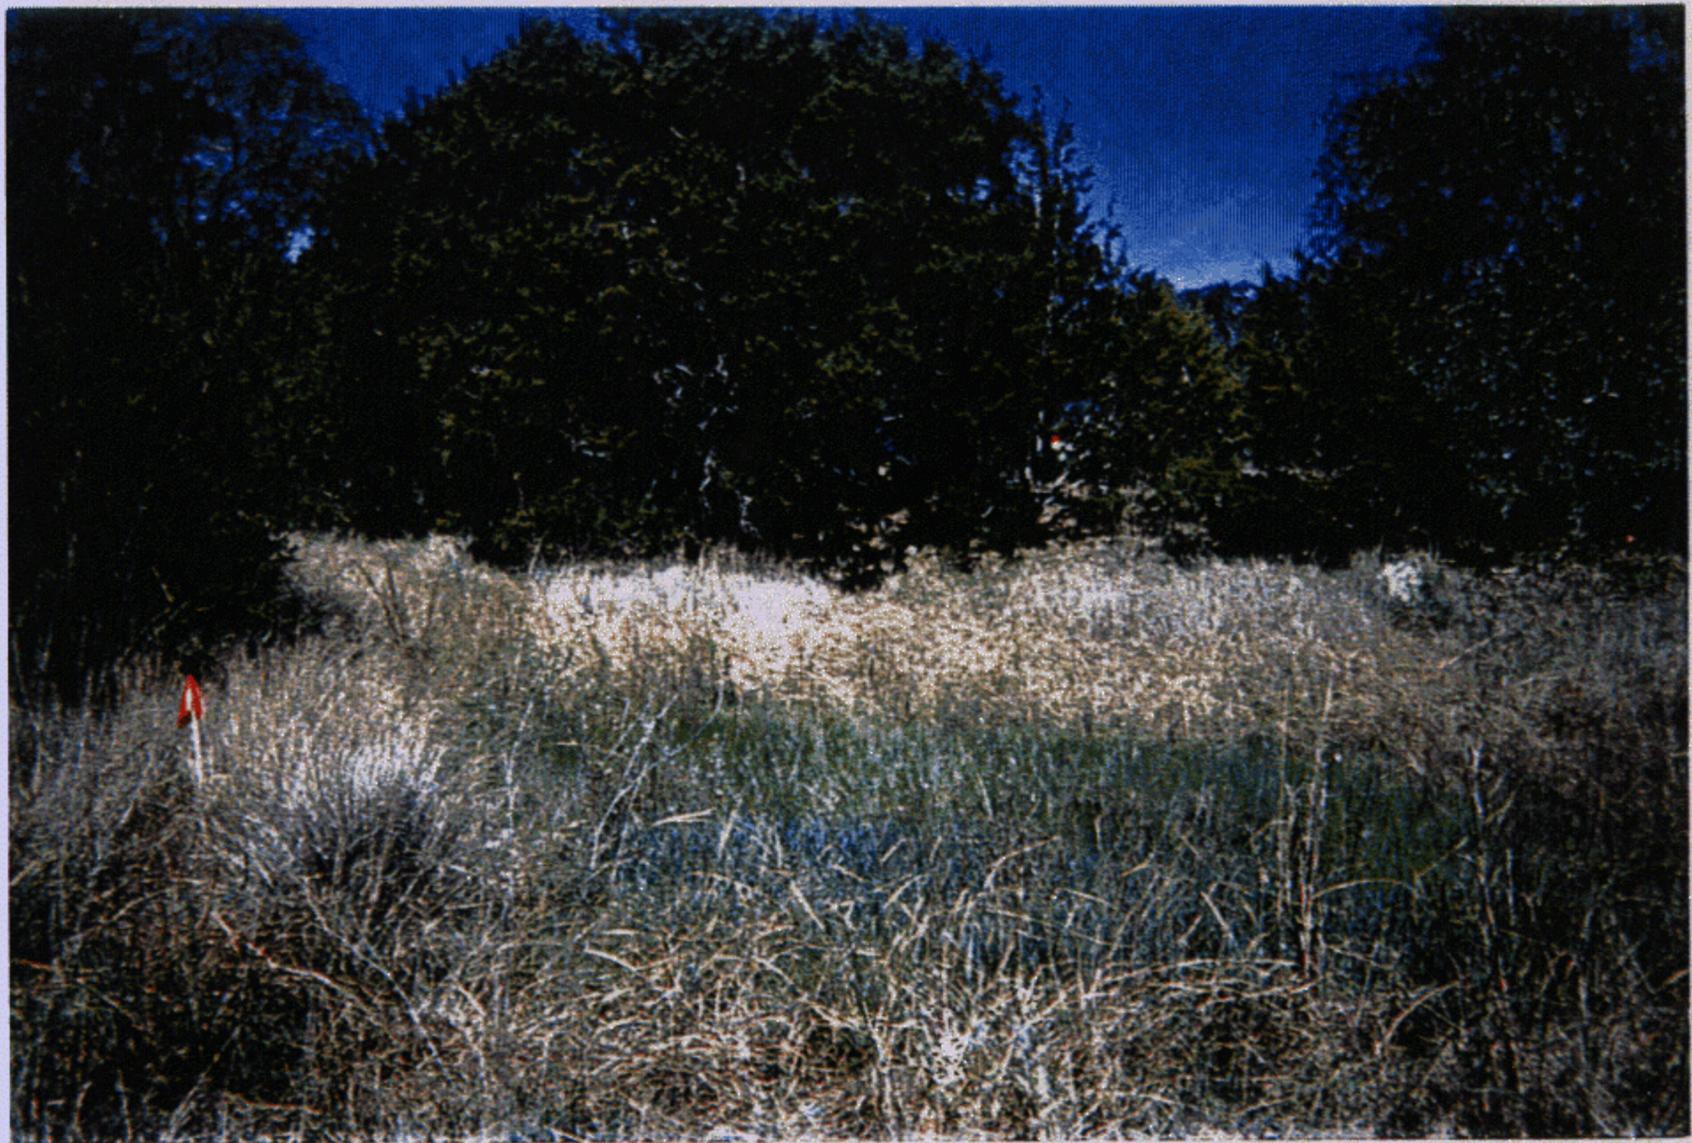
NOTE:
 NO MAGNETIC ANOMALIES WERE DETECTED IN CRATERS 11 OR 13. CRATER 13 CONTAINS WATER AFTER PERIODS OF PRECIPITATION. AT THE TIME OF THE MAGNETOMETER SURVEY, THE CRATER CONTAINED APPROXIMATELY 6 INCHES OF WATER.

1349.9 ft. MSL = ELEVATION AT CENTER OF CRATER 11
 1351.4 ft. MSL = ELEVATION OF CRATER EDGE (CRATER 11)
 1351.5 ft. MSL = ELEVATION AT CENTER OF CRATER 13
 1352.7 ft. MSL = ELEVATION OF CRATER EDGE (CRATER 13)
