# RELEASE INVESTIGATION REPORT

## AREA OF CONCERN 69 (AOC-69) CAMP STANLEY STORAGE ACTIVITY

### **Camp Stanley Storage Activity Boerne, Texas**

June 2009

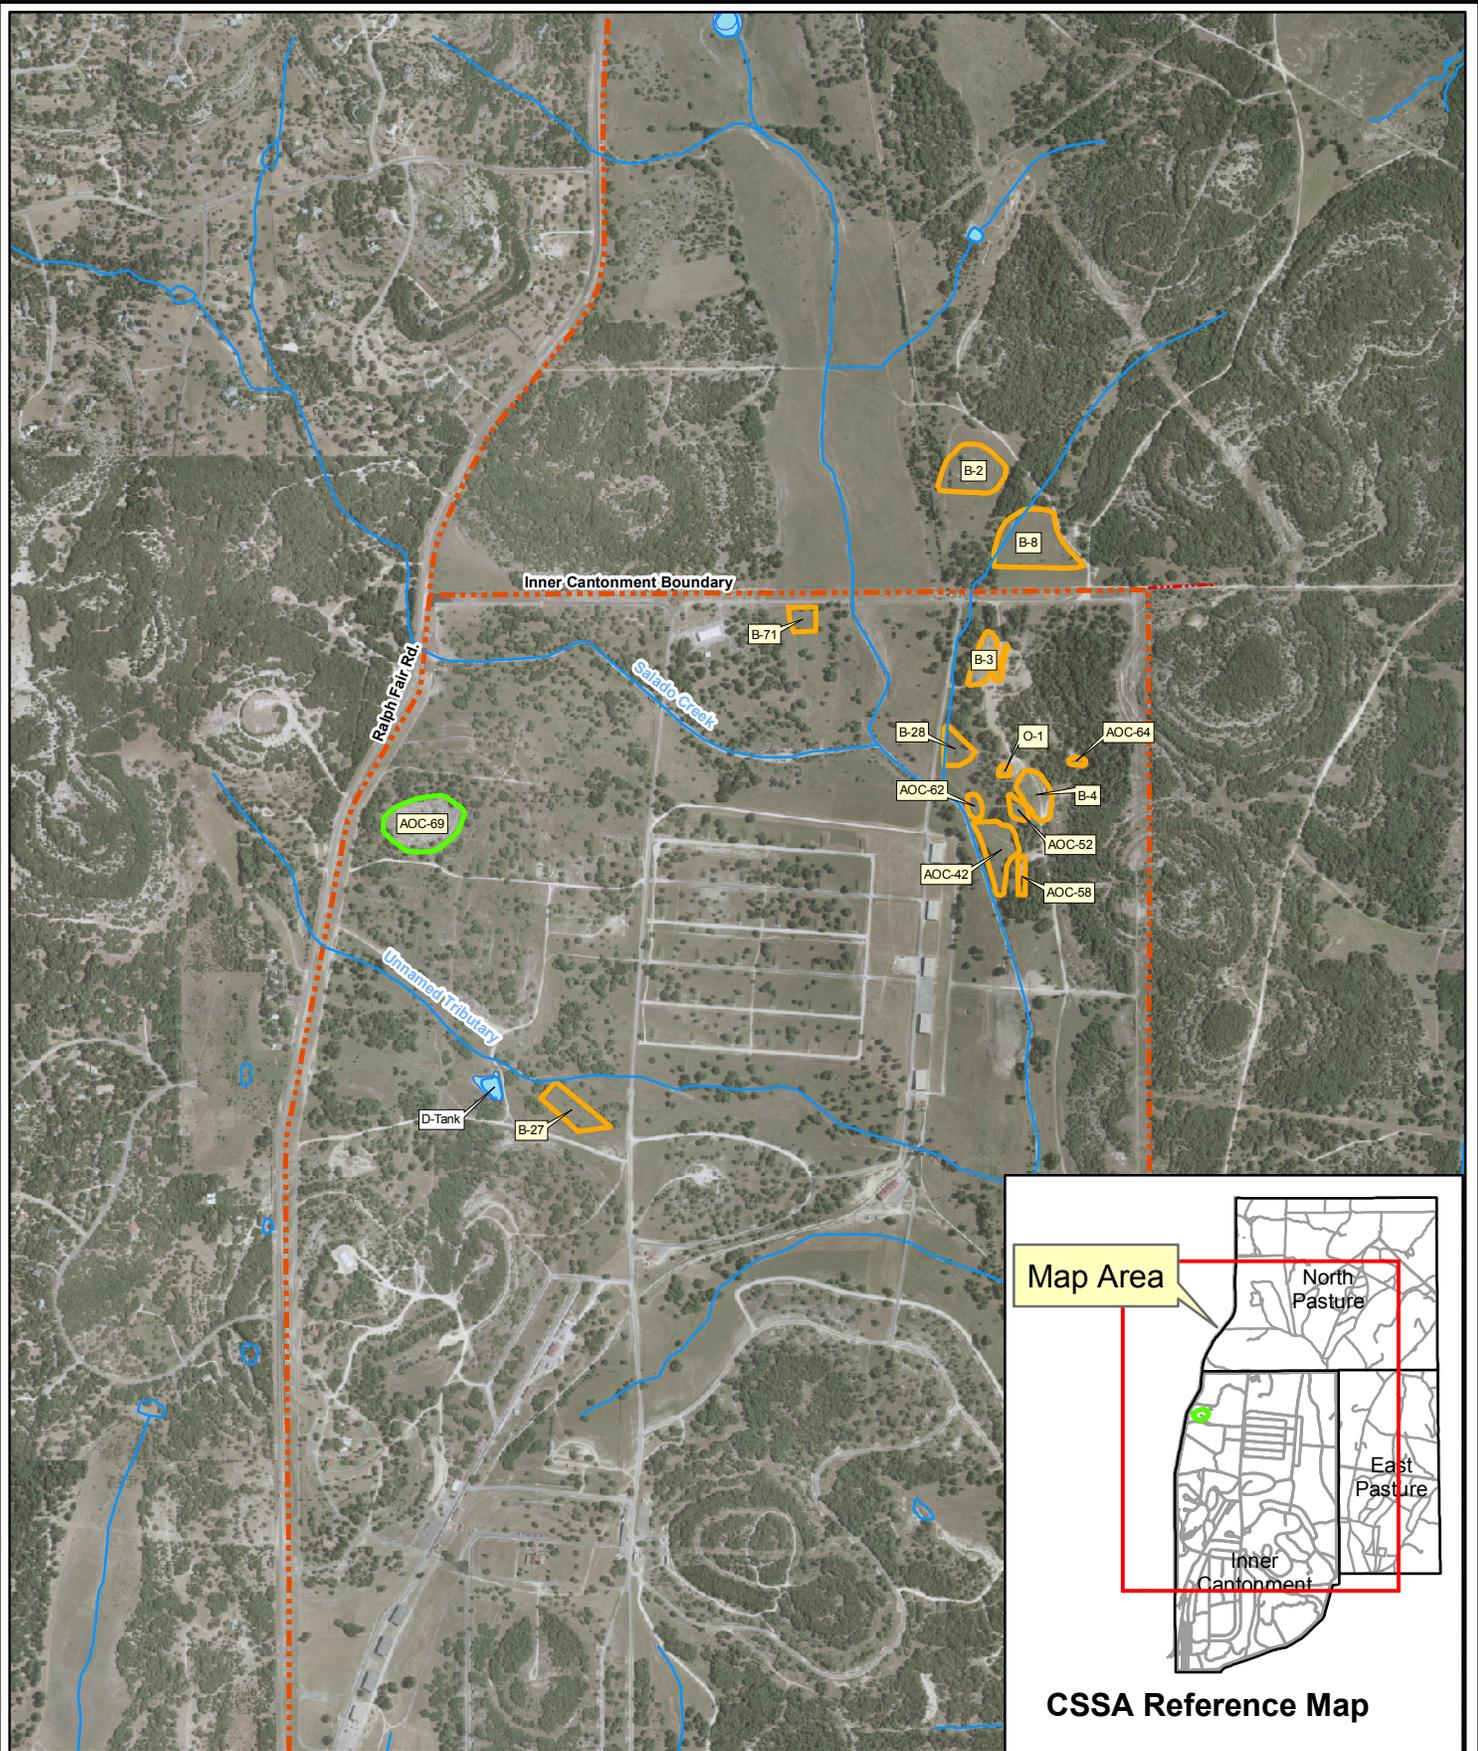
**Figure 2**

AOC-69 is located in the Inner Cantonment of CSSA (Figure 2). It is approximately 1,588 feet south of the fence that separates the Inner Cantonment from the North Pasture of the installation. It is approximately 310 feet east of Ralph Fair Road, which forms the western boundary of CSSA. The site covers approximately 4.765 acres.

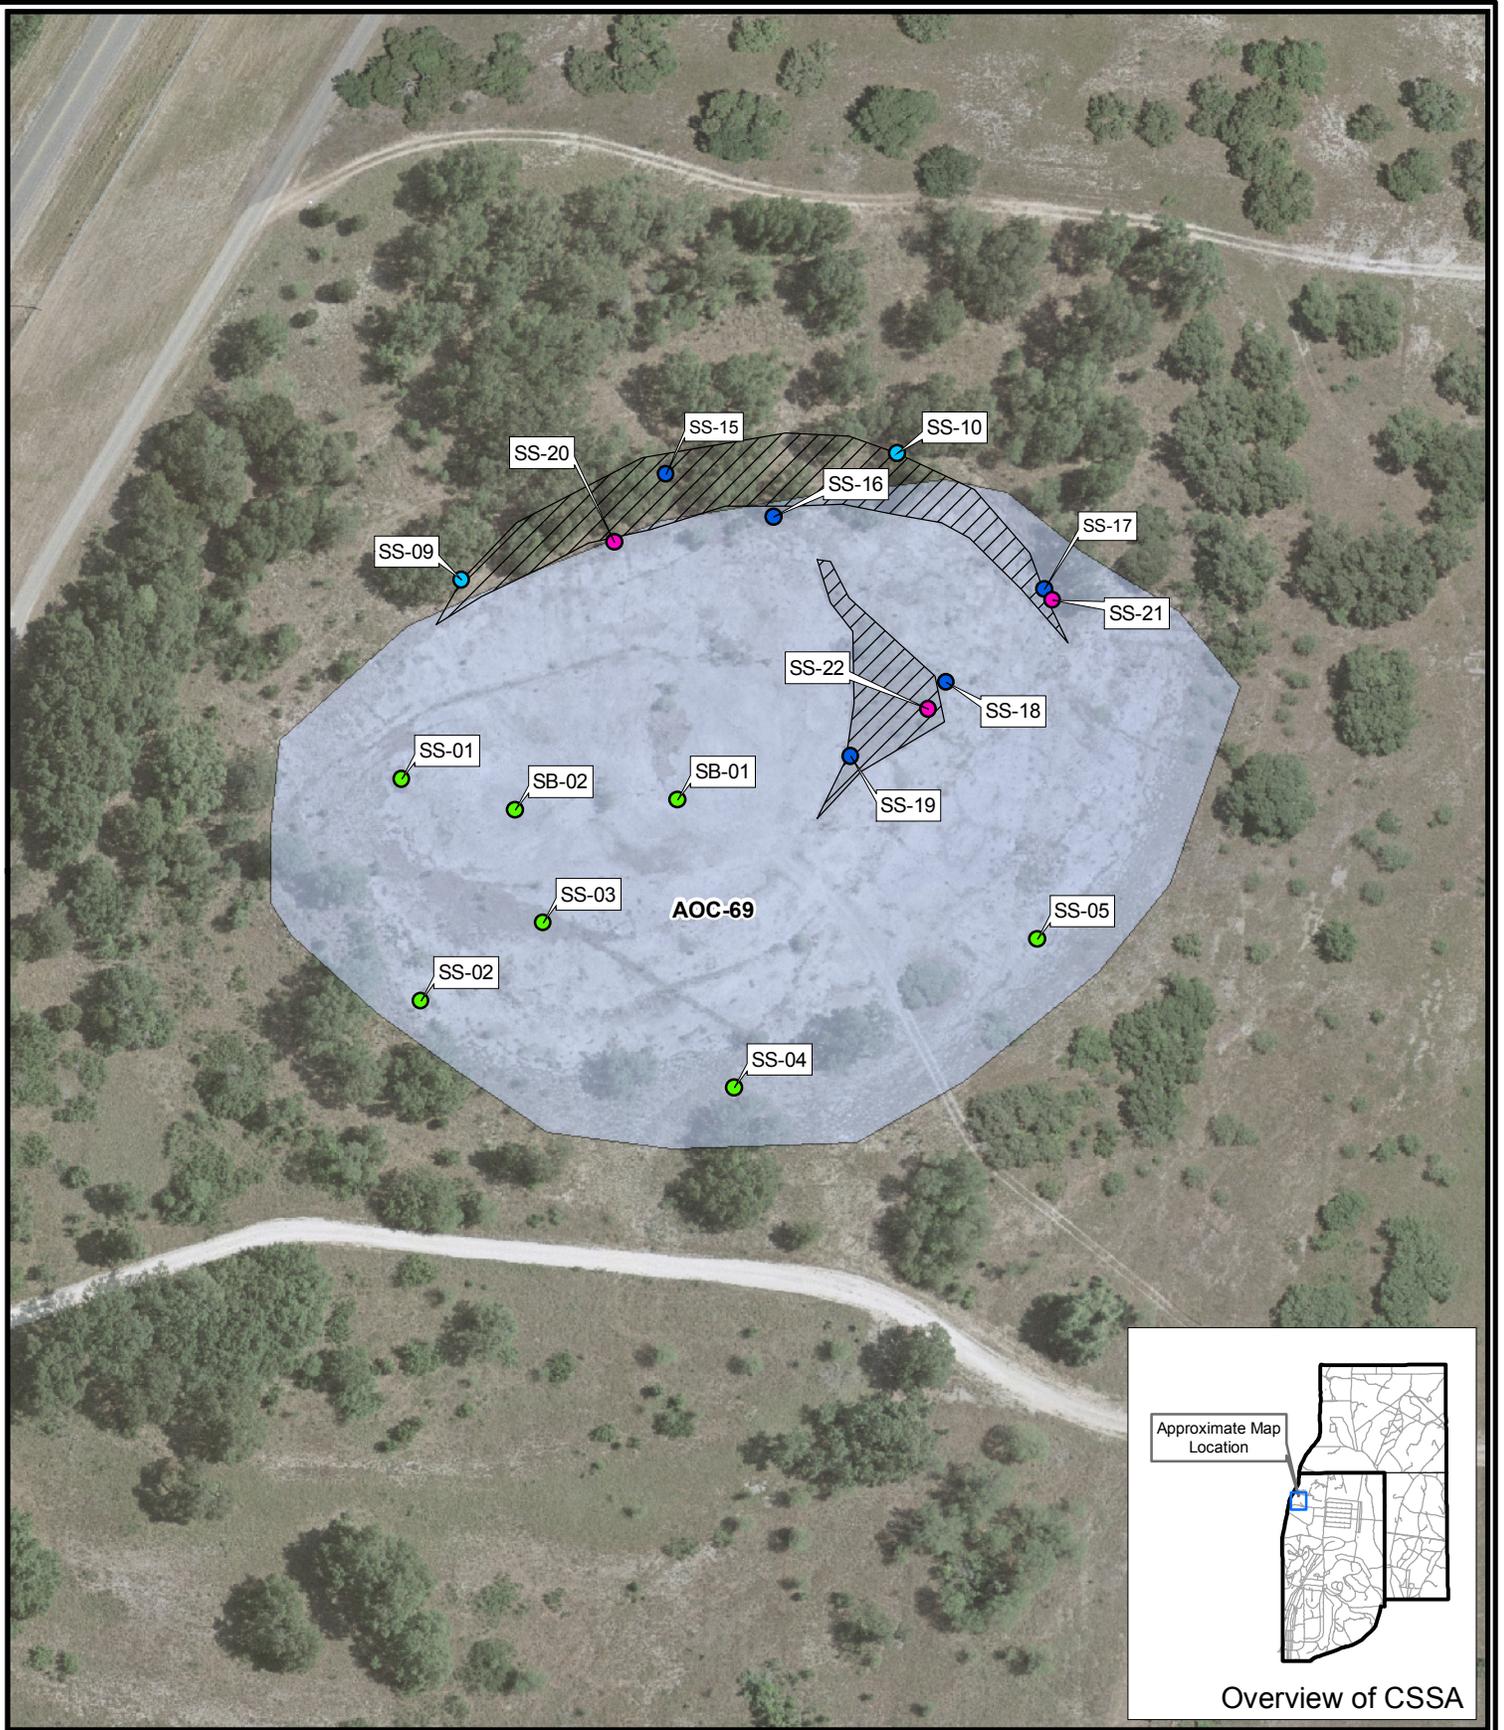
AOC-69 Sample Locations  
Camp Stanley Storage Activity

Soil sampling and excavation activities that have been performed at AOC-69 are summarized in Table 1. A summary of the sampling results for soils remaining at the site (*i.e.*, soils not excavated and removed from the site) are shown in Table 2 and the final soil sampling locations that remain at the site are shown on Figure 4.

As described in Table 1, the initial investigation showed that three metals (lead, copper, and zinc) were detected at concentrations above their respective PCLs. No other chemicals were above PCLs. As summarized in Table 1, lead was detected above its PCL at three sample locations. One of these locations also had copper and zinc concentrations above their respective PCLs. Two of the three sample locations were along the northern side of the site (down slope of the topographic mound) and the other sample location was in a low-lying area where soil had collected along the central north-eastern portion of the site. Although some volatiles and semivolatiles were detected, all detections were much lower than their PCLs. See Table 1 for a summary of these results. The list of the analytical results for soils remaining at the site is provided in Table 2. Sample locations for soils remaining at the site are shown on Figure 4. The clearance areas where soils were excavated and removed are also shown on Figure 4 (described below.)

A second round of samples was collected on June 23, 2008 to identify the extent of metal contamination at AOC-69. Five samples were collected in the areas of the three sample locations that were found to have high metal concentrations in the initial (April 10, 2008) sampling event. The samples were analyzed for the nine CSSA metals. Results showed that three of the five sampling locations had metals concentrations above PCLs. Lead was detected above its PCL at the three locations. Cadmium, copper, mercury and zinc were also each detected above their respective PCLs at one of the three locations. No other sample results exceeded PCLs. See summary of results in Table 1; the list of analytical results for soils remaining at the site in Table 2; and the sample locations for soils remaining at the site on Figure 4.

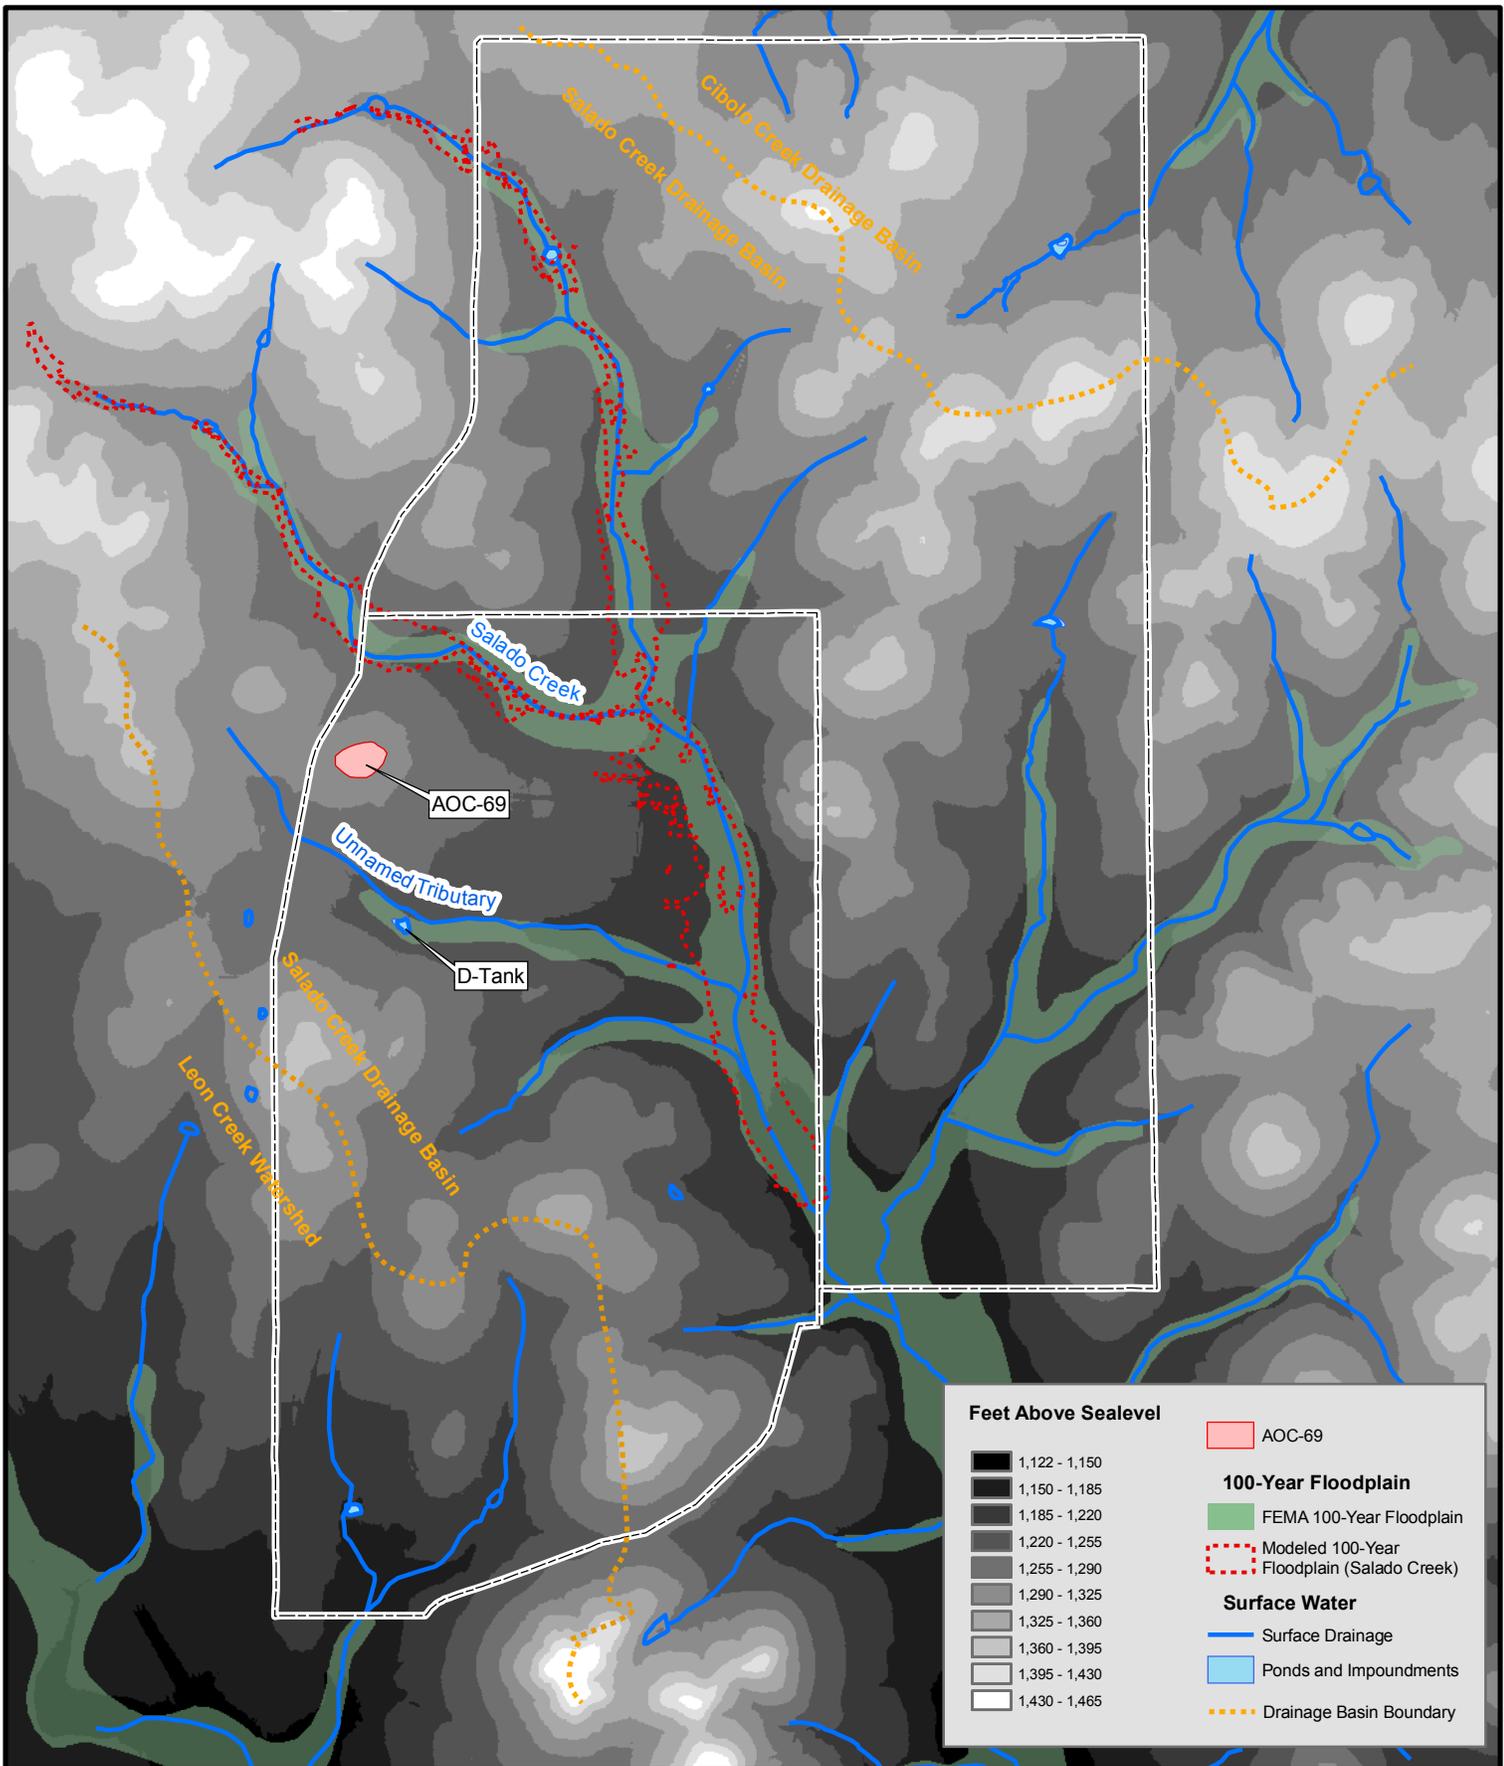
**Figure 5**

Salado, Leon and Cibolo Creeks drain surface water from CSSA (Figure 5). All creeks at CSSA are intermittent and only contain water during and immediately following rain events.

As shown on Figure 5, the closest creek to AOC-69 is an unnamed tributary located 956 feet to the southwest. This unnamed tributary does not receive potential surface water runoff from the site. It is also not a State classified segment under Texas Surface Water Quality Standards (§§307.1 - 307.10). The nearest downgradient creek from AOC-69 is Salado Creek (which is classified under Texas Surface Water Quality Standards as Segment 1910 from the confluence with the San Antonio River in Bexar County to Rocking Horse Lane west of Camp Bullis). The creek is 1,050 feet north-northeast of AOC-69.

The nearest perennial surface water body to AOC-69 is the D-Tank pond which is located 1,830 feet to the south-southeast of the site (Figure 5). This pond is 105 feet upgradient from the unnamed tributary of Salado Creek. At this point along the unnamed tributary, the distance to Salado Creek is 4,450 feet.

Topography, Surface Water, and  
Floodplains at CSSA  
Camp Stanley Storage Activity

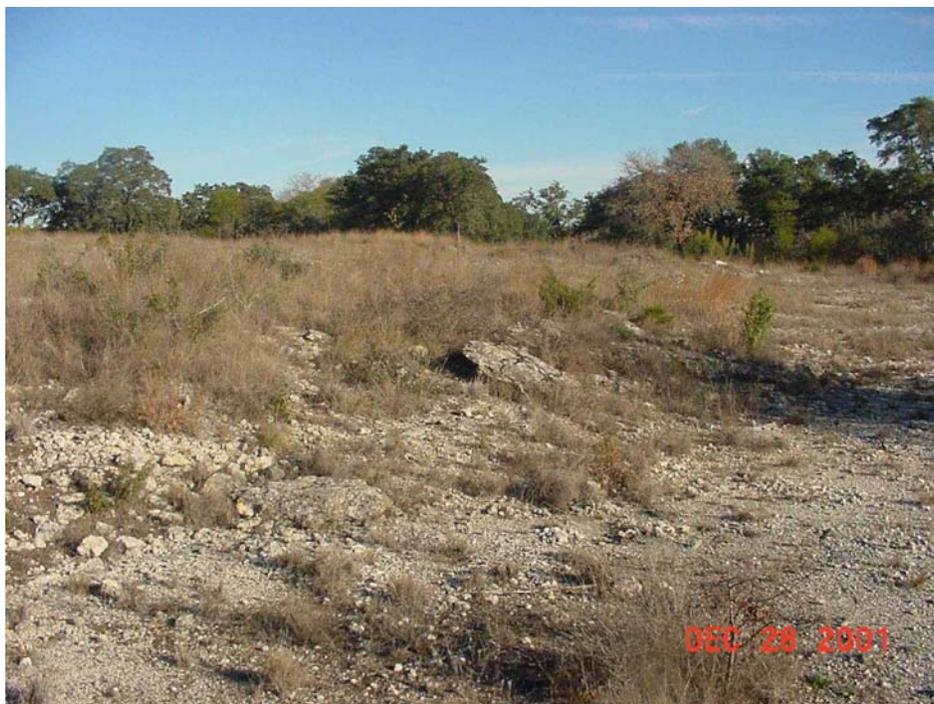
The site is located on exposed bedrock, on a topographic high, and has minimal soil horizon. Vegetation is scarce at this location due to lack of soil profile and shallow or exposed bedrock. Karst features are present at CSSA and three features were found at AOC-69 (see photo 3 in Appendix A). The karst features are not situated in locations that receive runoff from the site. Also, as discussed in Section 3.2.2, there is no evidence of groundwater contamination due to past practices at AOC-69.

**Photo 2. Exposed bedrock and typical vegetation at AOC-69. (Photo taken 12-28-01.)**

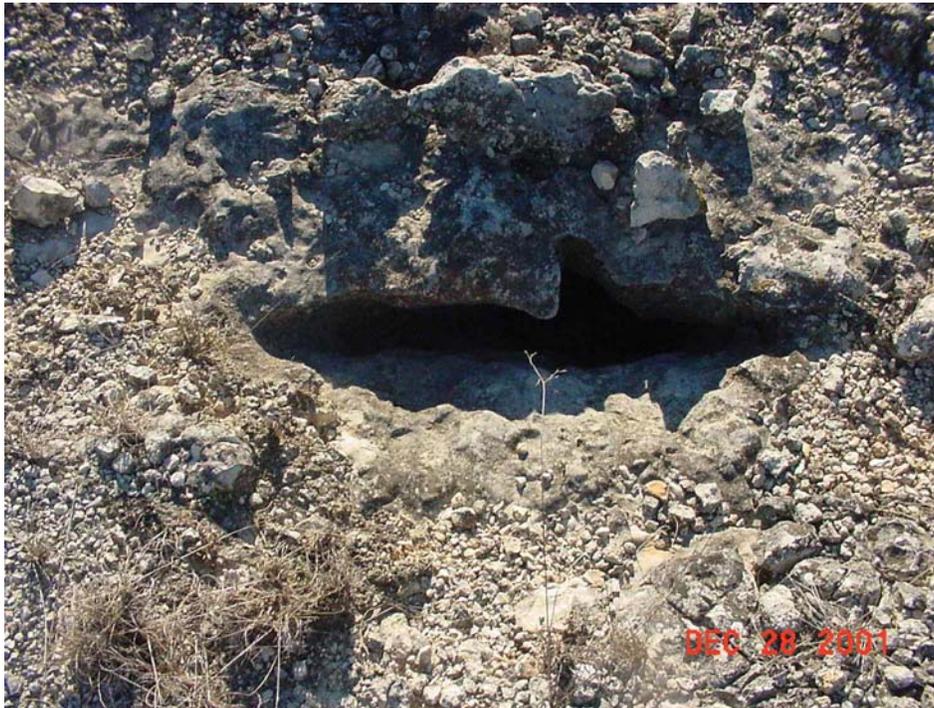
**Photo 3. Karst feature at AOC-69. (Photo taken 12-28-01.)**

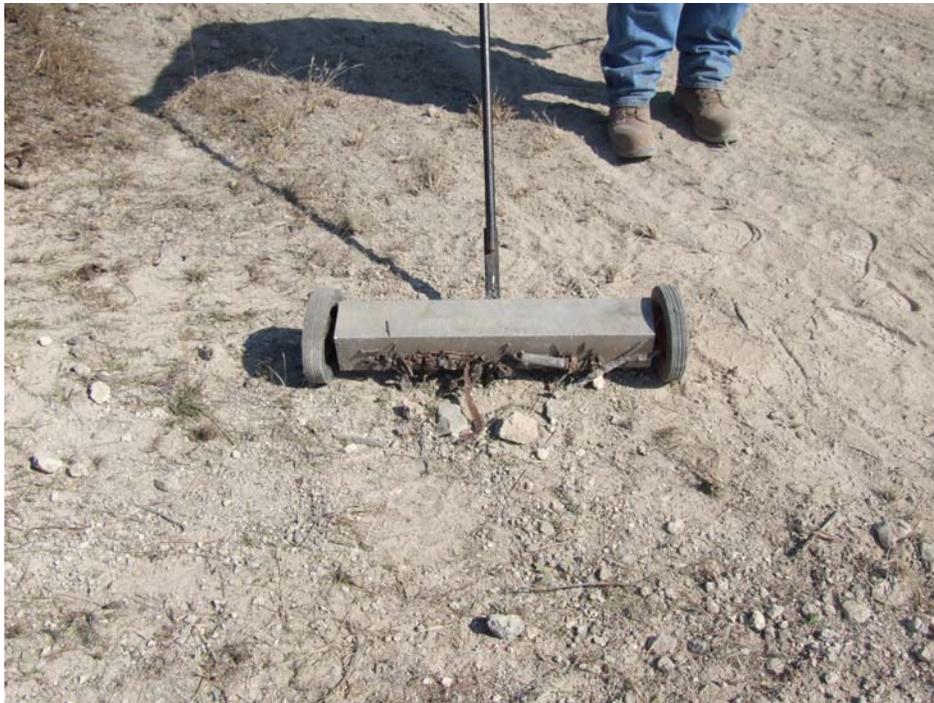
**Photo 4. Magnetic roller used to clean up scrap metal at AOC-69. (Photo taken 11-13-08.)**

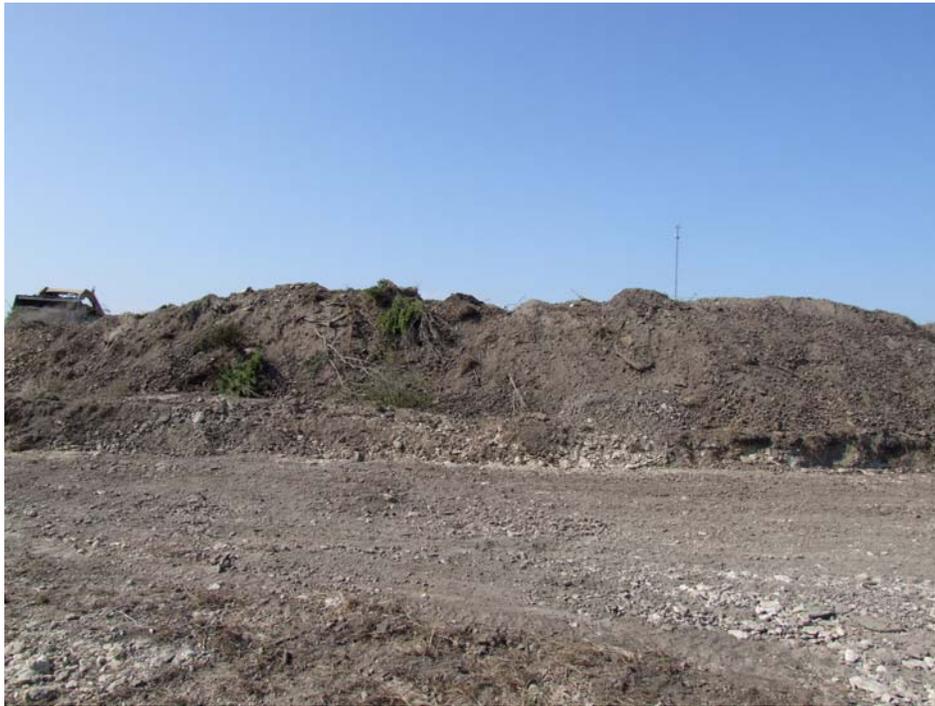
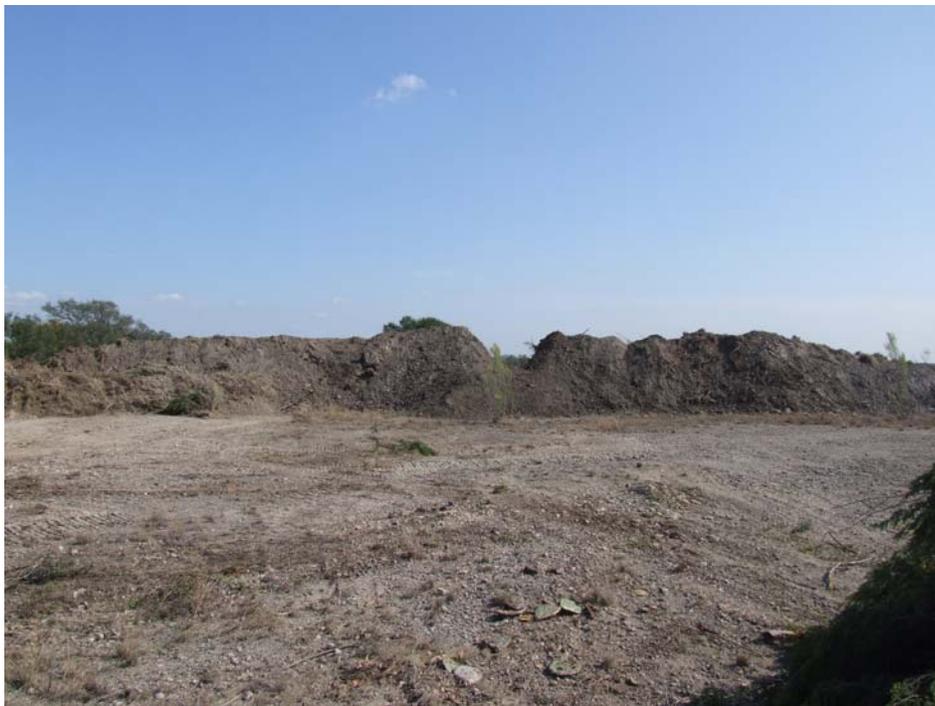
**Photo 5. Stockpile facing west at AOC-69. (Photo taken 11-13-08.)**

**Photo 6. Stockpile facing east at AOC-69. (Photo taken 11-13-08.)**

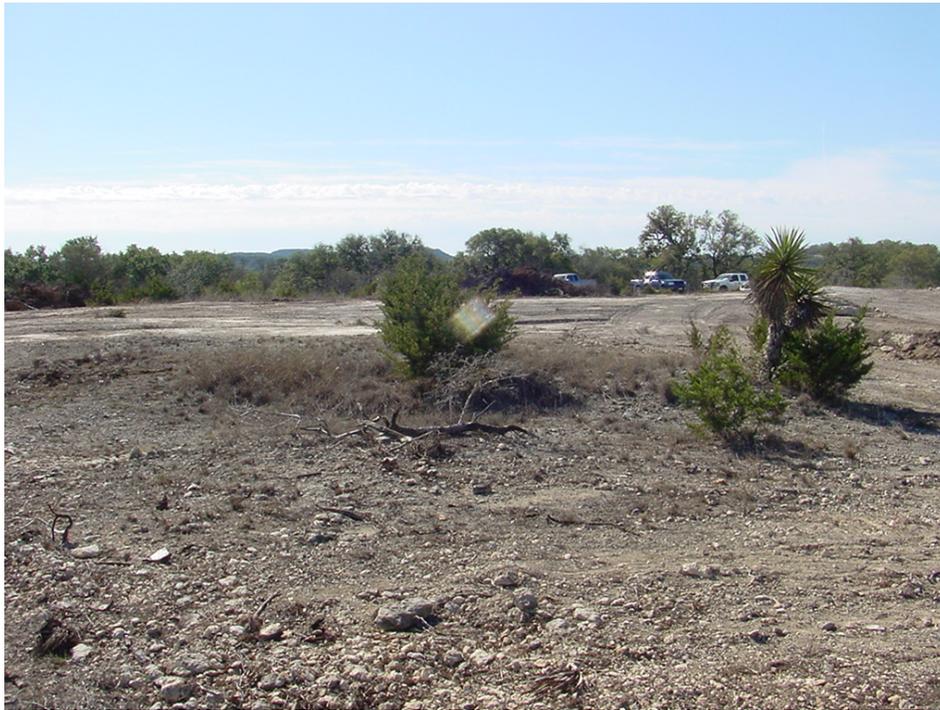
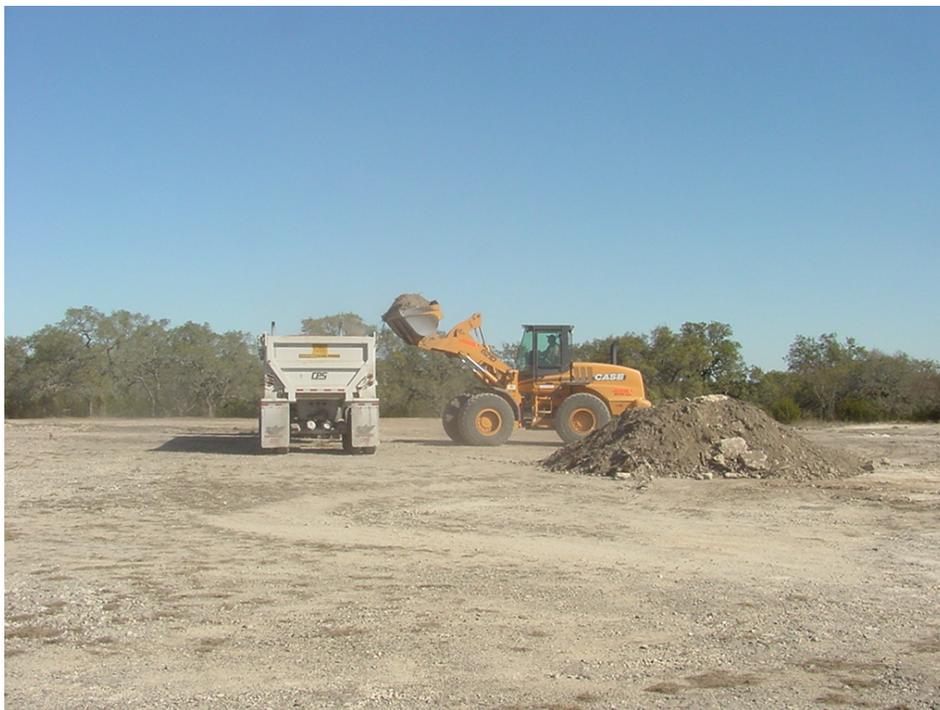
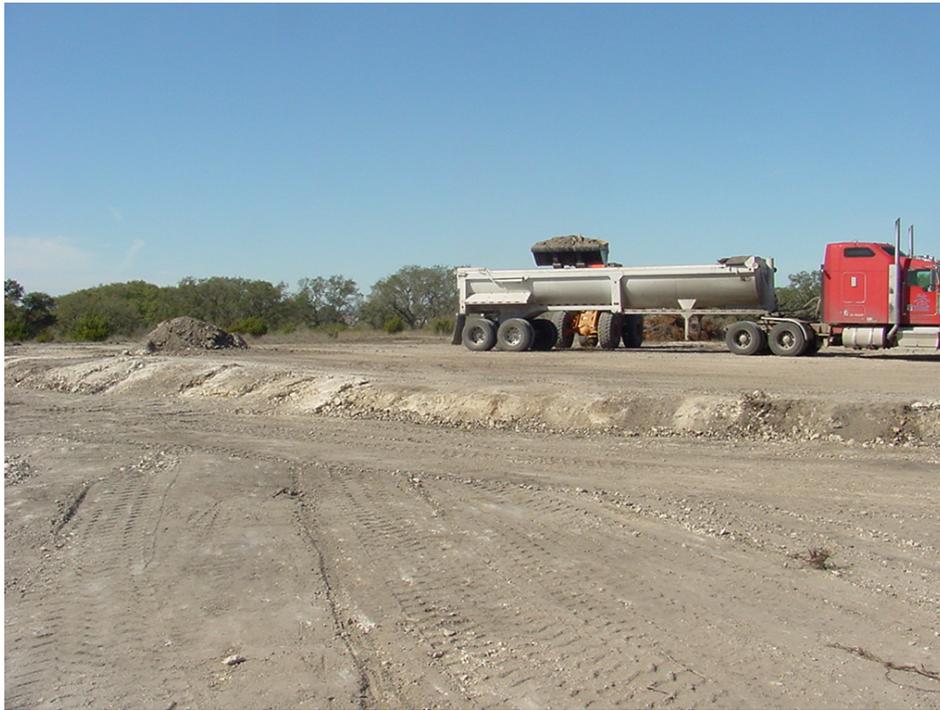
**Photo 7. View of AOC-69 during February 2009 excavation and confirmation sampling activities.  
(Photo taken 2-19-09.)**

**Photo 8. View of AOC-69 during February 2009 excavation removal activities.  
(Photo taken 2-19-09.)**

**Photo 9. View of AOC-69 during February 2009 excavation removal activities.  
(Photo taken 2-19-09.)**

During February 2009, additional excavation was conducted at and around the sample location from November 2008 where lead was detected above its PCL. Approximately 50 CY of additional soil/waste material was removed. Three confirmation samples were then collected and analyzed for lead, copper, and zinc. All sample results were below the PCLs.

The excavated soil/waste material from AOC-69 was also removed off post during February 2009. Waste characterization efforts were performed in accordance with requirements of CSSA's RCRA Facility Investigation (RFI) and Interim Measures (IM) Waste Management Plan – Revised, dated May 2006 (approved by TCEQ in August 2006). Results of waste characterization showed that the impacted media met State of Texas Class 2 non-hazardous criteria (30 TAC §335 Subchapter R). A total of approximately 440 CY of AOC-69 impacted soil media and waste were transported and disposed of off post at Waste Management, Inc. (WMI), Covell Gardens Landfill in San Antonio, Texas.
