# RELEASE INVESTIGATION REPORT RANGE MANAGEMENT UNIT 3 CAMP STANLEY STORAGE ACTIVITY

Camp Stanley Storage Activity Boerne, Texas

**May 2013**

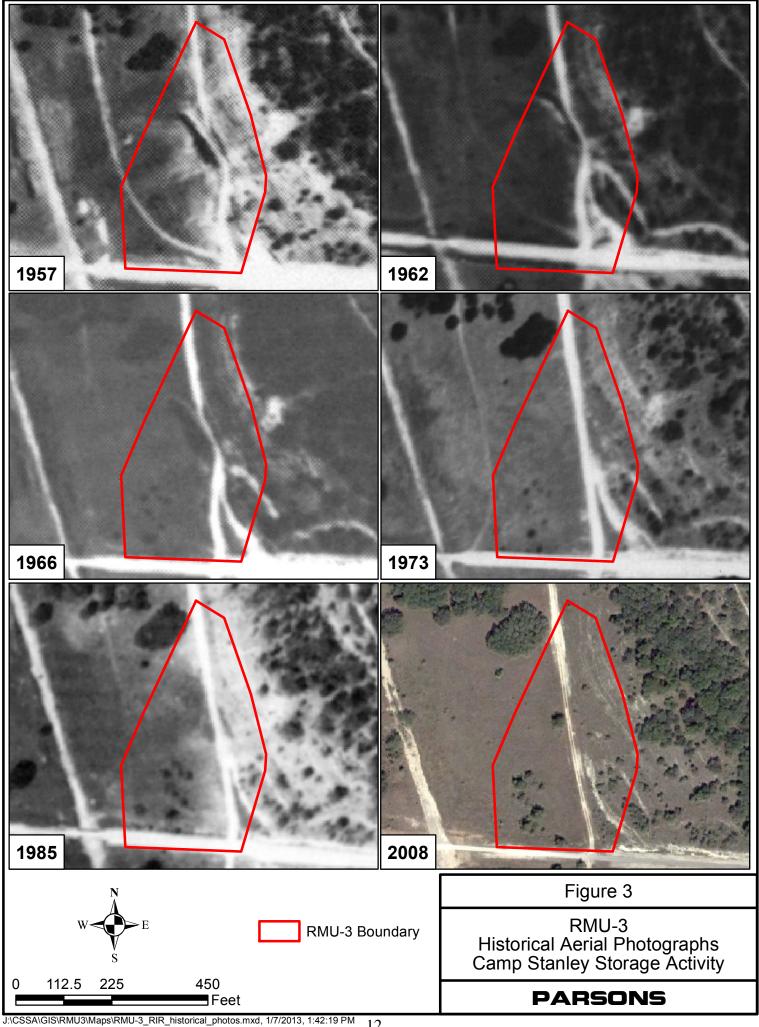
Reported historical use as a rifle range prompted initial investigations at the site. Review of historic aerial photographs showed a disturbed area in the lower left portion of a 1957 photo that may indicate the location of a firing point toward a berm (see Figure 3). The COC at RMU-3 is lead.

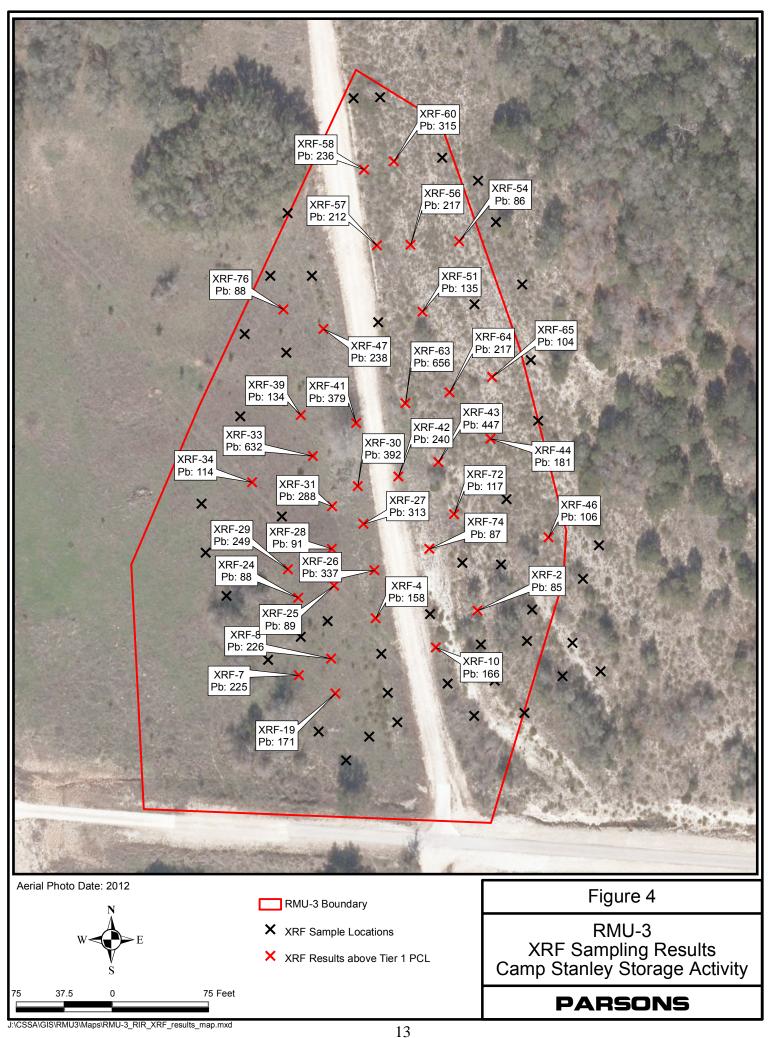
Previous investigations at RMU-3 include conducting an XRF survey and surface/subsurface soil sampling. The XRF survey was conducted in December 2010 (RMU3-XRF-01 through

RMU3-XRF-80) and indicated lead contamination at concentrations exceeding Tier 1 PCLs as shown on **Figure 4**. In February 2011, ten surface soil samples (RMU3-SS01 through RMU3-SS10) were collected and analyzed for CSSA 9 metals. Two of the samples (RMU3-SS01 and RMU3-SS09) exceeded the Tier 1 PCL for lead of 84.5 milligrams per kilogram (mg/kg). Sixteen additional surface and subsurface samples were collected in January 2012 (RMU3-SS11 through RMU-SS23). Eight of these samples exceeded the PCL for lead and were used to define the vertical and horizontal extent of contamination. Lead concentrations in the samples that exceeded the Tier 1 PCL ranged from 110 mg/kg to 990 mg/kg.

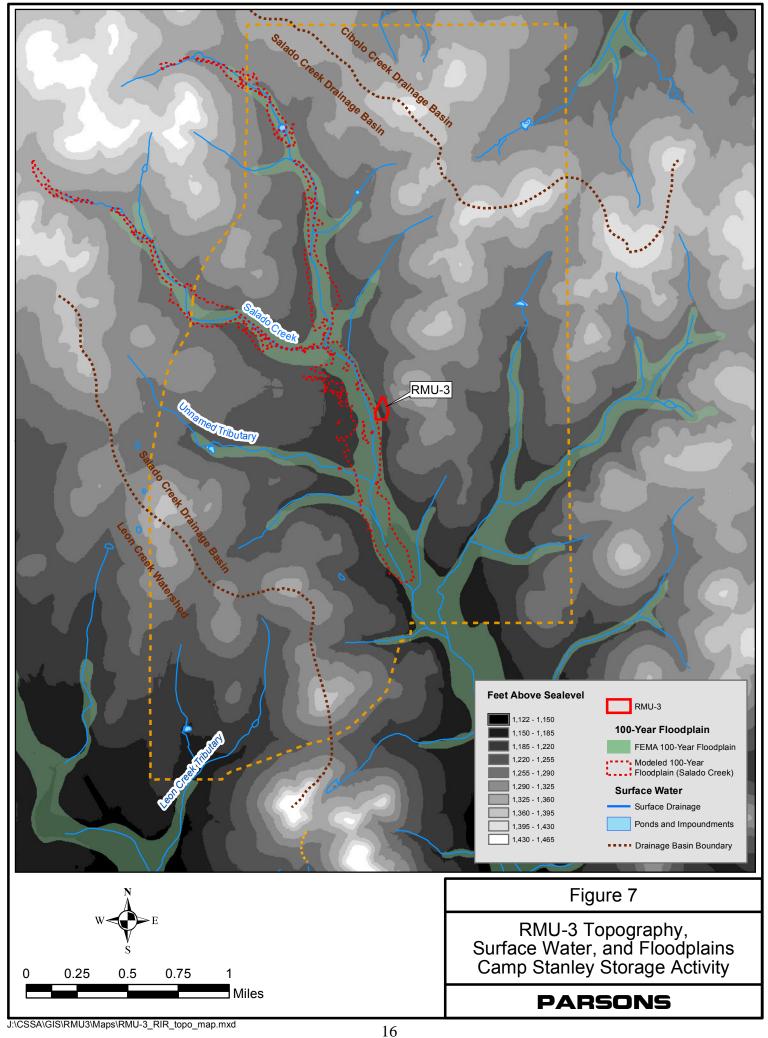
The closest surface water body to RMU-3 is Salado Creek located approximately 240 ft west of the site (**Figure 7**). The north-south trending creek exits the CSSA boundary approximately 7,854 ft south-southeast of the site. As all the lead contamination above Tier 1 PCLs has been removed from the soil, no significant degradation of high quality receiving waters is anticipated from RMU-3.

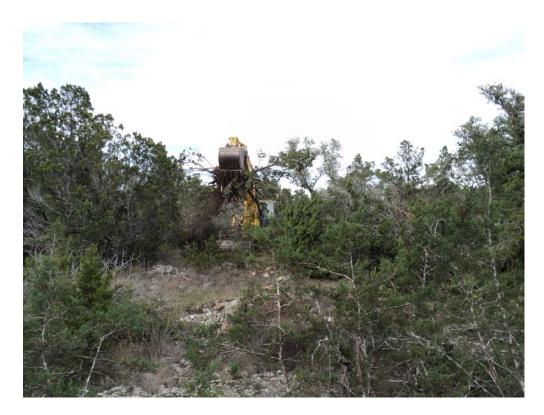
Photo 1. Pre-excavation vegetation removal.

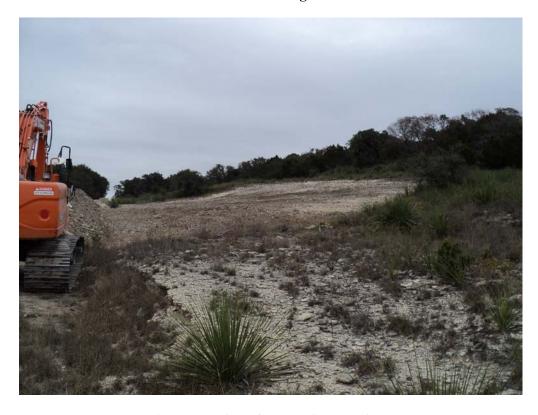
Photo 2. Top portion of excavation, looking north.

The excavation of contaminated soils began on December 10, 2012 and resulted in the removal of approximately 4,000 cubic yards (CY) of soil in total. The progression of the excavations and associated confirmation sample locations at RMU-3 are shown on Figure 5. The first round of confirmation samples (RMU3-SS24 through RMU3-SS36) were collected from the excavation footprint on December 17, 2012 (Table 1), and XRF samples were collected in late January 2013 to support the excavation effort. Additional excavation began on February 4, 2013 to remove the road portion of the site and to address previously excavated areas that required additional soil removal (Figure 5, middle and right panels). Confirmation sampling on the newly-excavated areas began on February 6, 2013 with the last sample collected on February 26, 2013 (RMU3-SS37 through RMU3-SS40). The final extent of excavation and confirmation sample locations are shown on Figure 6.

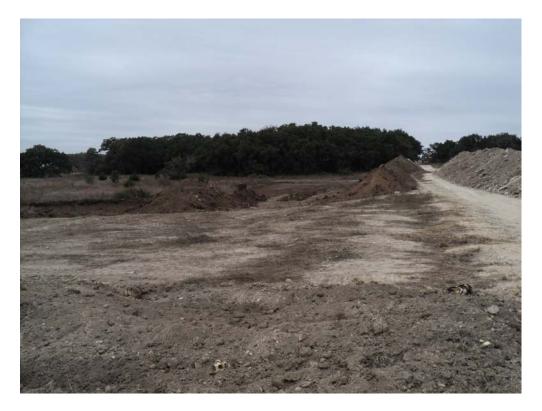
${\bf Photo~3.~Bottom~potion~of~excavation, looking~north.}$

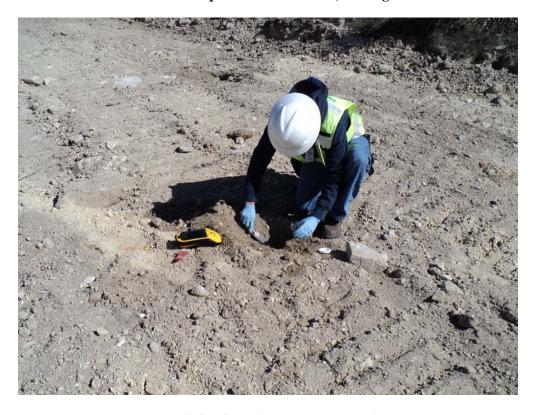
**Photo 4. Confirmation sample collection.**
