WORK PLAN AND SAMPLING AND ANALYSIS PLAN ADDENDUM

RMU-4

ADDENDUM TO WORK PLAN AND SAMPLING AND ANALYSIS PLAN SITE CLOSURE INVESTIGATION FOR RMU-4

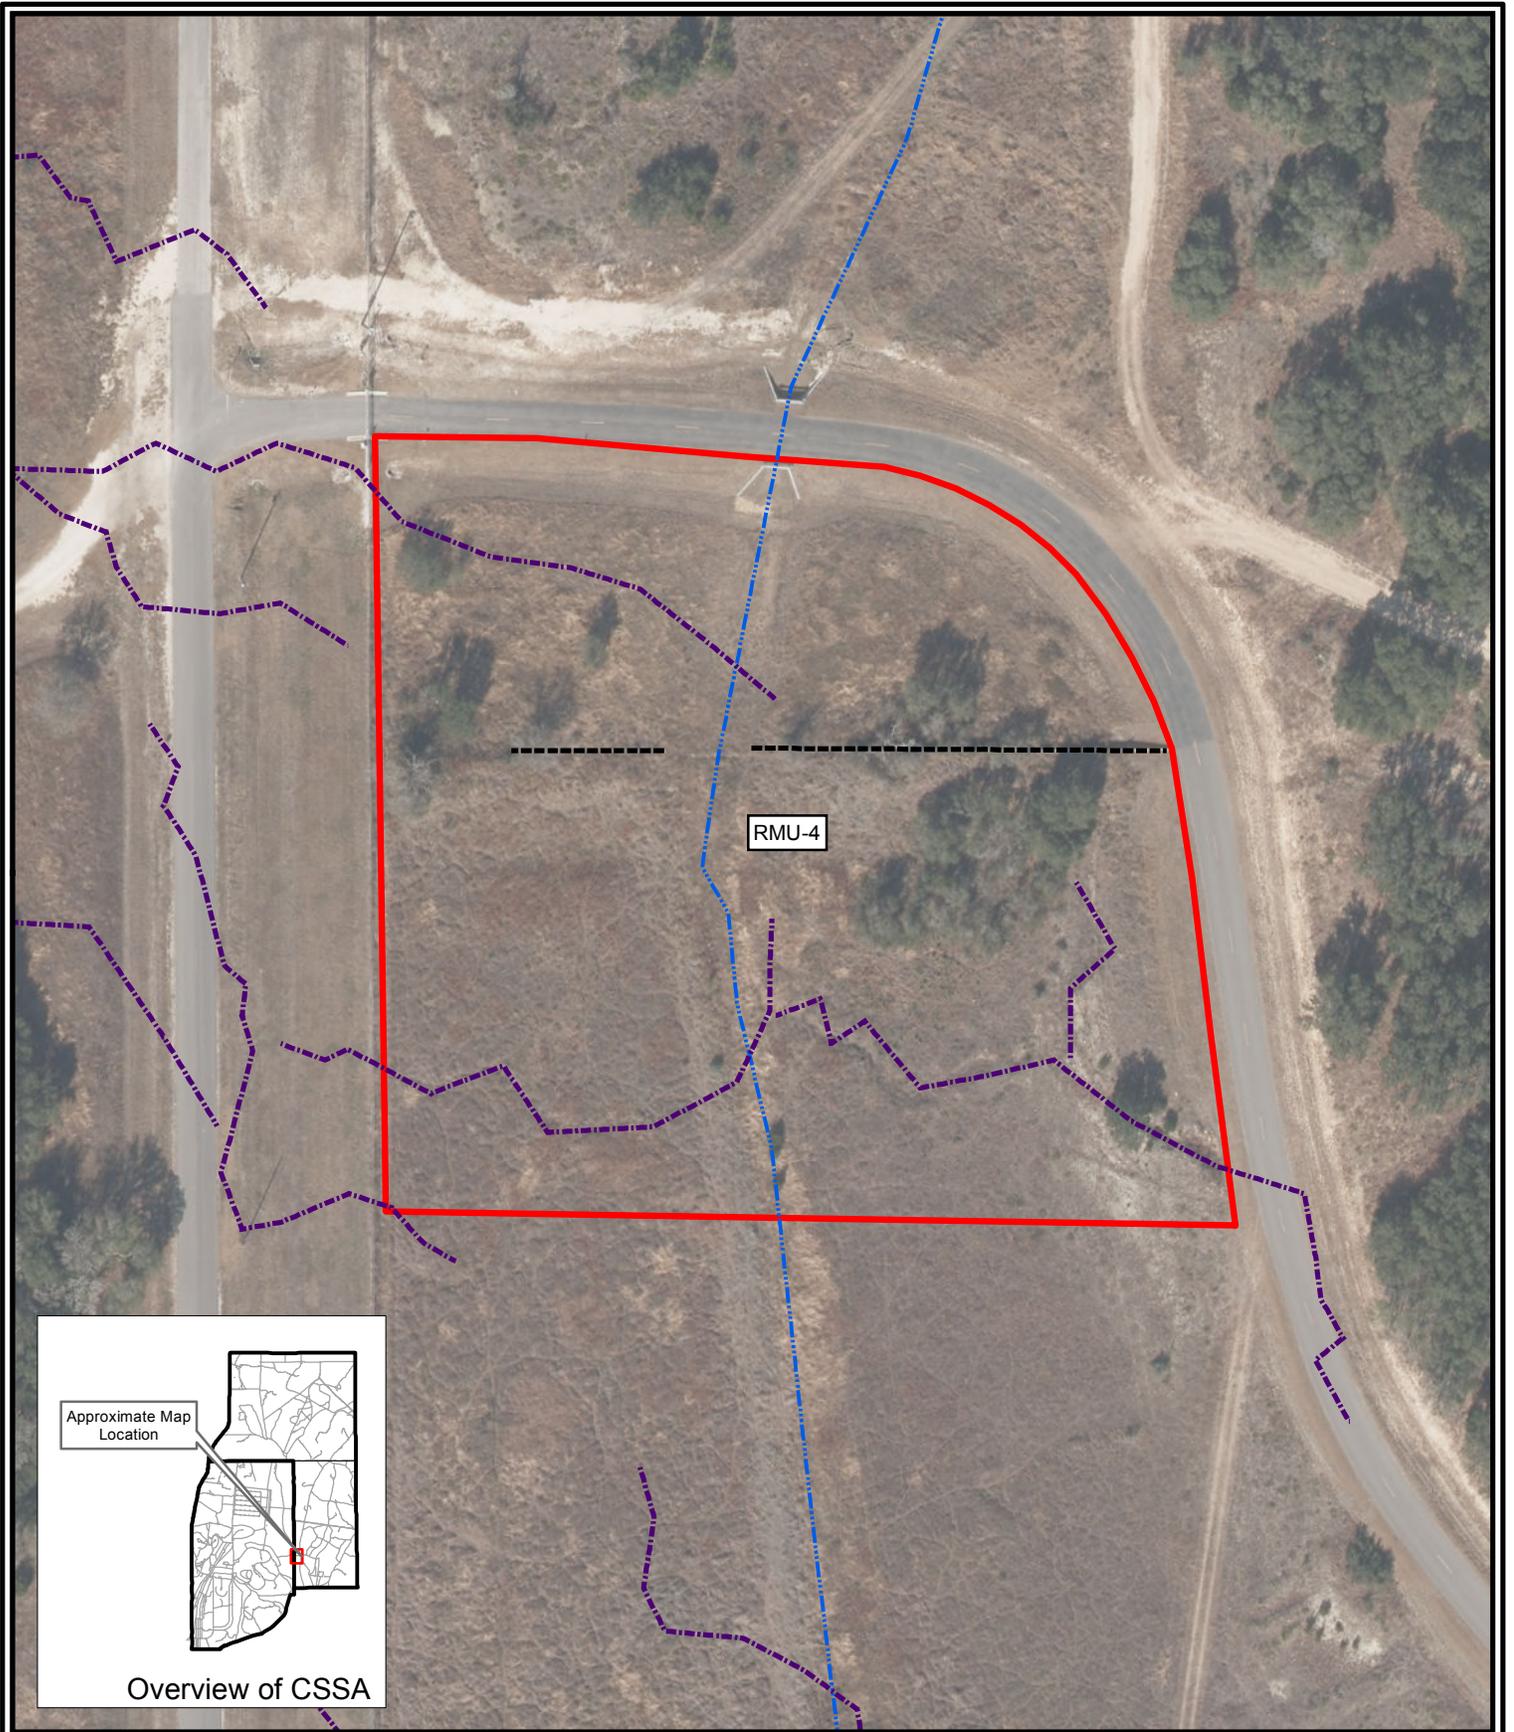
Figure 2

RMU-4
Features of Interest
Camp Stanley Storage Activity

There are two features of interest located in the vicinity of RMU-4 that have been investigated for potential historic interest: a small arms range abutment consisting of a concrete wall abutted to the south by a large berm of soils; and a series of military training trenches (zig-zag trenches) (see **Figure 2**). The 1998 *Archeological Survey and Testing Report* (CSSA Environmental Encyclopedia, Volume 1-6) stated that, although the concrete abutment is associated with World War I training activities, it was determined not to be significant because the integrity of the site has been compromised. The abutment was therefore considered ineligible for National Register nomination. The

identified zigzag trenches were used as World War I training devices and were most likely used in the filming of the 1926 movie *Wings*. Based on the 1998 archeological assessment, these trenches were determined to be historically significant and were considered eligible for listing in the National Register of Historic Places.

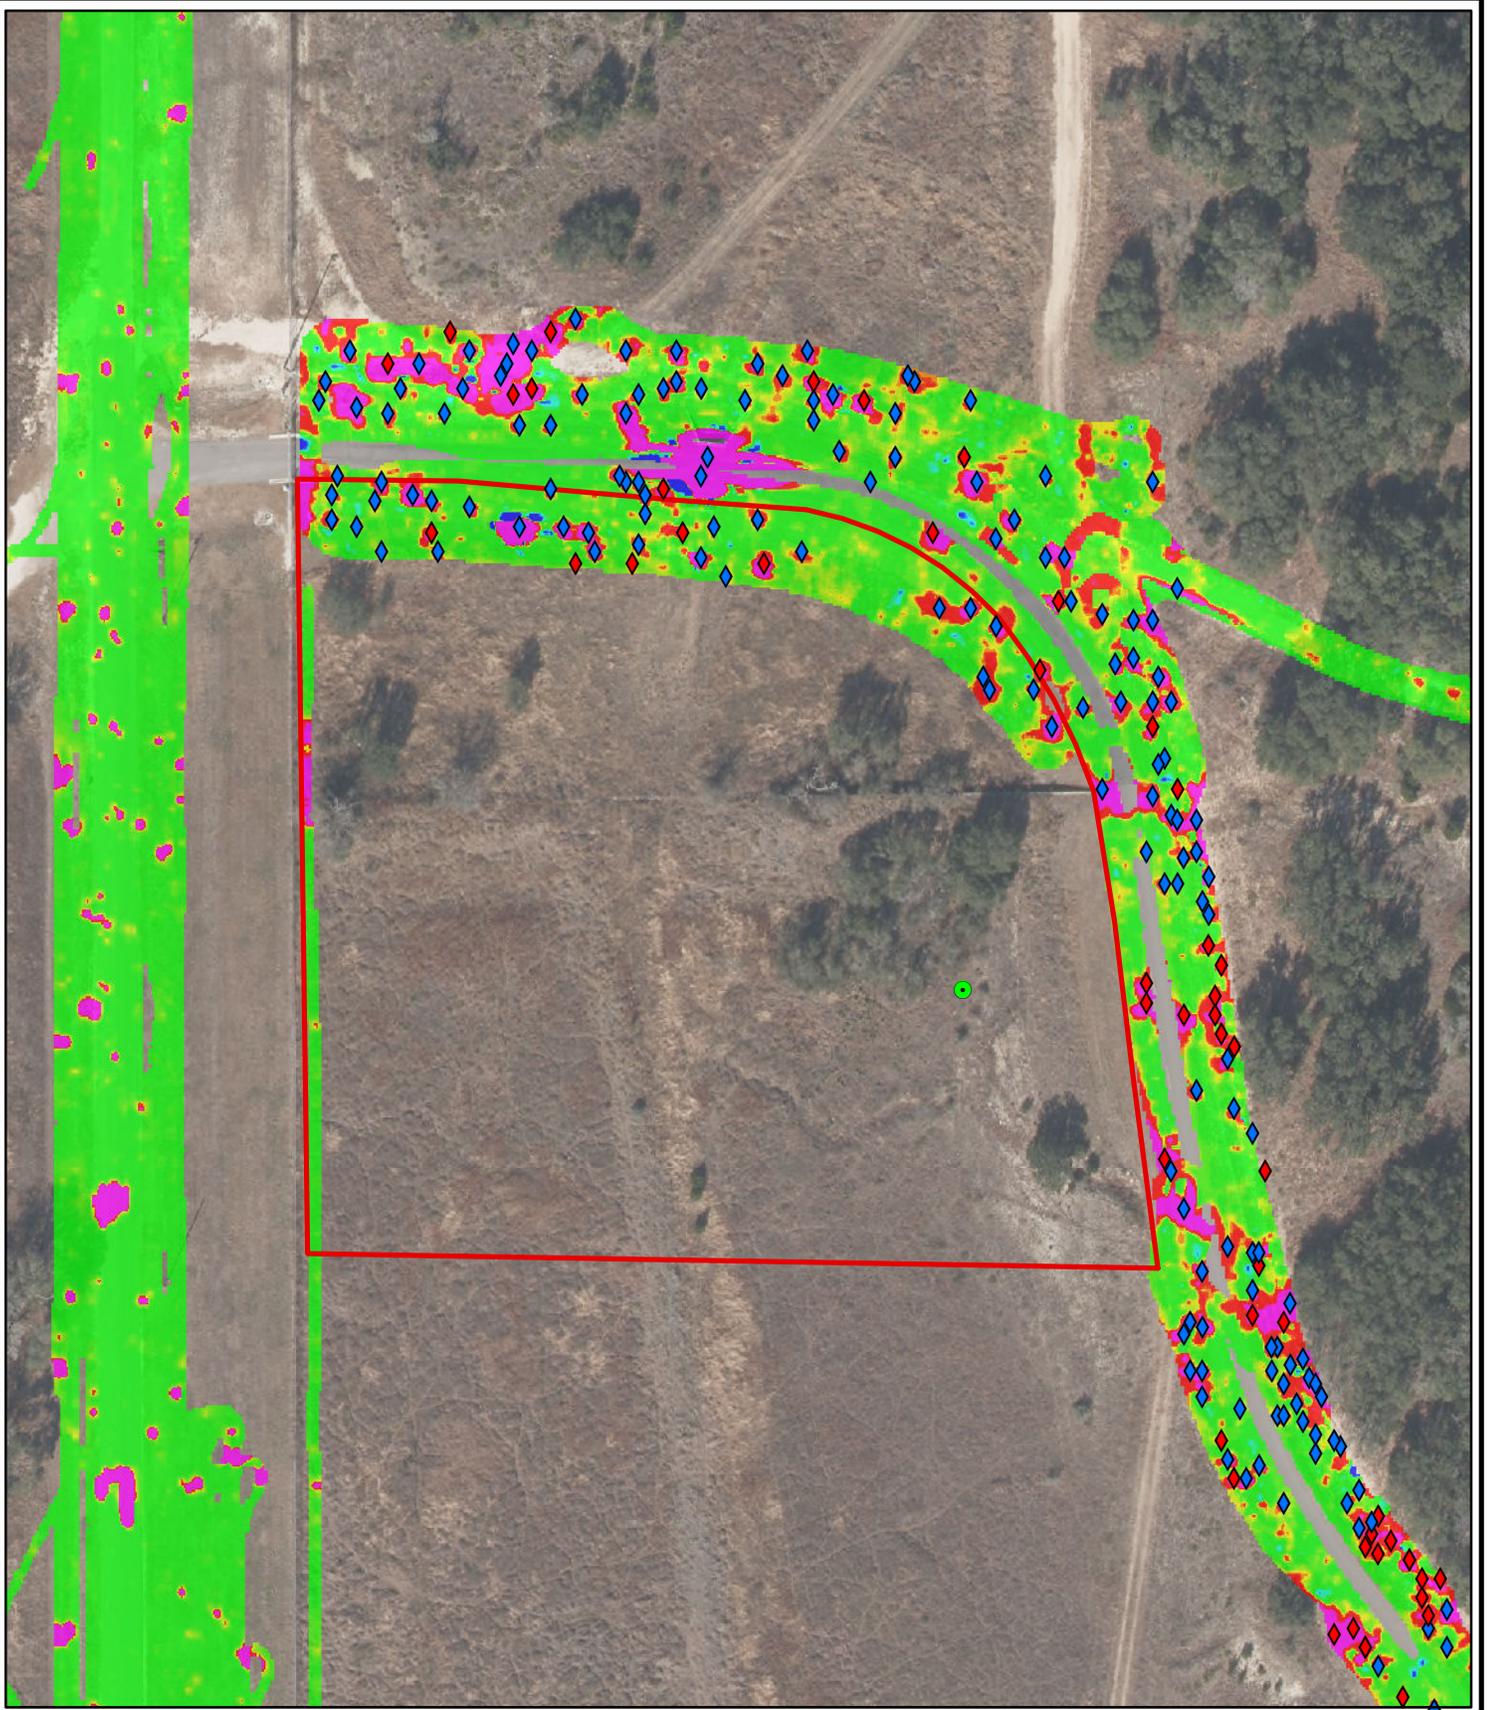
Figure 3

RMU-4
Anomaly Location Map
Camp Stanley Storage Activity

A field survey was conducted at the site in 1997. No spent ammunition was observed in the area, but the aforementioned small arms range abutment was identified. In 2006, the road that runs along the very northern portion of RMU-4 was included in unexploded ordnance (UXO) construction support and investigation activities. The purpose of the investigation was to reduce the risk associated with possible remaining munitions items during future construction activities in the East Pasture. Several munitions debris (MD) items and bullets were identified during the roadway investigation in 2006, but only five were found within the northern RMU-4 boundary (**Figure 3**). Another 15 MD contacts were identified along the perimeter of RMU-4 along what is now the paved roadway leading into the east pasture.

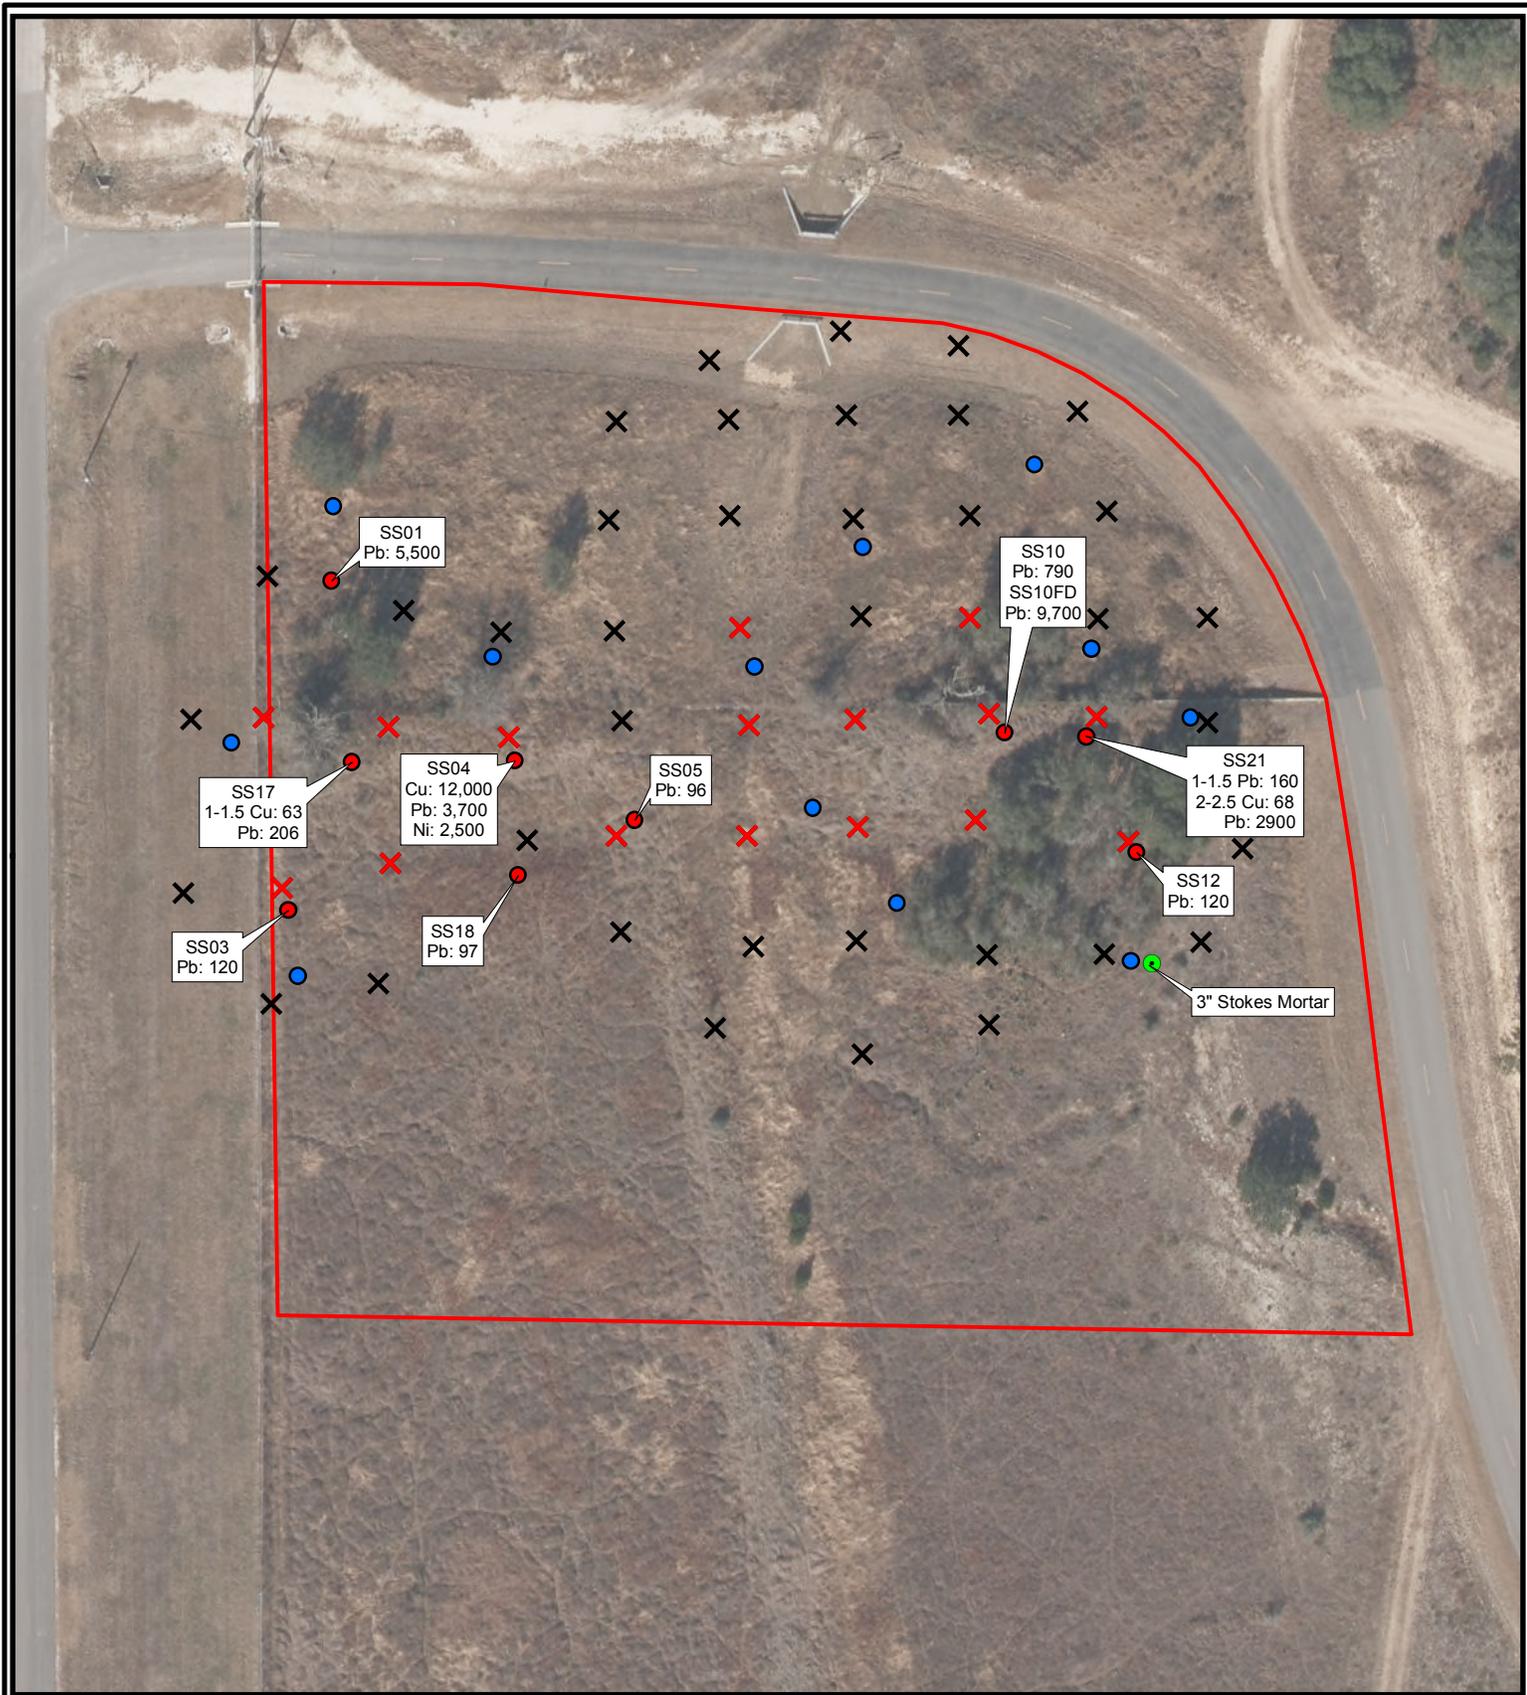
Figure 4

RMU-4
Previous Sampling Locations
Camp Stanley Storage Activity

A total of 27 surface soil samples were collected at RMU-4 in June 2011 to delineate potential metals contamination at the site. Three sample results exceeded the Tier 1 PCL for copper of 61 milligram per kilogram (mg/kg), 11 sample results exceeded the Tier 1 PCL for lead of 84.5 mg/kg, and one sample result exceeded the Tier 1 PCL for nickel of 35.5 mg/kg. These results, including the results of an XRF survey conducted in January 2012, are shown on **Figure 4**.

During a site walk in the summer of 2011, an unfuzed stokes mortar was discovered at the site by a UXO technician. The mortar was removed and disposed of by the CSSA Surveillance Section. The location of the mortar is depicted on both **Figure 4** (Previous Investigations) and **Figure 5** (Estimated Excavation Extent).

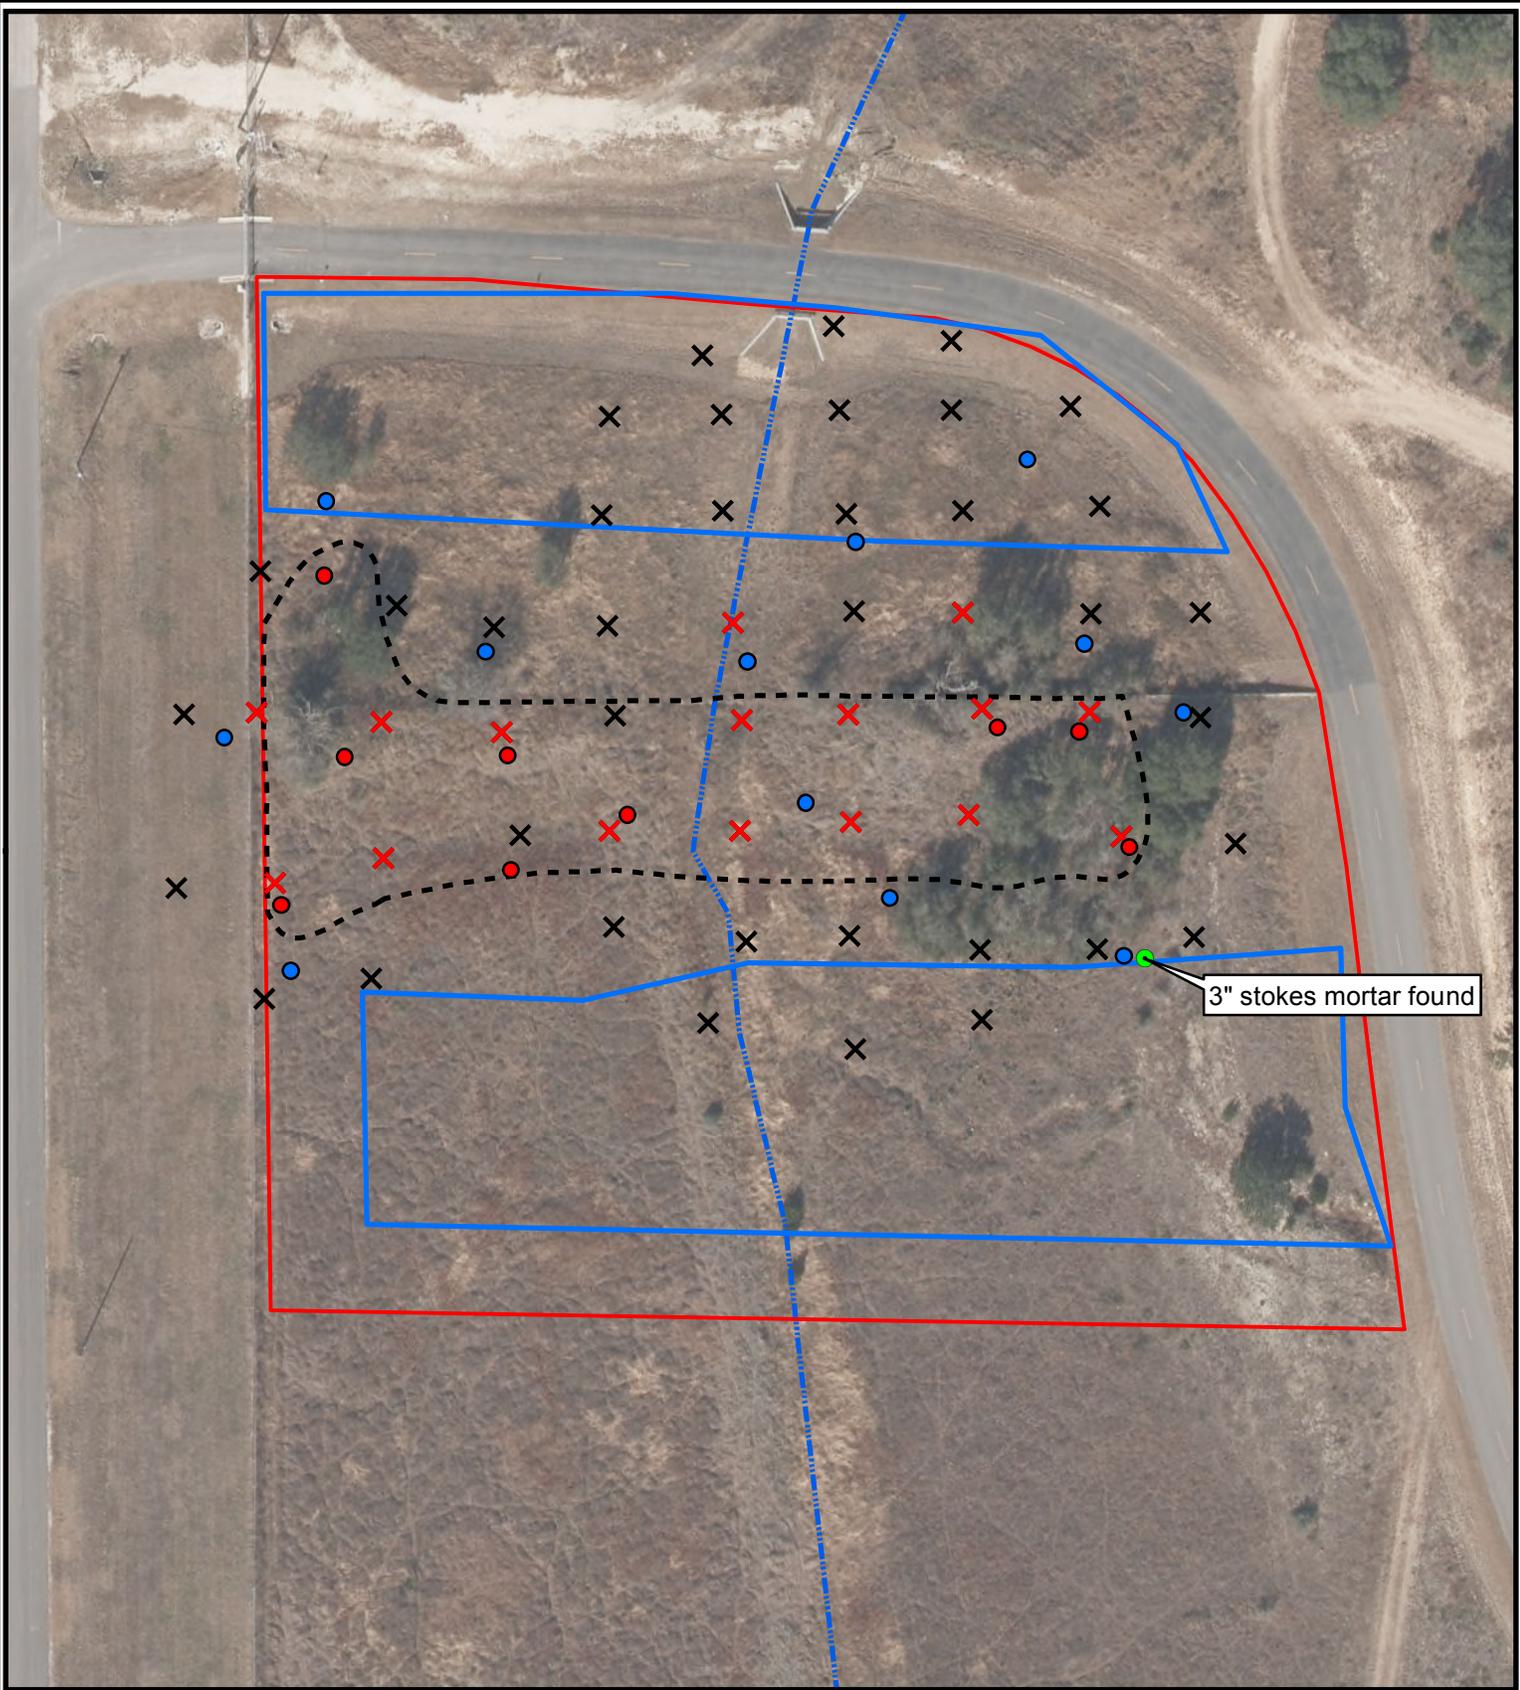
3" stokes mortar found

Figure 5
RMU-4
Proposed Excavation Effort
Camp Stanley Storage Activity
PARSONS

Soil identified as contaminated (criteria described in Section 2.3) through field screening efforts and confirmation sampling will be excavated and managed accordingly. An estimated 4,500 cubic yards (CY) may be excavated. The excavated soil will be moved directly to the respective staging area (**Figure 5**) and placed into 500 CY piles.
