**FINAL
RELEASE INVESTIGATION REPORT**

**RANGE MANAGEMENT UNIT 5
CAMP STANLEY STORAGE ACTIVITY**

**Camp Stanley Storage Activity
Boerne, Texas**

PARSONS

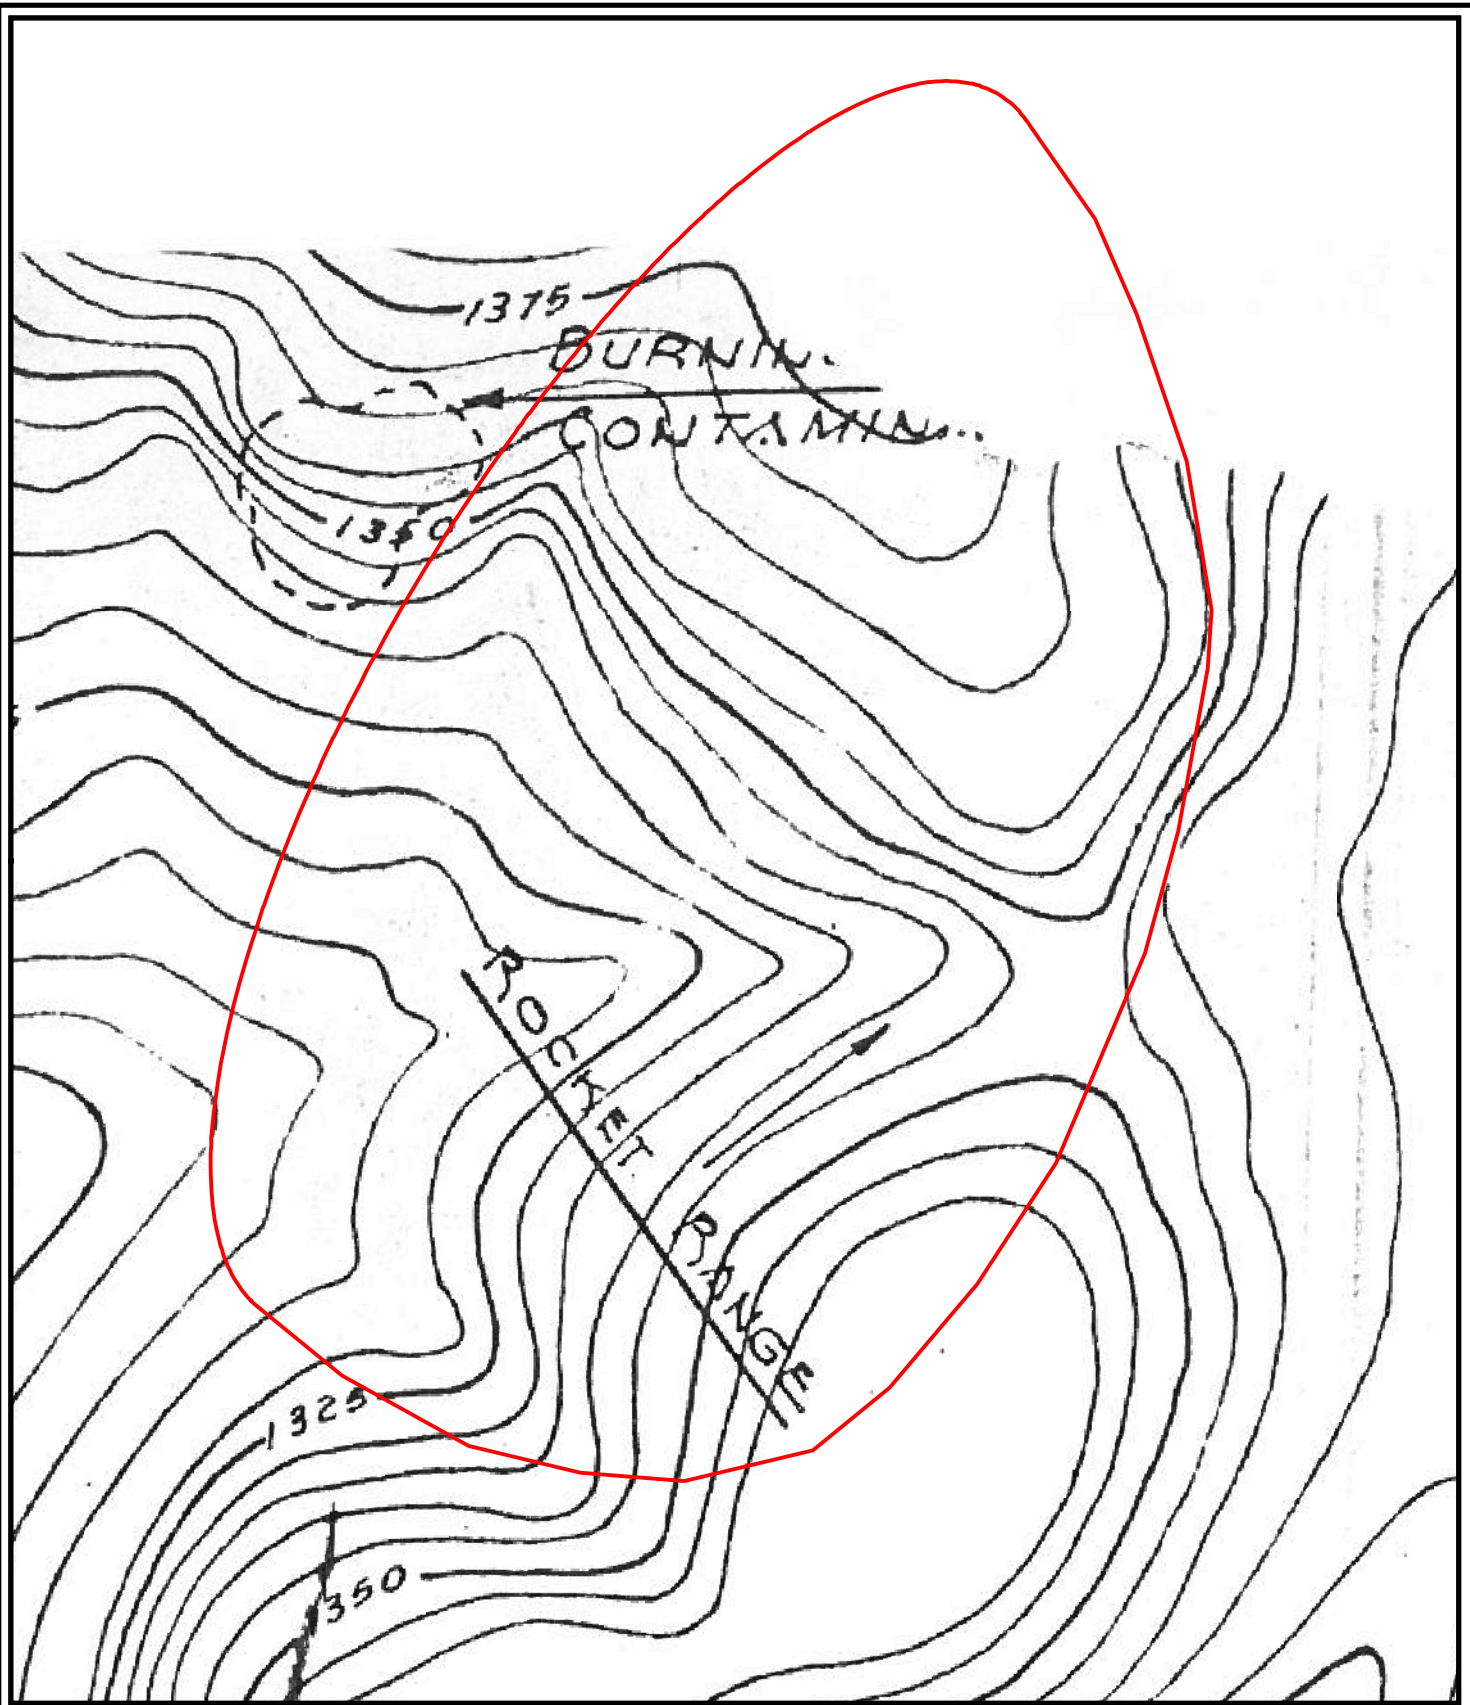
Figure 3

RMU-5 was identified as a rocket range on a 1953 map of CSSA. As shown in **Figure 3**, which is a scan of the 1953 map, the area was shown simply with a line labeled “Rocket Range” and an arrow. No other documentation regarding this potential range has been found, and historic aerial photographs (**Figure 4**) do not show any evidence of the range. The 1953 map also showed an area to the north-northwest labeled as “burning contamination.” Munitions debris (MD) had reportedly been found previously in the vicinity but the nature was undocumented and source unknown.

RMU-5 1953 Historical Map
Camp Stanley Storage Activity

Given that the denoted location of the rocket range on the historic map (**Figure 3**) was not optimum for a rocket range, the hillside situated to the lower east of the site boundary was investigated as the possible location of the range in February 2012. No evidence of the rocket range was found in that location.

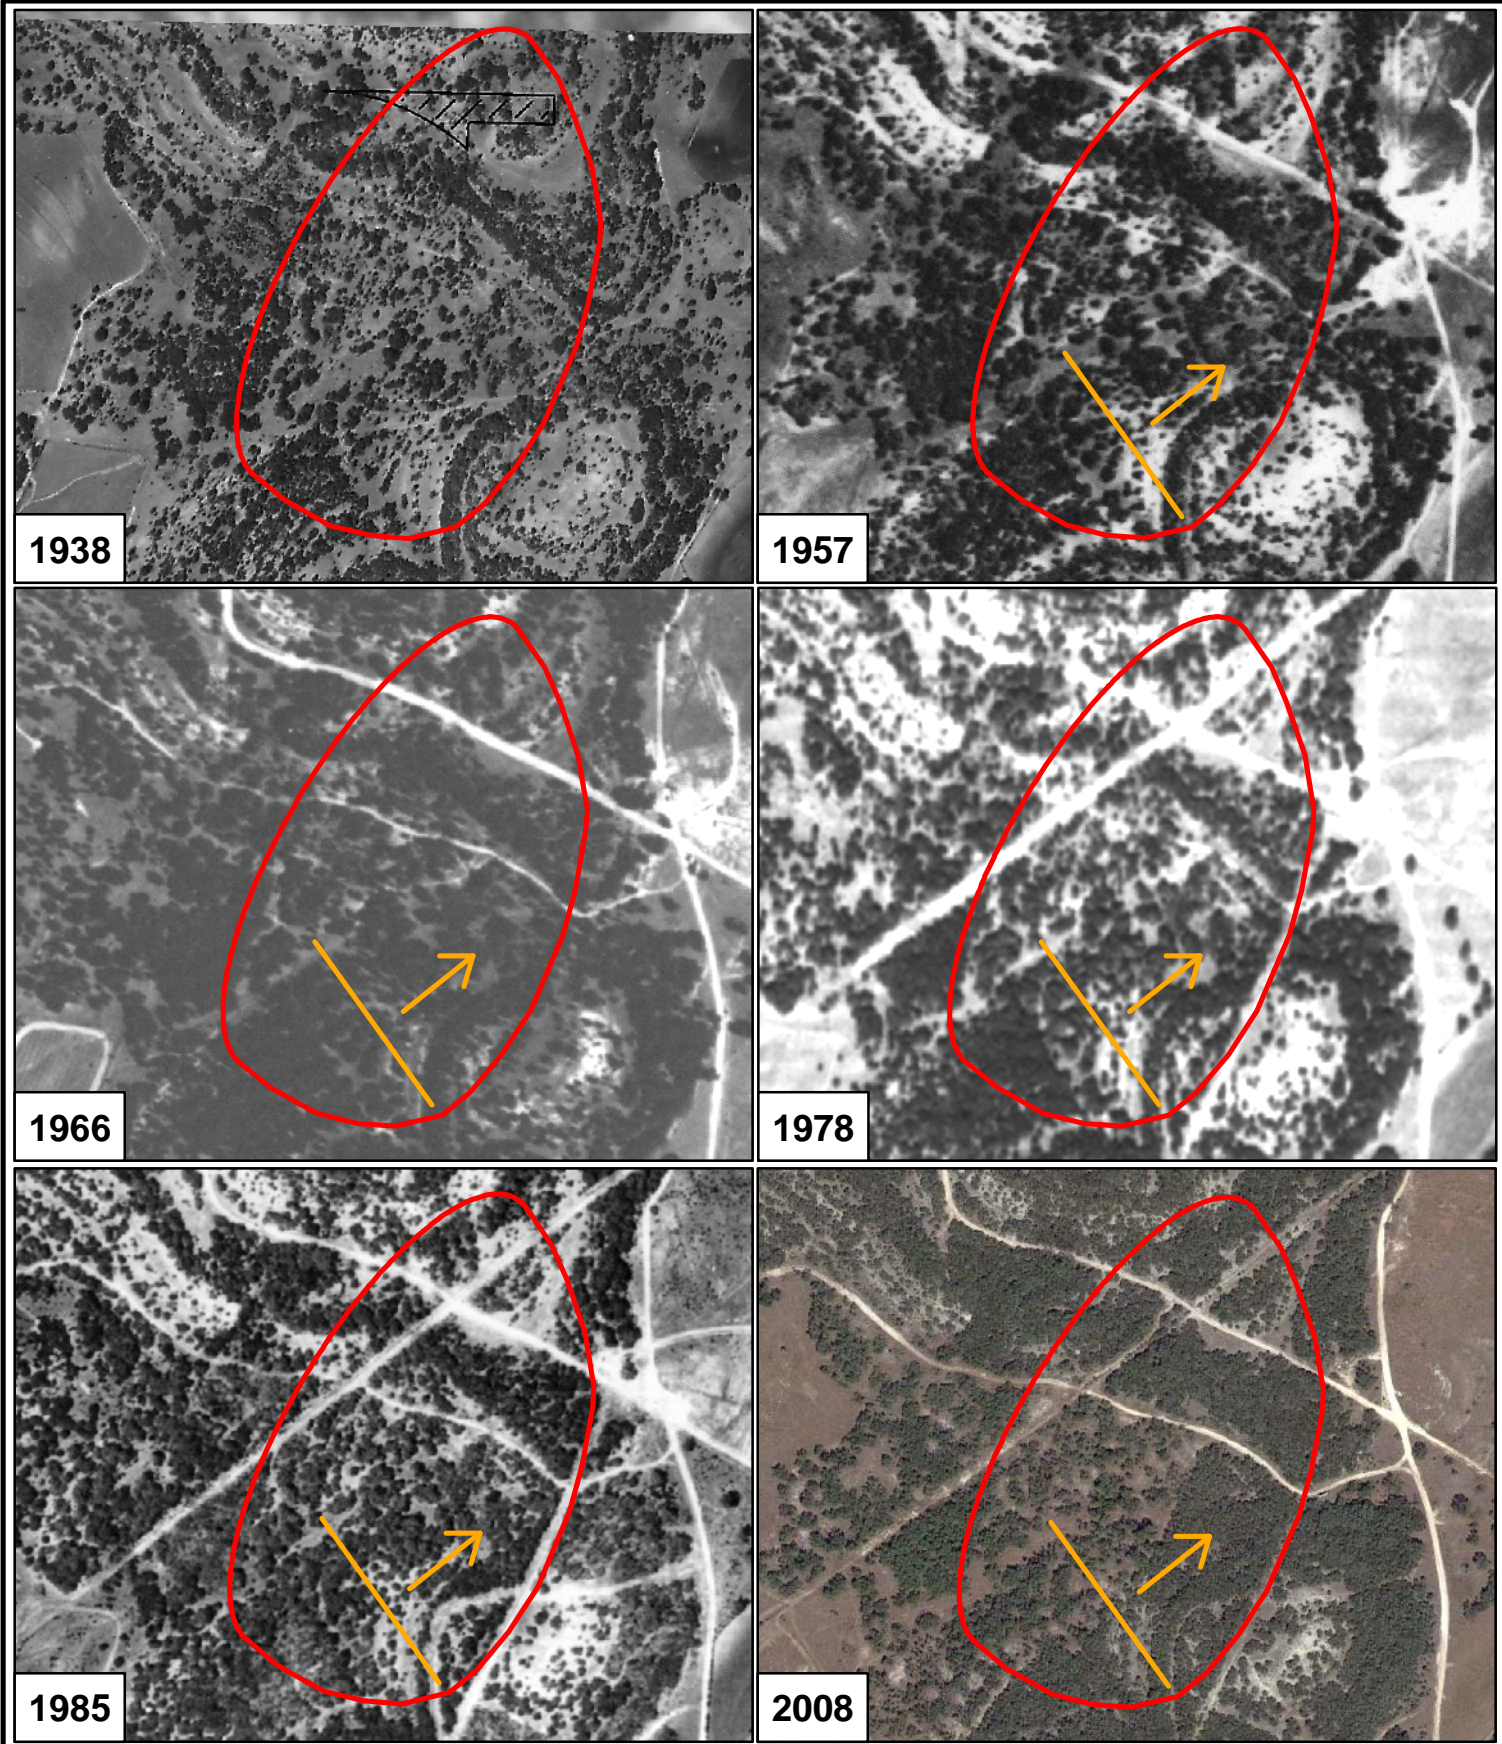
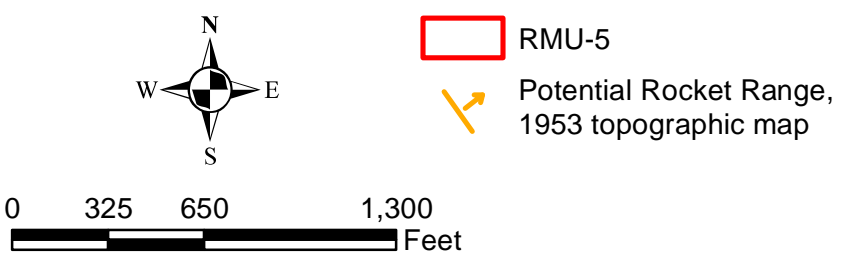
Figure I
 RMU-5
 Aerial Photographs
 Camp Stanley Storage Activity
PARSONS

A series of historical aerial photos of the site are shown on Figure 4 and photographs showing the site are provided in **Appendix A**. The history of the site and previous investigations at the site are discussed below.

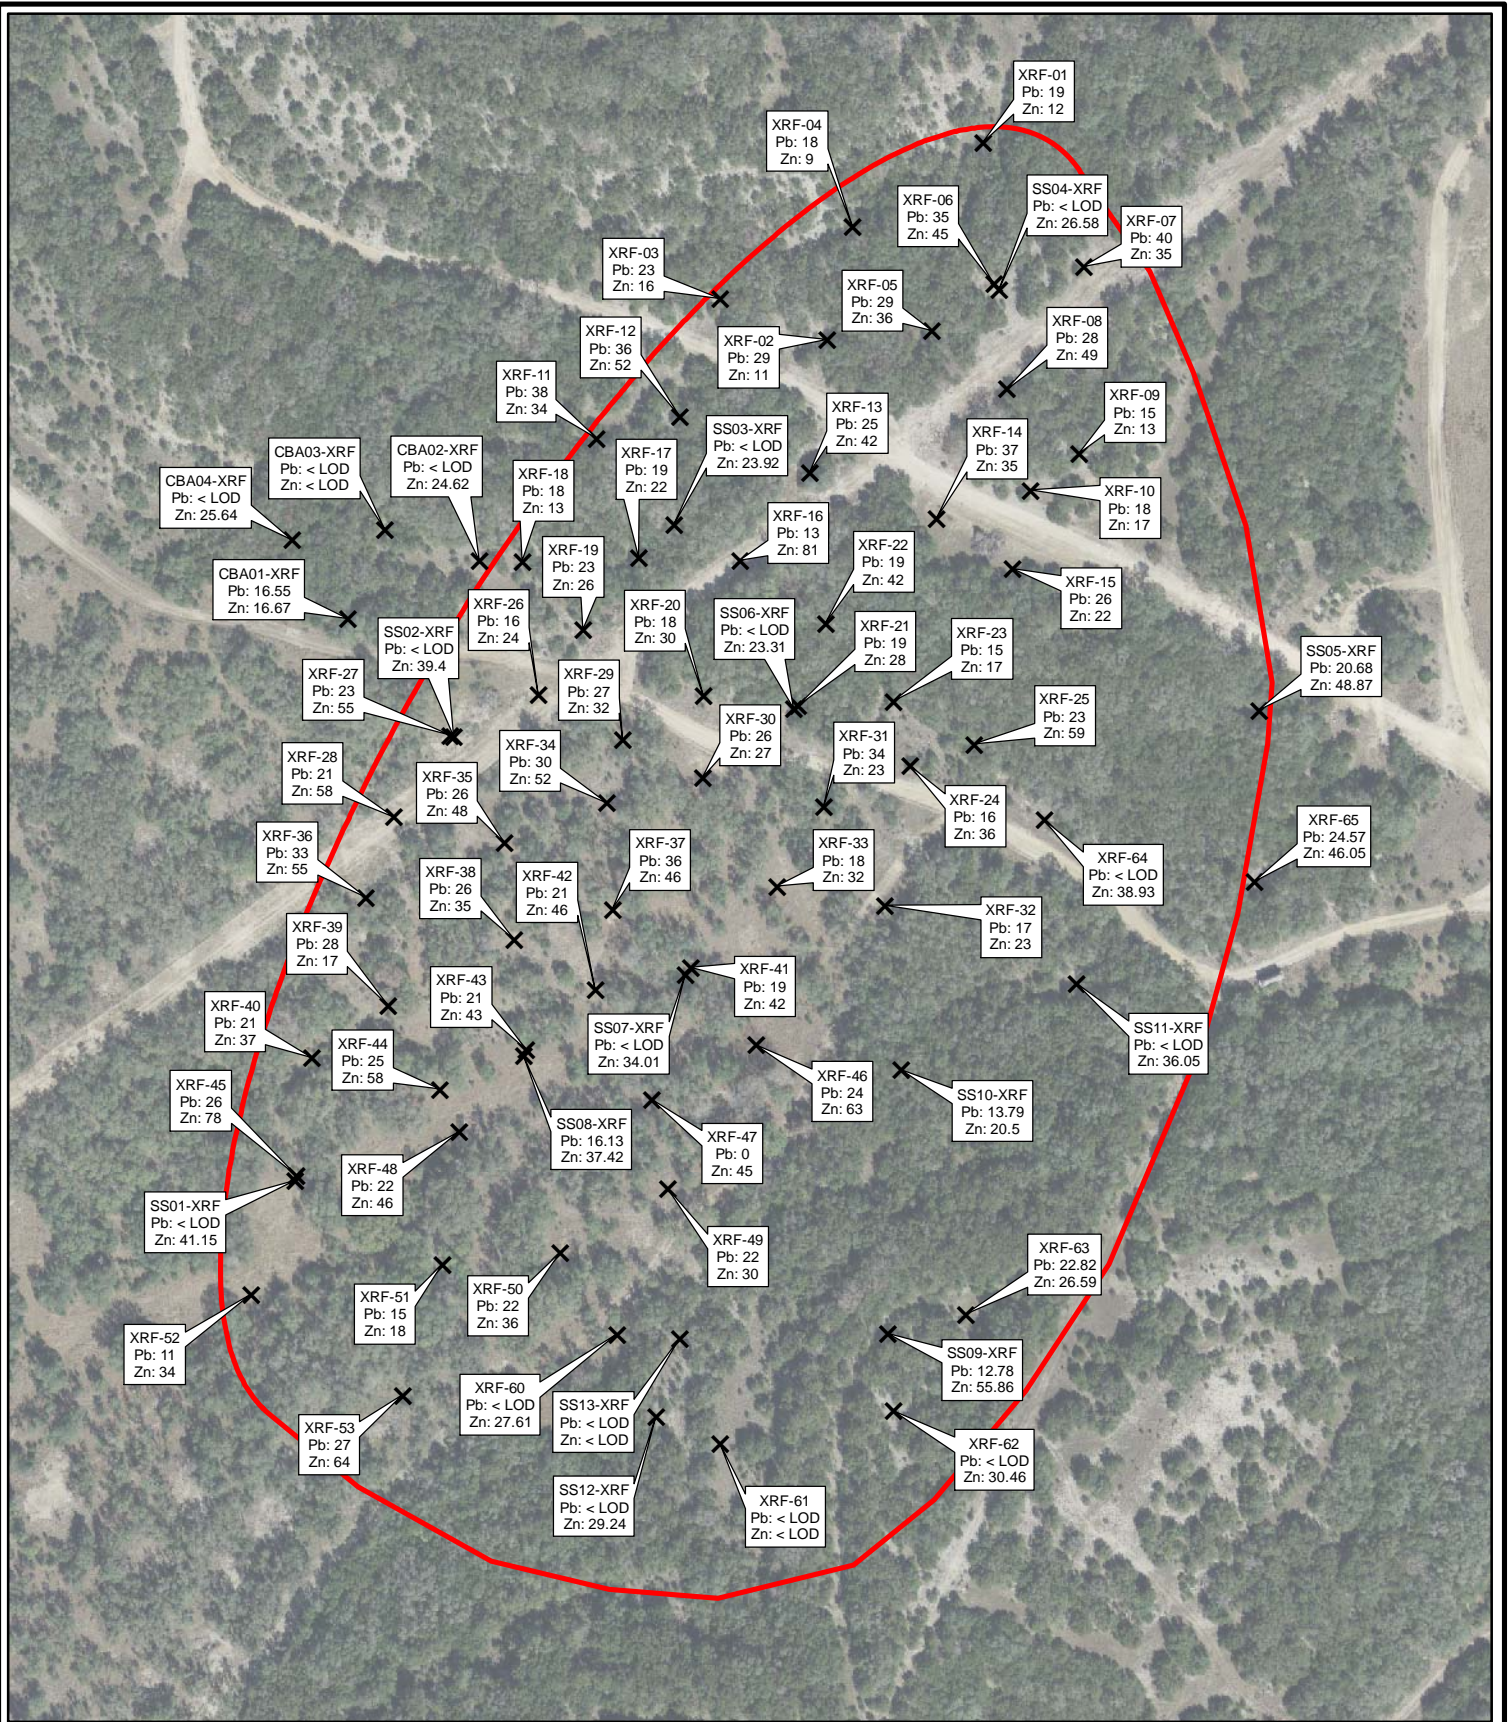
Figure 6
RMU-5
XRF Sampling Results
Camp Stanley Storage Activity
PARSONS

An XRF survey was conducted within the boundary of RMU-5 in December 2010 to gather field screening data regarding the presence of metals above Tier 1 protective concentration levels (PCLs) in surface soils. Many munitions contain lead, and our experience at CSSA has shown that lead is an excellent indicator of impacted areas. In addition, lead and zinc XRF results have shown a strong statistical correlation with laboratory-verified samples. Therefore, an XRF

analyzer was used to identify potentially contaminated areas, particularly because there was no visual evidence or evidence on historical aerial photographs that there was an area of concern. Sample locations and results of the XRF survey are shown on **Figure 6**. Samples for XRF analysis were collected from a total of 64 locations across the site. XRF results showed that neither lead nor zinc was detected above Tier 1 PCLs at RMU-5.

RMU-5 Boundary
X XRF Sample Location

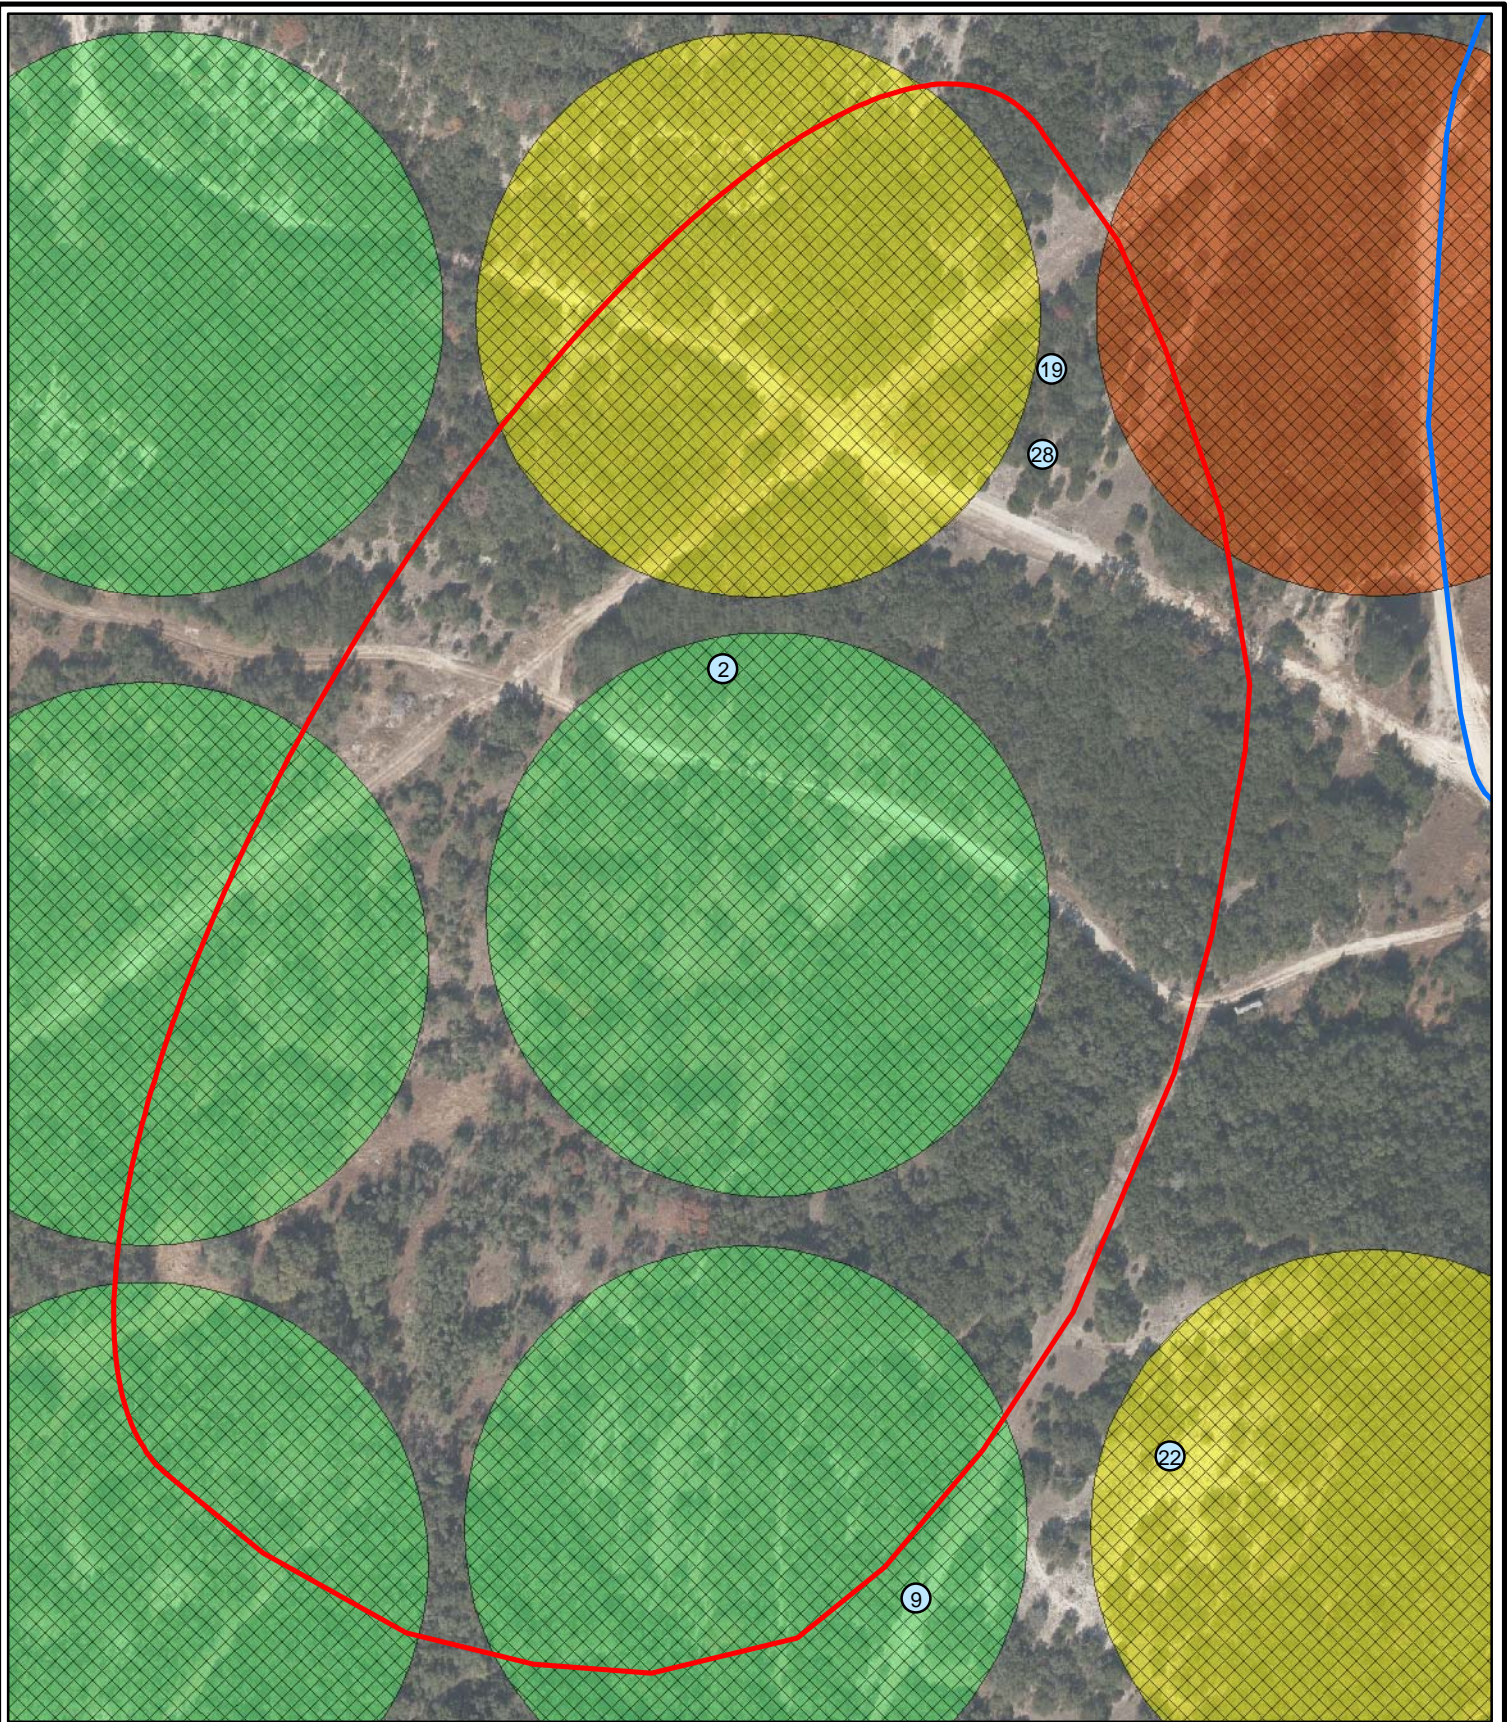
Figure 7

Most recently, in October 2011, an assessment took place in the North Pasture, including in and around RMU-5, to evaluate if there was any evidence indicating that there was a rocket range in the area of RMU-5. A Schonstedt hand-held magnetometer was used by the UXO team to estimate the subsurface anomaly density (**Figure 7**). A medium density (between 151 and 300 detections) was estimated at the north end of the site and a low density (between 0 and 150 detections) was estimated for the rest of RMU-5 (**Figure 7**). The presence and nature of the MD identified during this investigation within the RMU-5 boundary was not indicative of a rocket range, but of kick-out from historical ordnance activities at SWMU B-20/21.

B20/21 Perimeter Assessment, 2010

North Pasture UXO Assessment, 2011

**RMU-5
Munitions Assessment Results
Camp Stanley Storage Activity**

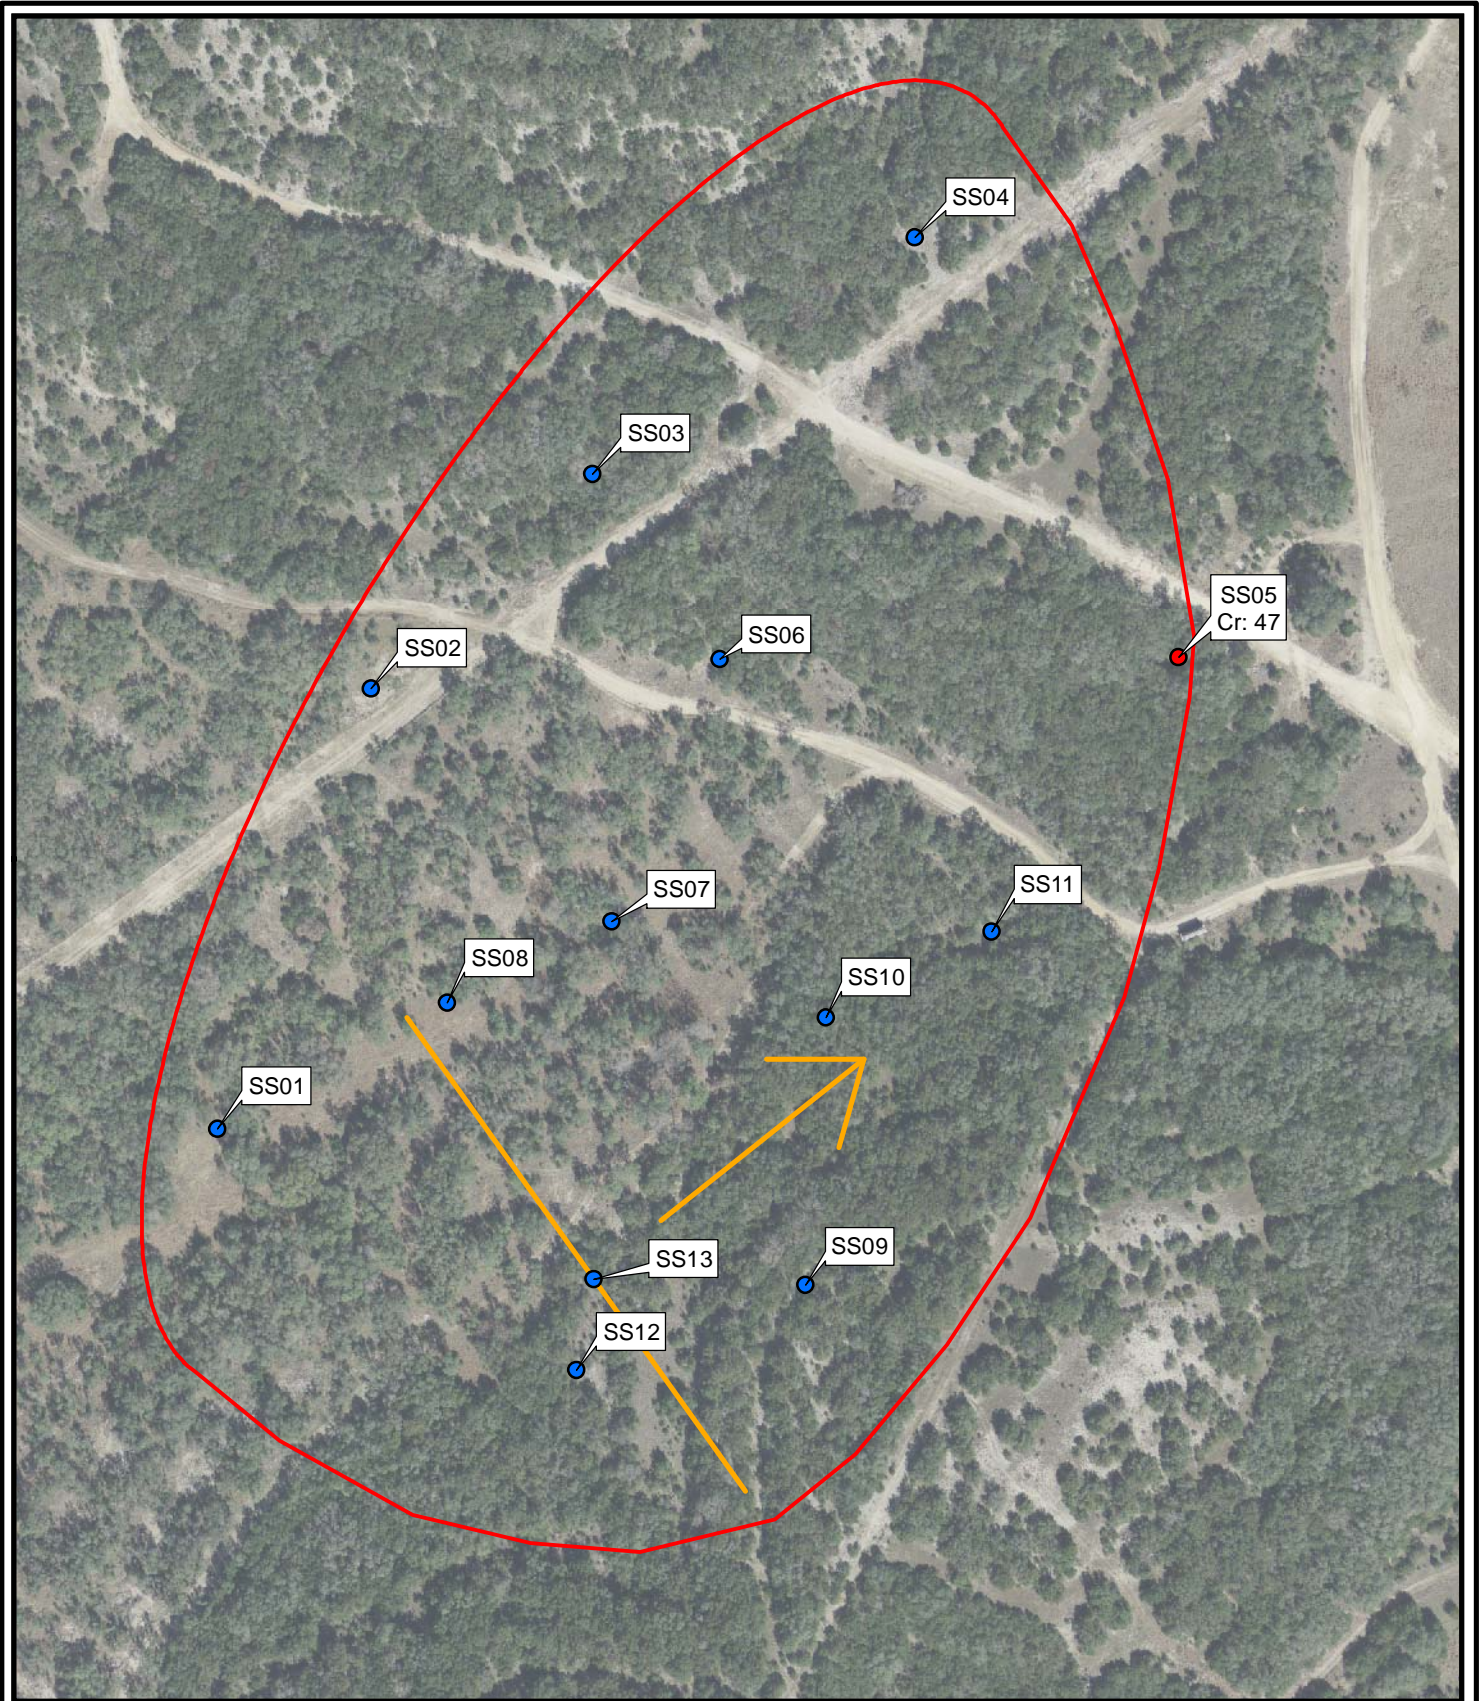
Figure 8
 RMU-5
 Sample Locations
 Camp Stanley Storage Activity

Soil sampling at RMU-5 was conducted in February 2012 to assess whether historical activities affected the site. A total of 13 surface soil samples were collected at RMU-5 and analyzed for metals and explosives. A summary of the soil sampling results at the site are shown in **Table 1** (detected compounds only) and **Appendix C** (all analytes), and the soil sampling locations are shown on **Figure 8**. The data verification summary report for the sampling and analytical results is provided in **Appendix D**.

As shown in Table 1, arsenic, barium, cadmium, chromium, copper, lead, mercury, nickel, and zinc were not detected at concentrations exceeding Tier 1 PCLs. One soil sample (RMU5-SS05) slightly exceeded the Tier 1 PCL for chromium of 40.2 milligrams per kilogram (mg/kg). Per TAC §350.79(2)(A), a 95% UCL may be calculated to determine if there is a statistical basis for no further action on a particular COC. A 95% UCL of 25.92 mg/kg was calculated for the chromium concentrations remaining in site soils, which does not exceed the Tier 1 PCL of 40.2 mg/kg (**Appendix E**).

- Soil Sample
- Soil Sample Location with result above Tier 1 PCL in mg/kg
- Rocket Range
- RMU-5 Boundary

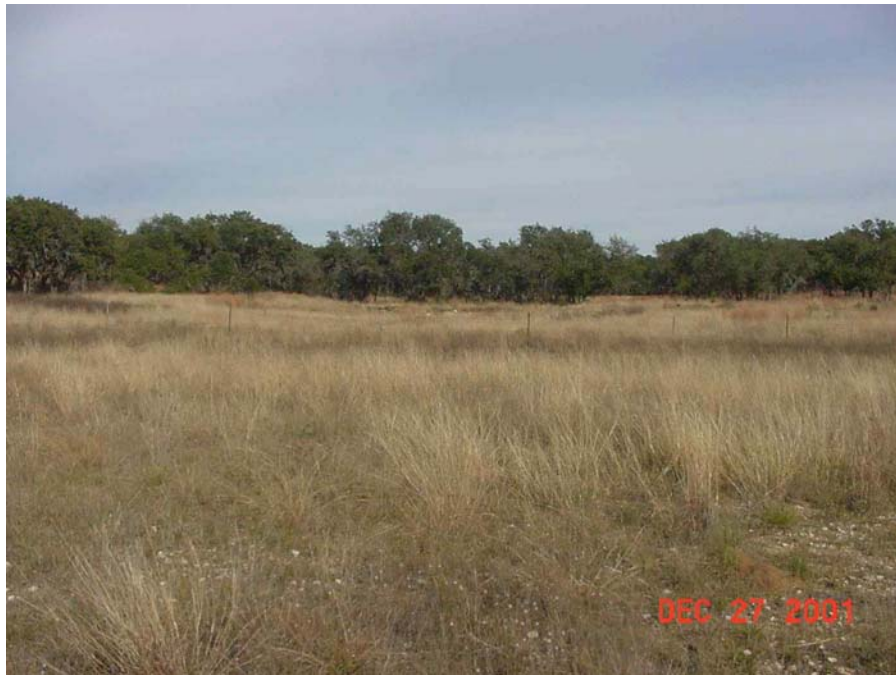
Photo 1. View of RMU-5, looking northeast (December 2001).

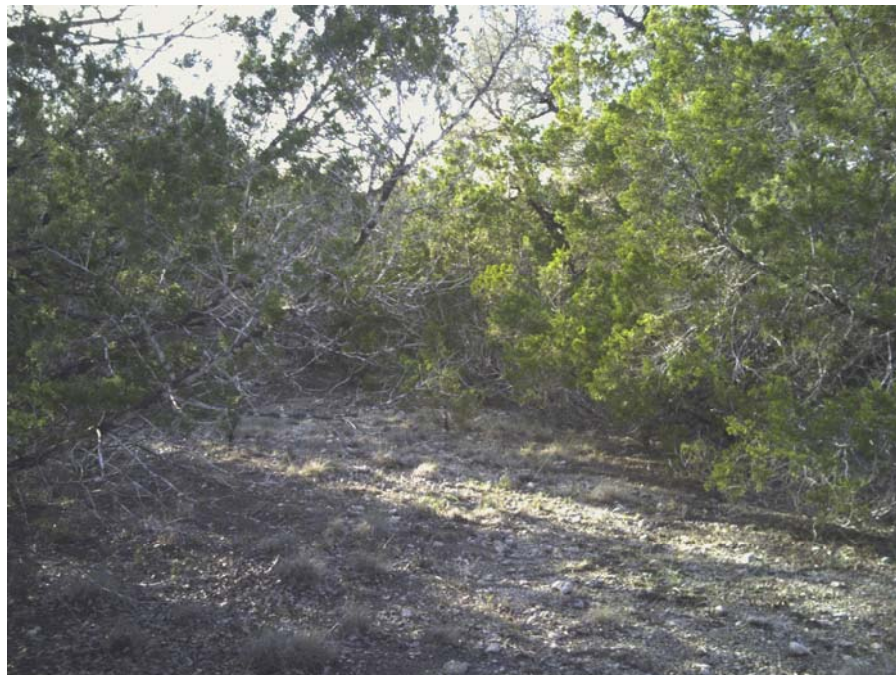
Photo 2. View of RMU-5, looking southeast (December 2011).

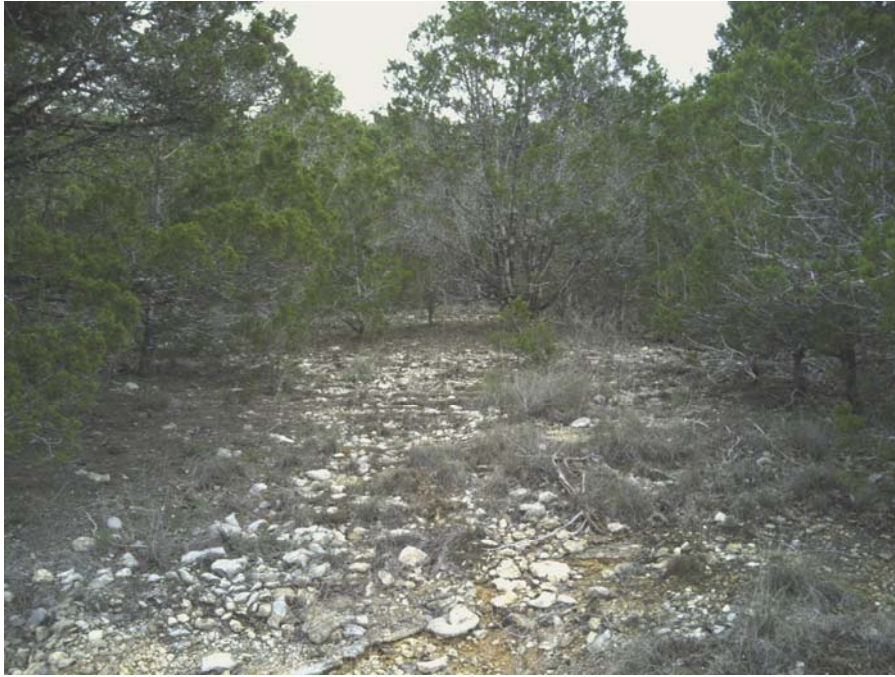
Photo 3. View of RMU-5, looking north (December 2011).

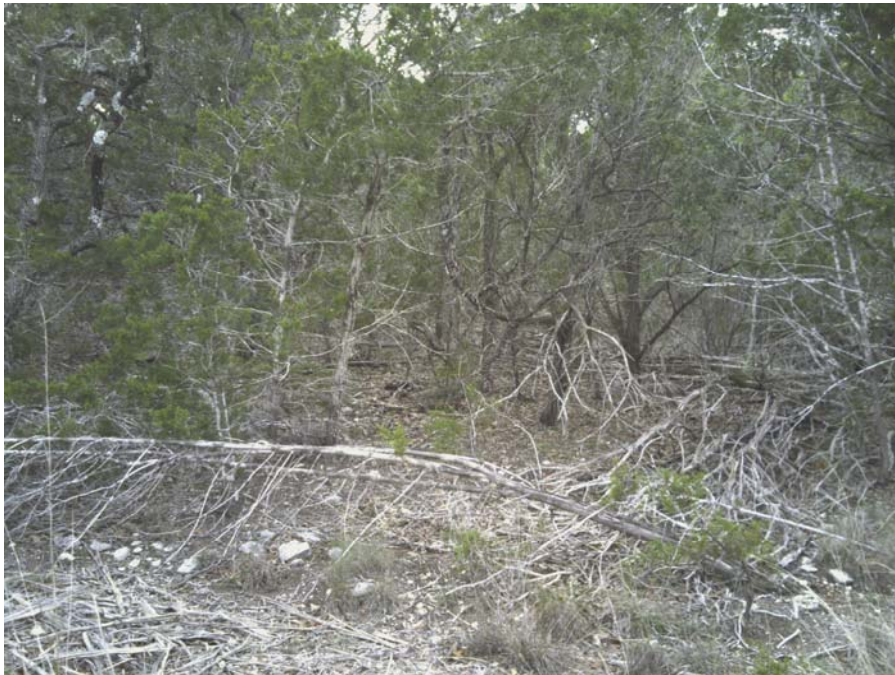
Photo 4. View of RMU-5, looking west (December 2011).
