Subject: Removal of Solid Waste Management Units (SWMUs) B-14 area and Coal Bins from the Installation SWMU List, Camp Stanley Storage Activity (CSSA), Solid Waste Registration Number 69026, EPA Identification Number TX2210020739

Reference: Removal of Coal Bins and B-14 Area, Camp Stanley Storage Activity (CSSA), Solid Waste Registration Number 69026, EPA Identification Number TX2210020739

Figure 1
Coal Bin Area
Aerial Photographs
Camp Stanley Storage Activity
PARSONS

B-14 Area
Aerial Photographs
Camp Stanley Storage Activity

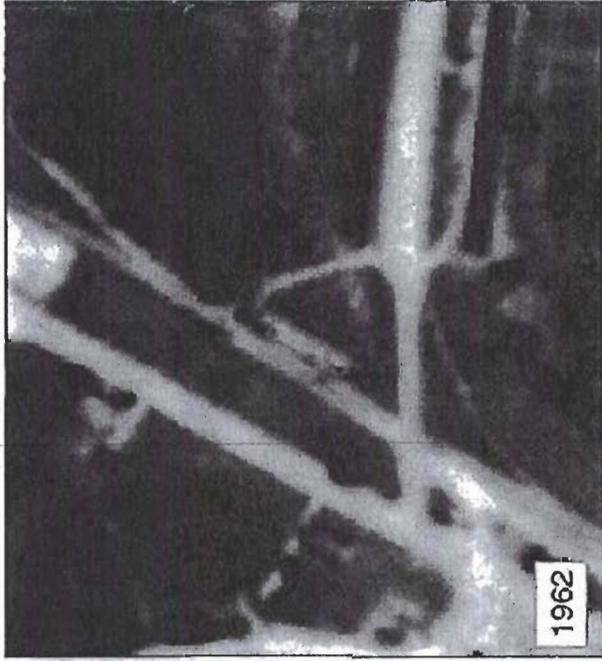
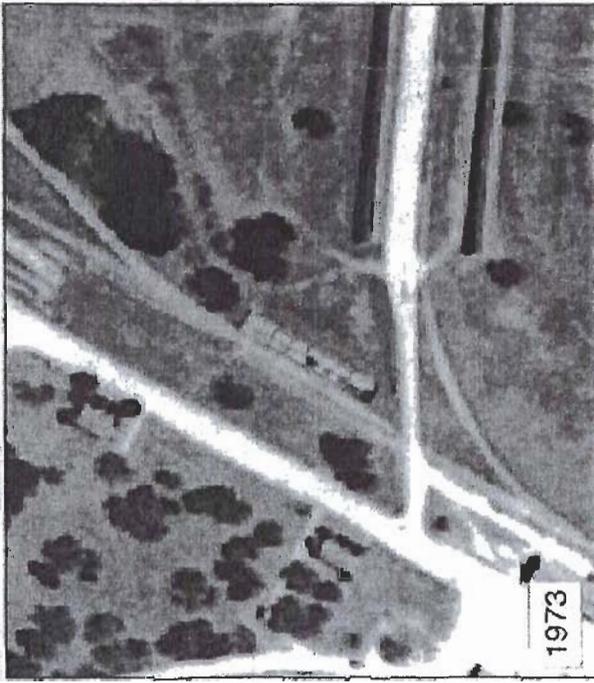
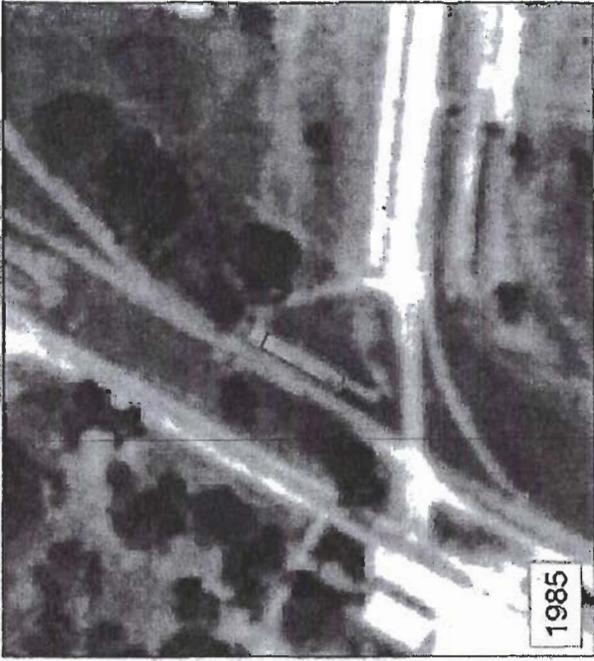
Aerial photos do not show waste management activities in 1957, 1962, 1966, 1973, or 1985, as shown in Figure 1. In addition, historical file records and interviews with present installation employees did not indicate historical waste management in this area. Field surveys completed in September 1992 and March 1996 did not indicate any evidence of waste management activity. Neither the bins nor the surrounding area show any evidence of waste management activities.

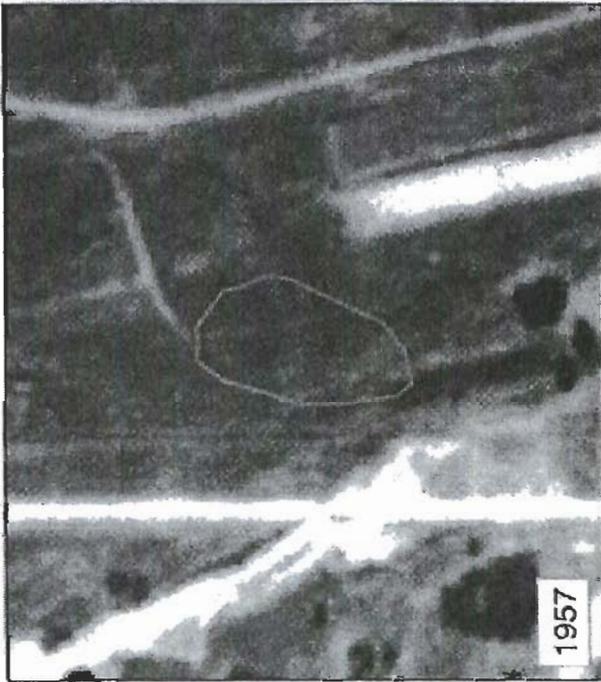
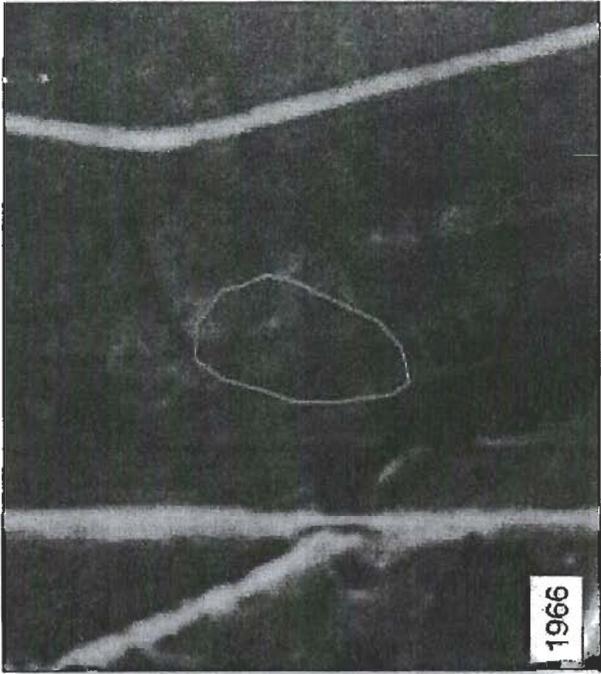
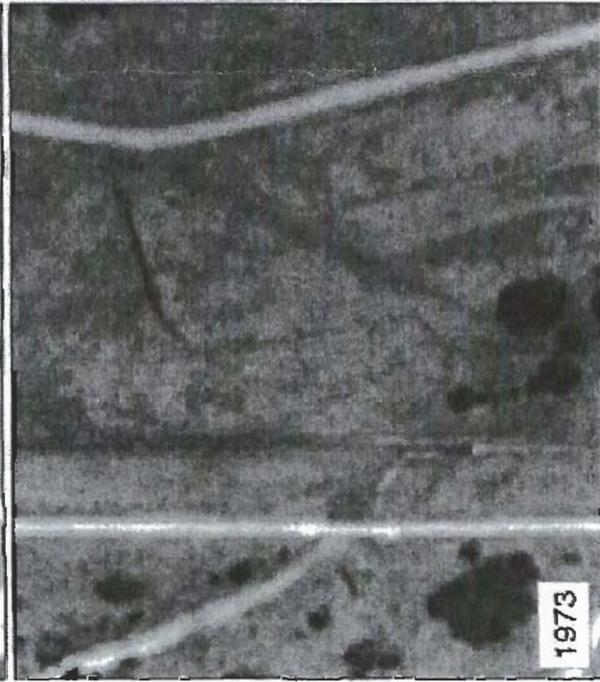
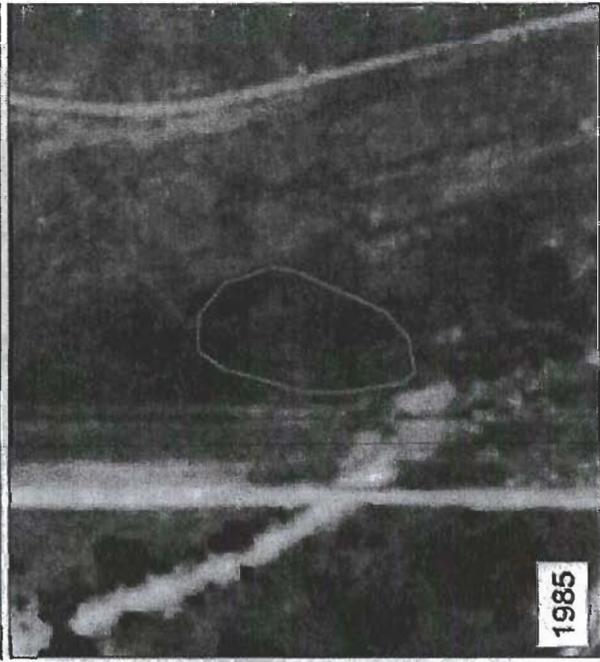
Figure 2

Aerial photos do not show waste management activities in 1957, 1962, 1966, 1973, or 1985, as shown in Figure 2. During the initial (1992) field survey, the reported B-14 area could not be located, even with the area cleared for fence repair operations. No spent casings were identified. No evidence of solid waste management activities was found in a subsequent field survey in 1996.

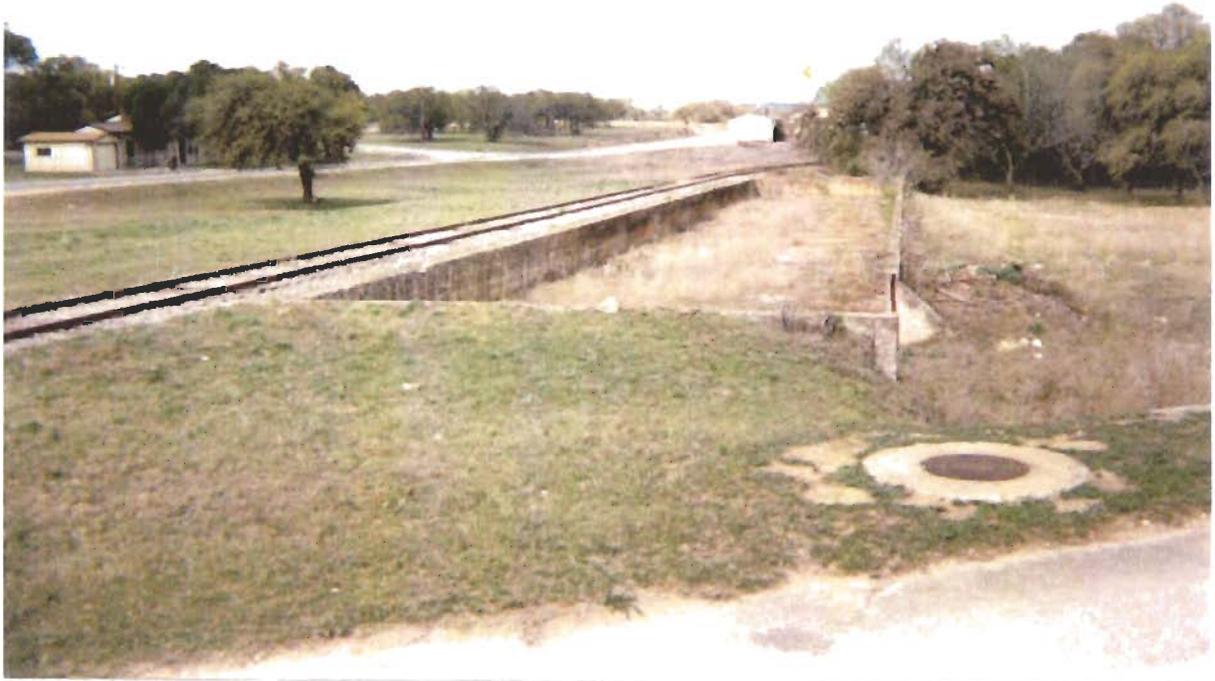
The former coal bin area is located northwest of the headquarters building (Figure 1). The bins are concrete structures as shown in Photograph 1. This area was used for bulk coal storage, according to CSSA records. The structural integrity remained intact for the duration of its operation.

Photograph 1: Coal Bin concrete structures.

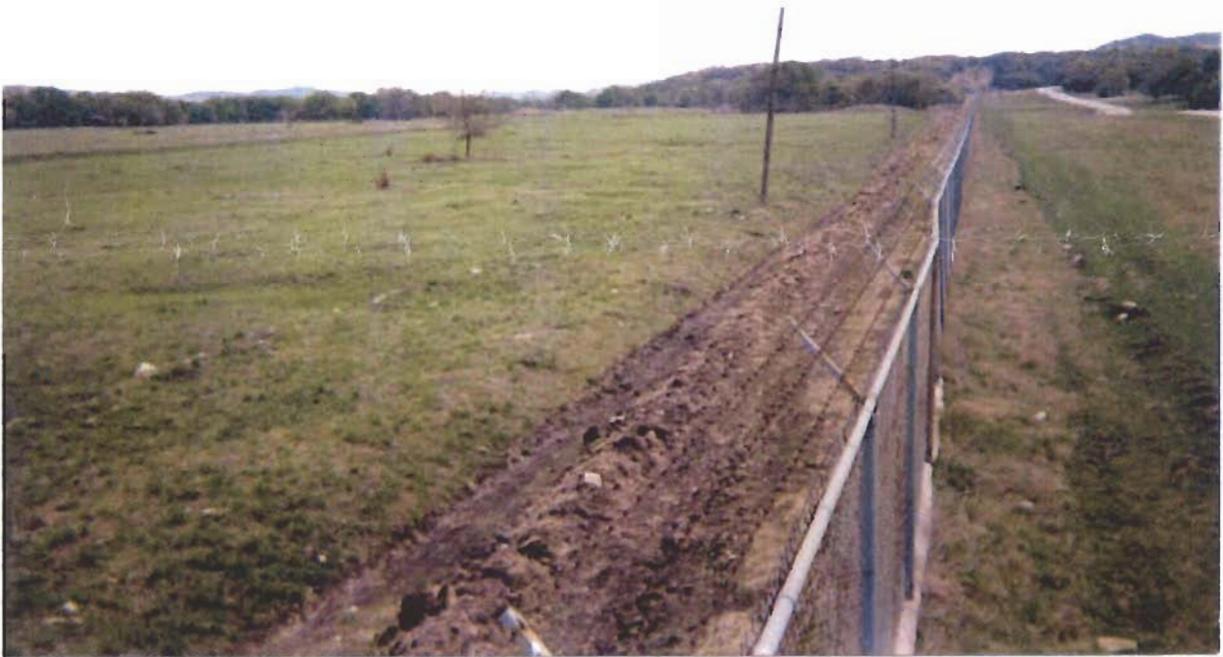
The approximate location of the B-14 area is shown in Figure 2. A photograph of the area where the site may have been located is shown in Photograph 2. According to the EA, this area was supposedly a fired brass area located in the east pasture at CSSA. Fired brass areas are typically characterized by spent brass casings at the surface.

Photograph 2: Presumed location of SWMU B-14.
