RELEASE INVESTIGATION REPORT

SOLID WASTE MANAGEMENT UNIT B-15/16 CAMP STANLEY STORAGE ACTIVITY

PARSONS
Austin, Texas

May 2011

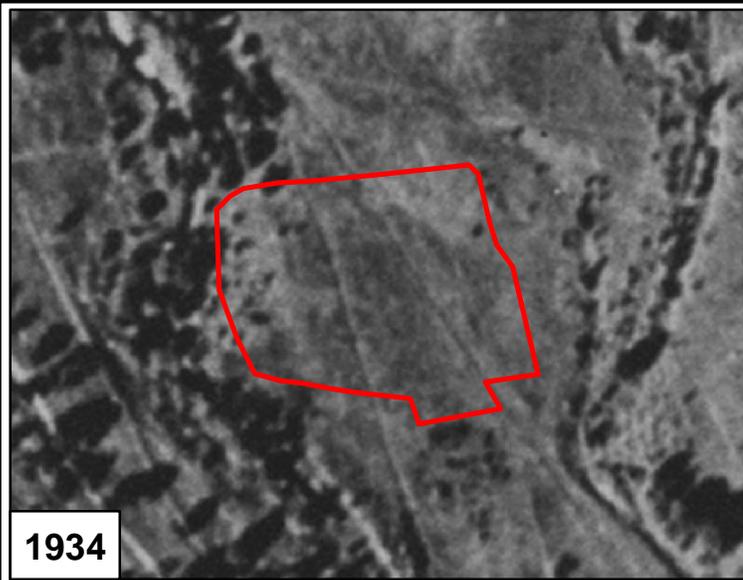
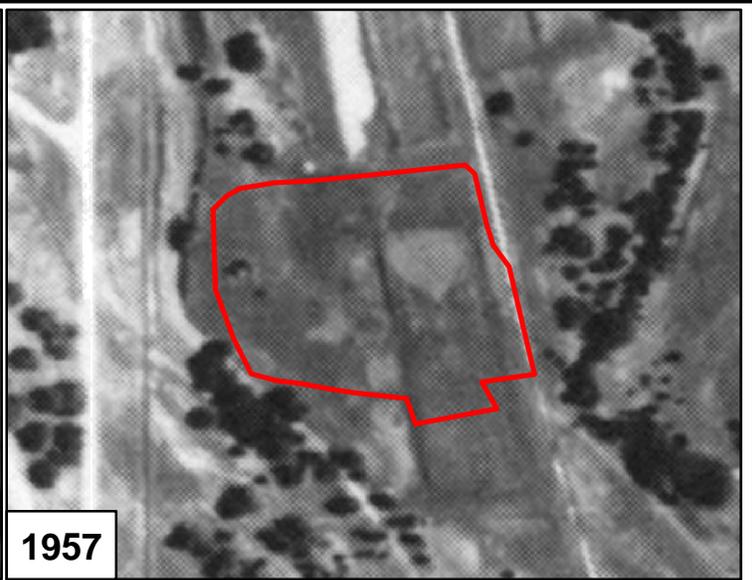
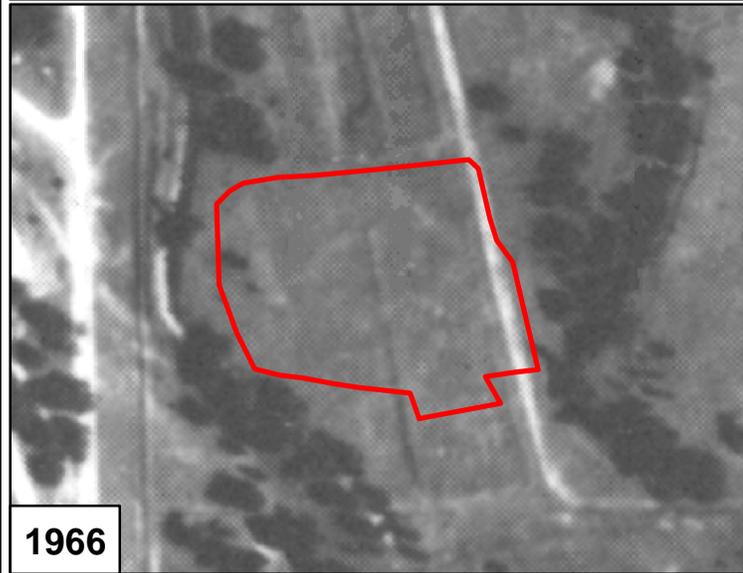
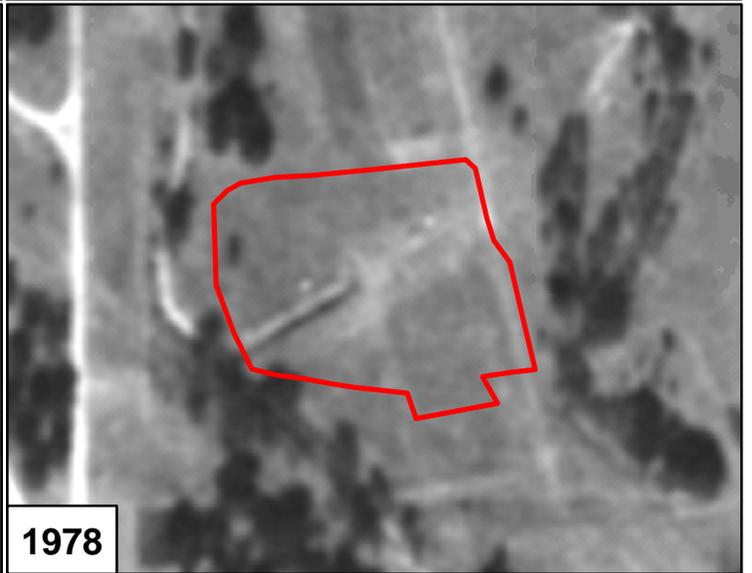
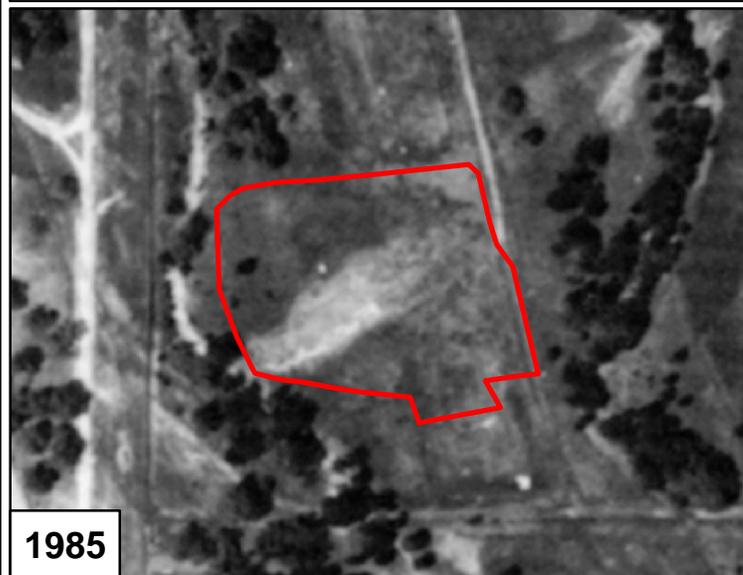
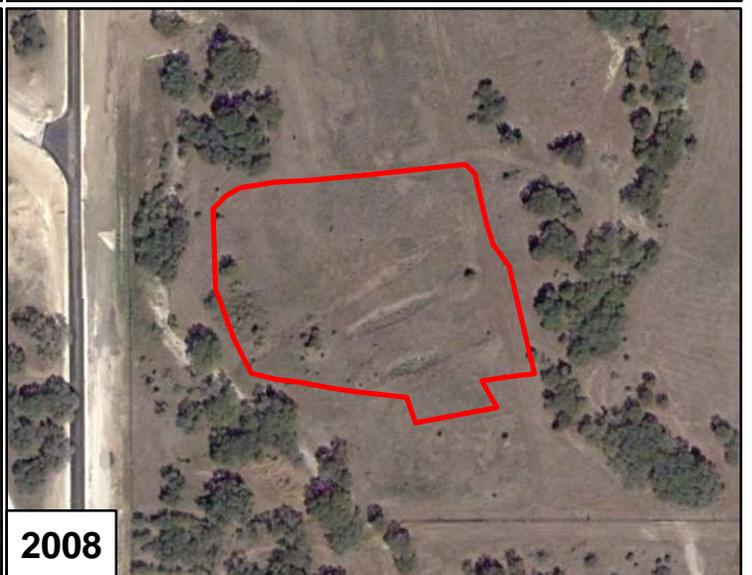
SWMU B-15/16
Aerial Photographs
Camp Stanley Storage Activity

The analytical results for contaminants of concern (COCs) remaining at the site are discussed in Section 3.1. A series of historical aerial photos of the sites are shown on **Figure 3** and photographs showing investigation, excavation, and removal activities at the sites are provided in **Appendix A**. The history of the sites and previous investigations at the sites are discussed below.

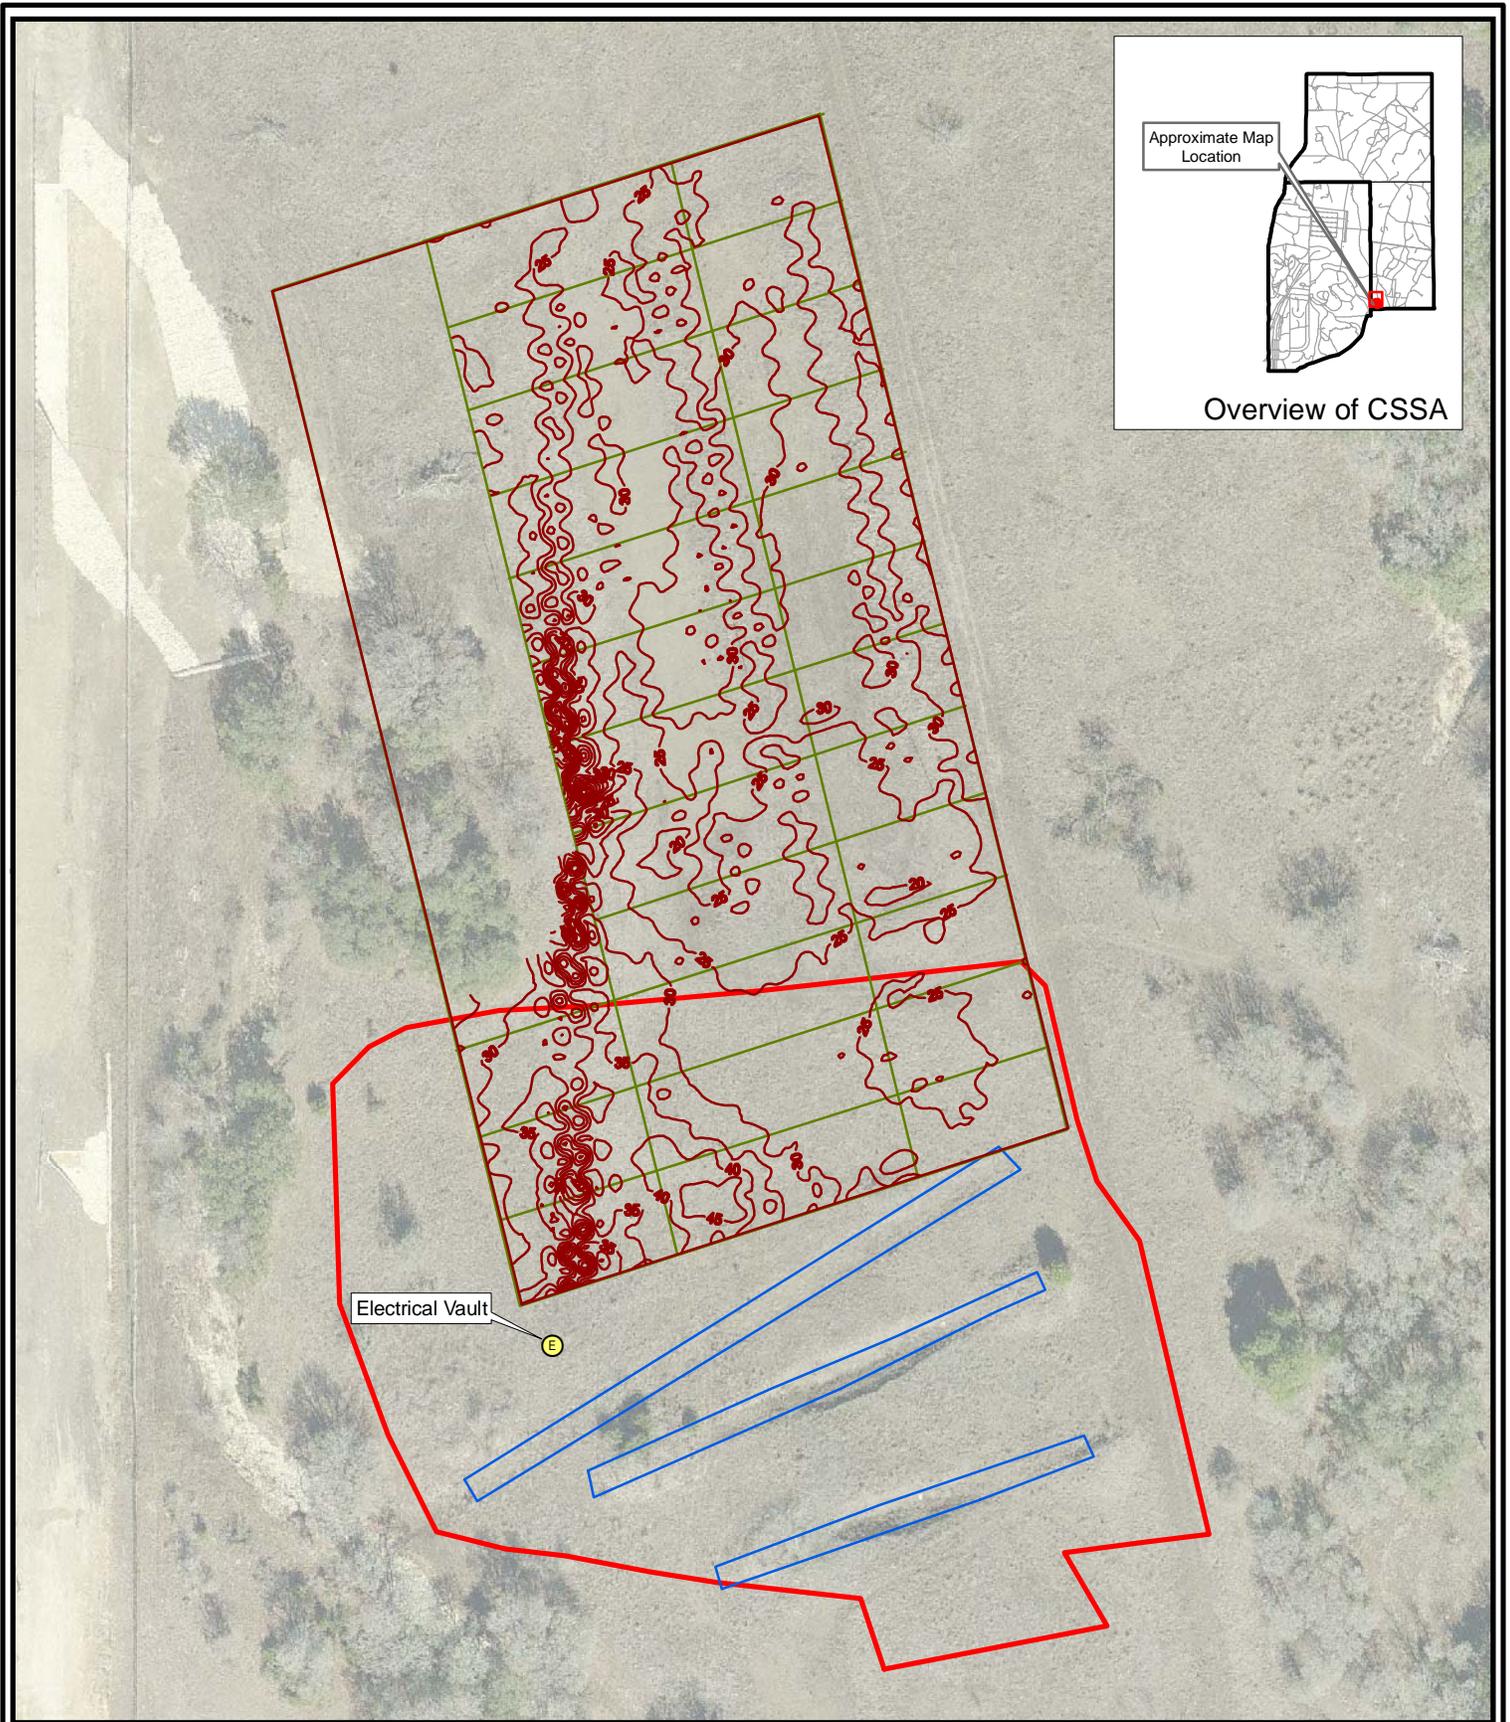
1999 Geophysical Survey at
SWMU B-15/16
Camp Stanley Storage Activity

Surface geophysical surveys were conducted in the northern portion of the site in 1995 and 1999. These surveys did not include the two southern trenches. Only the 1995 survey included the northern trench. The surveys did identify a linear feature to the north of the site, but this was determined to likely be associated with a historic utility line. A buried utility junction vault (**Photo 6, Appendix A**) was found during the most recent investigation that is in line with the linear feature (**Figure 4**). This vault box appeared to have utility conduit leading into it from two different directions which correspond with the linear anomalies identified in the area during the 1995 geophysical survey. The northernmost of the three anomalies was found to converge with the approximate north-south trending linear anomaly in AOC-48 (delisted in November 2004 and shown Figure 2). Further ground-penetrating radar investigation of the northern portion of SWMU B-15/16 and southern portion of AOC-48, as described in the RFI for AOC-48, indicated that the remaining northern portion of the site had no evidence of waste management activities ([CSSA EE, Volume 3-2, AOC-48 RFI and Delisting Reports](#)). All remaining anomalies at SWMU B-15/16 identified in previous investigations were investigated using a Schoenstadt prior to the excavation and waste management activities described in Section 3.1 of this RIR.

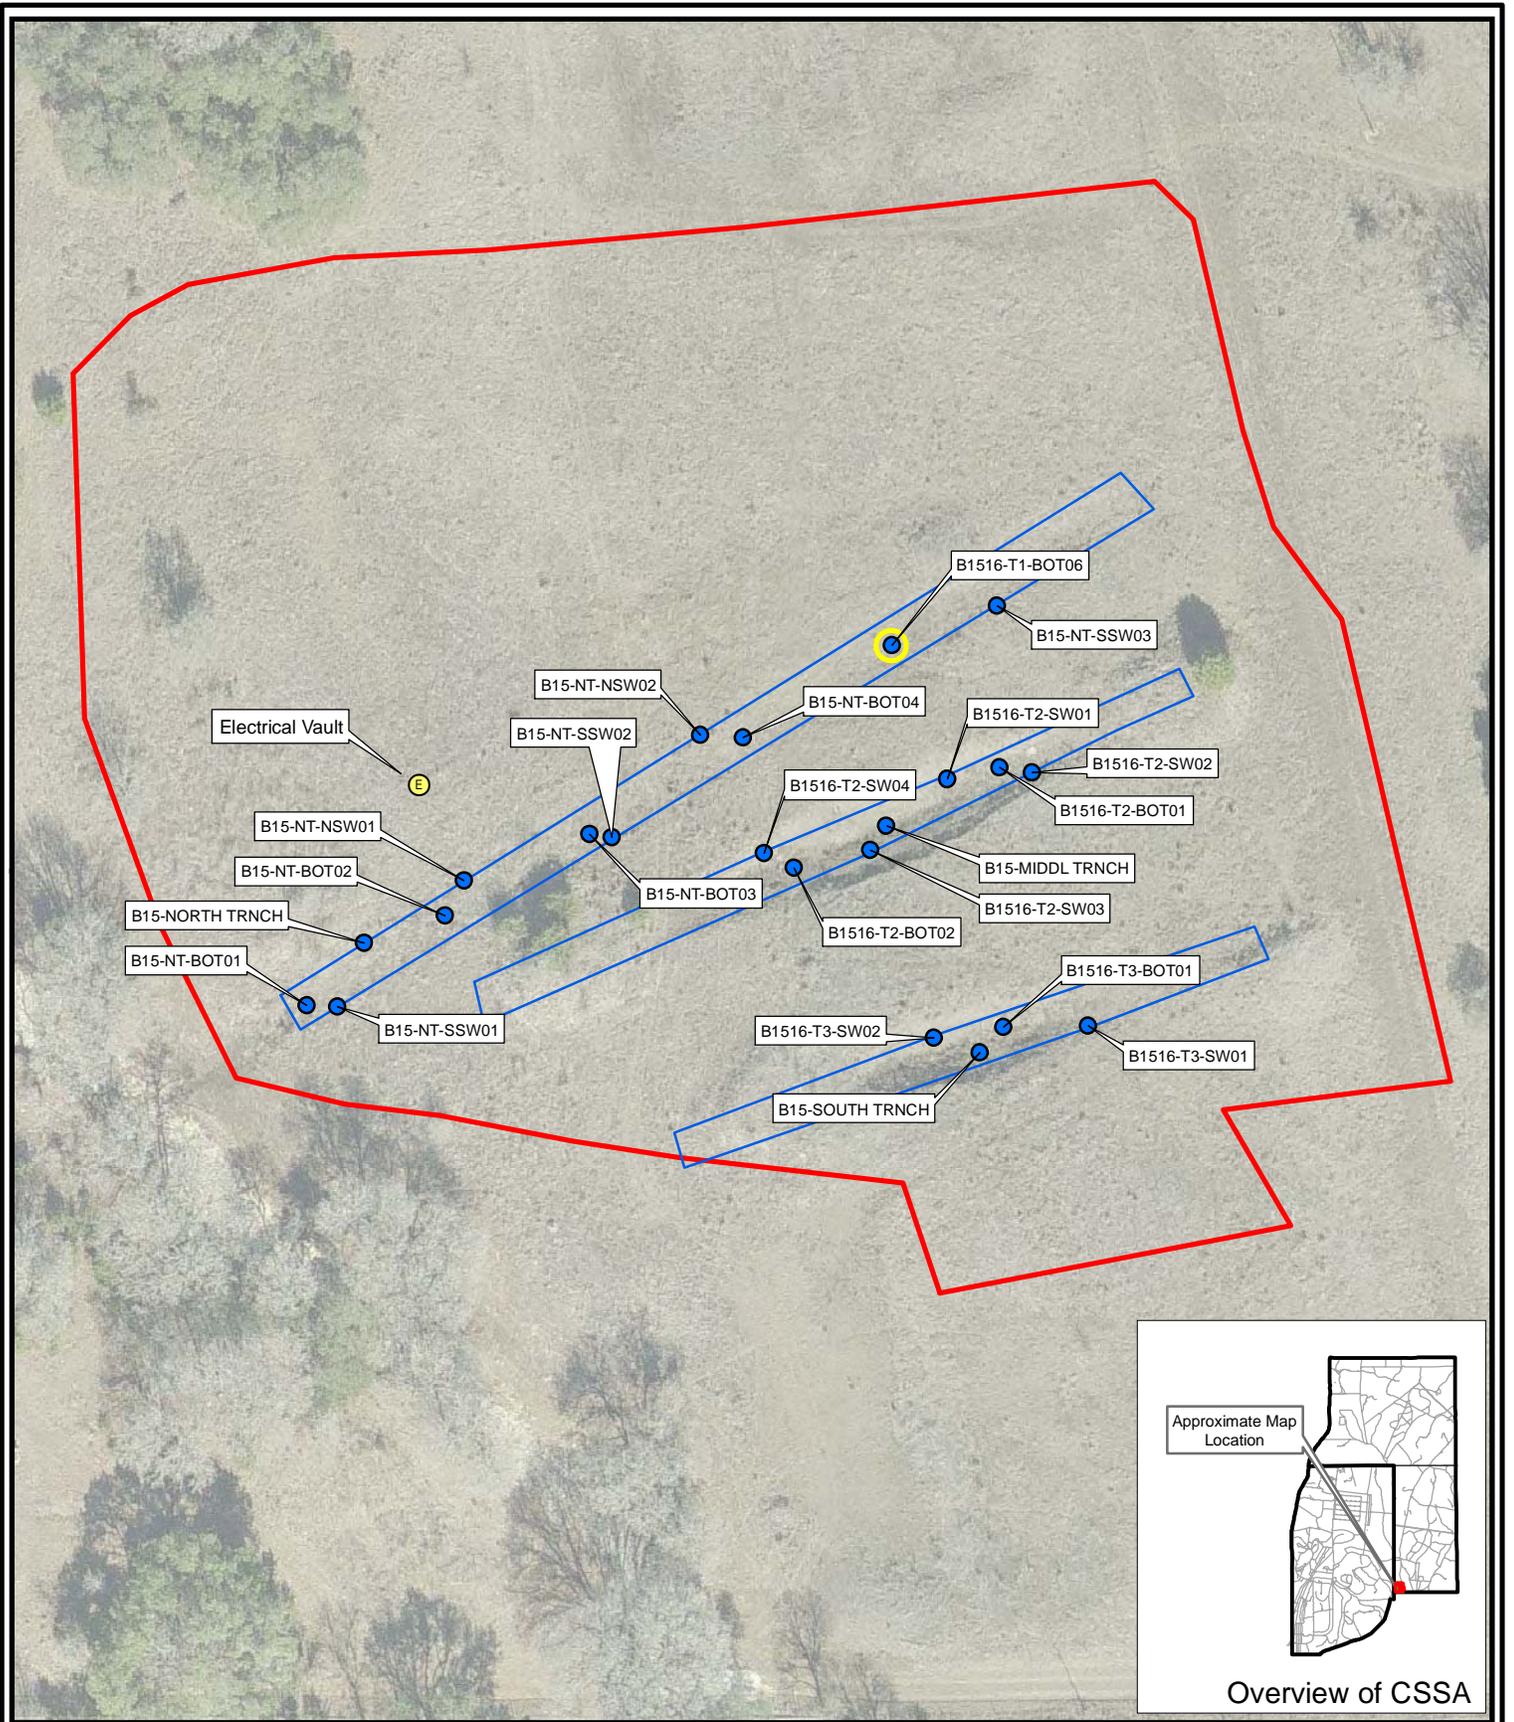
**SWMU B-15/16
Sample Locations
Camp Stanley Storage Activity**

A summary of the cleanup confirmation results at the sites are shown in Table 2 (detected compounds only) and **Appendix C** (all analytes), and the confirmation soil sampling locations are shown on **Figure 5**. Analytical results for samples collected from stockpiled soil excavated as part of this effort are shown in **Appendix F**. The soil stockpiles at the ends of the trenches described in the RFI Report were also sampled along with the newly excavated soil, and used as backfill following the excavation. As shown on Figure 5, excavation at the sites occurred within the boundaries of SWMU B-15/16.

As stated above, the list of the analytical results for soils remaining at the site is provided in Table 2. The data verification summary report for the sampling and analytical results is provided in **Appendix D**. Sample locations for soils remaining at the site are shown on Figure 5. The clearance areas where soils were excavated and removed are also shown on Figure 5. Waste characterization sampling and off-post removal activities are described in Section 3.1.2.2. Additional information about past activities and investigations at the sites can be found in the [CSSA EE \(Volume 3, SWMU B-15/16\)](#). Photos 1 through 9 in Appendix A show the excavation, removal, and confirmation sampling activities for SWMU B-15/16.

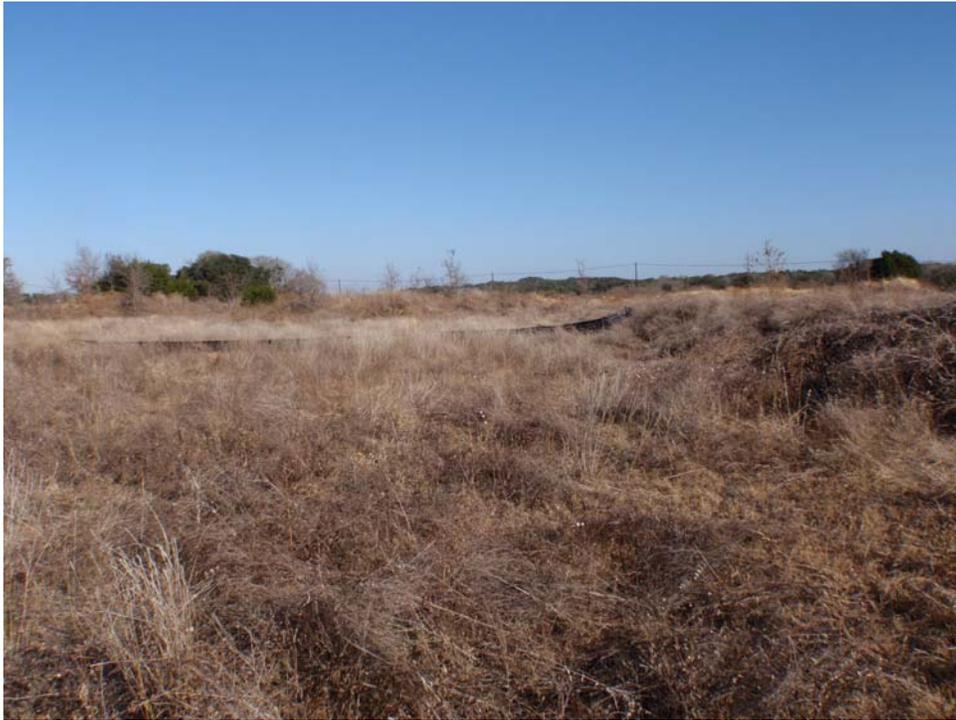
Photo 1. SWMU B-15/16 prior to excavation, looking south (February 2010).

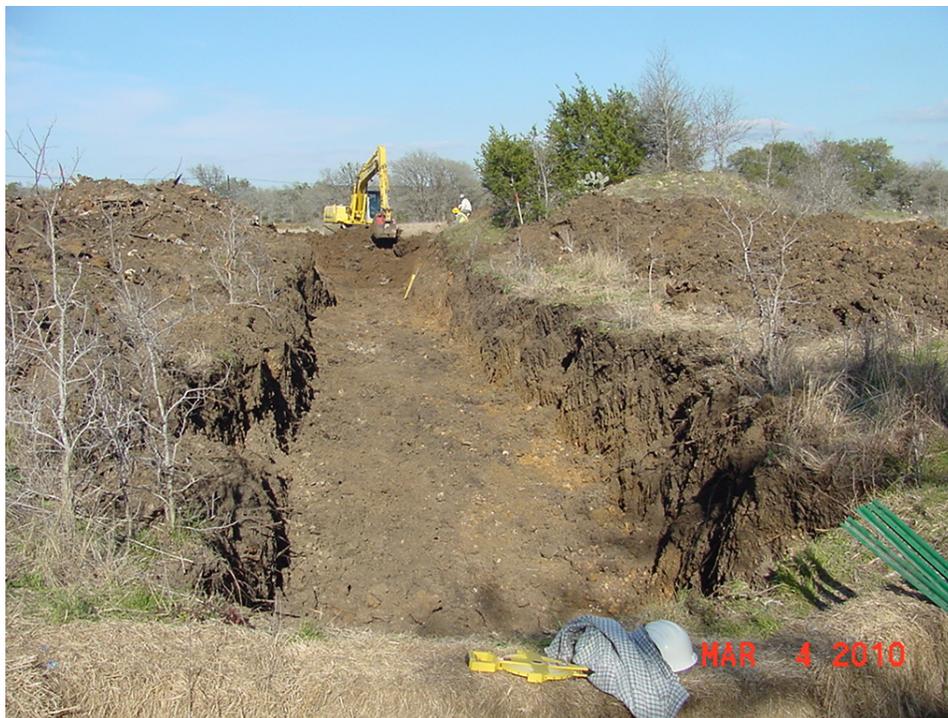
Photo 2. Excavation of the north trench (Trench 1), looking east.

Once all three trenches were excavated (**Photo 2, Appendix A**) and materials were placed into stockpiles, an excavator was used to remove larger metal debris from the soil matrix. After the excavator had worked through the stockpiles, a front end loader was used to spread out the material in 2-3 inch layers in the inspection area. UXO technicians, assisted by laborers, handpicked foreign debris from the soil matrix (**Photo 3, Appendix A**). When munitions items were (MD) observed during this effort a UXO technician would identify it as MEC or MD, certify it as inert (if appropriate), and place it in a secure area. No MEC was found in any of the trenches. All MD was segregated from other metal debris, removed from the site, and stored at CSSA in temporary storage containers (Conex) for future management at the discretion of CSSA (e.g., disposal, de-milling, or recycling). All MD removed from the trenches during this effort is listed in **Appendix E**.

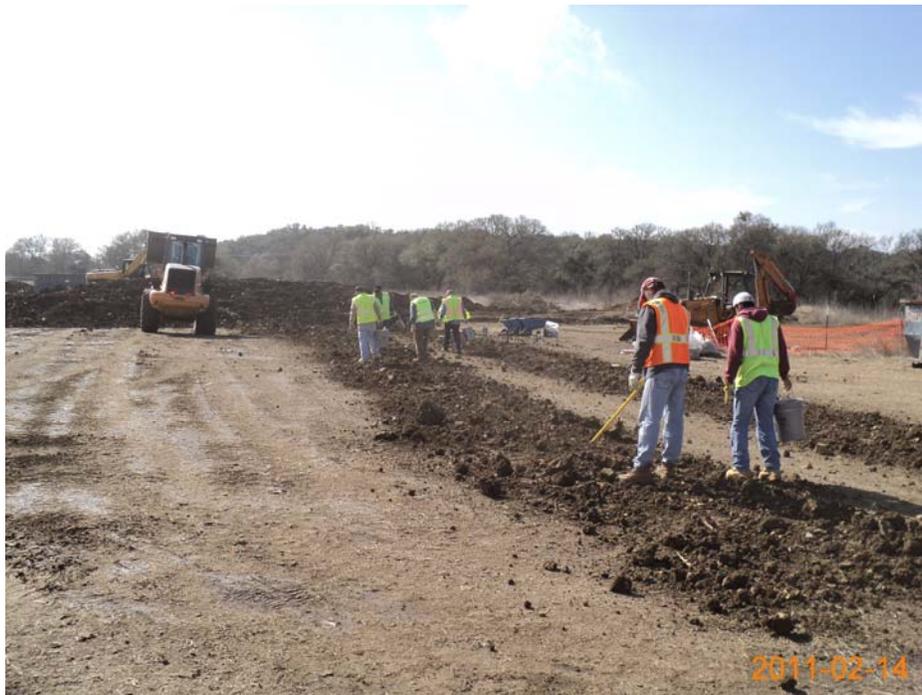
Photo 3. Inspection and removal of foreign objects.

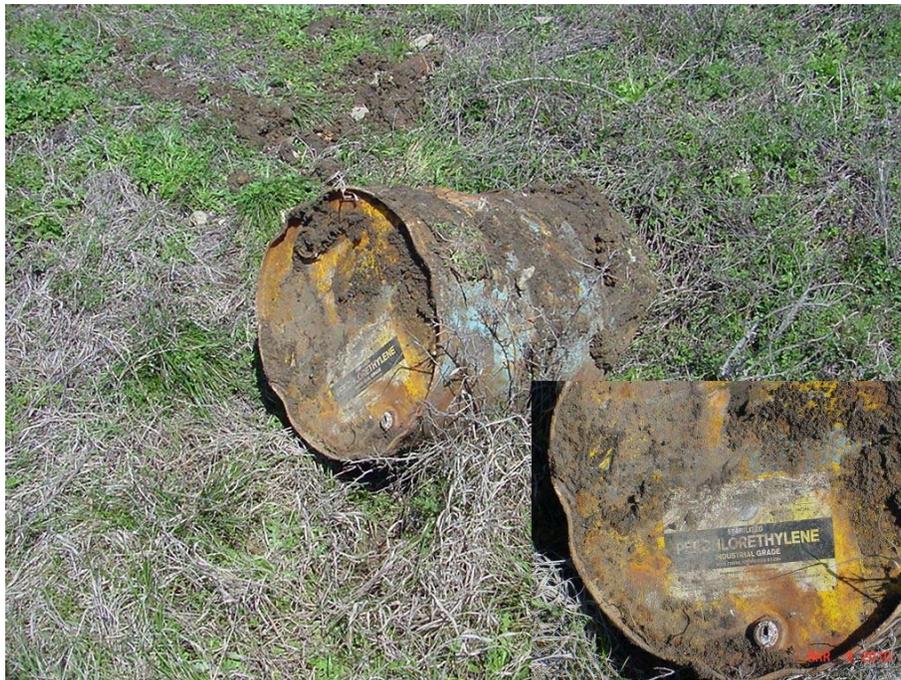
Photo 4. PCE Drum encountered in Trench 1.

One sample was collected at the location where the empty drum labeled “perchloroethylene,” was found (B1516-NT-BOT5, Table 2). Analytical results for that sample showed zinc levels in excess of the TCEQ ecological benchmark concentration of 156 mg/kg. No other metals were detected in confirmation samples above background, and there were no detections of VOCs, petroleum hydrocarbons, pesticides, or herbicides. Even though the zinc concentration at B1516-NT-BOT did not exceed the Tier 1 PCL, a conservative approach was taken. The location was excavated an additional 1-2 inches deeper, resampled, and analyzed for zinc (B1516-T1-BOT06, Table 2). The analytical results for the new sample showed a zinc concentration (8.9 mg/kg) below the CSSA background concentration of 73.2 mg/kg.

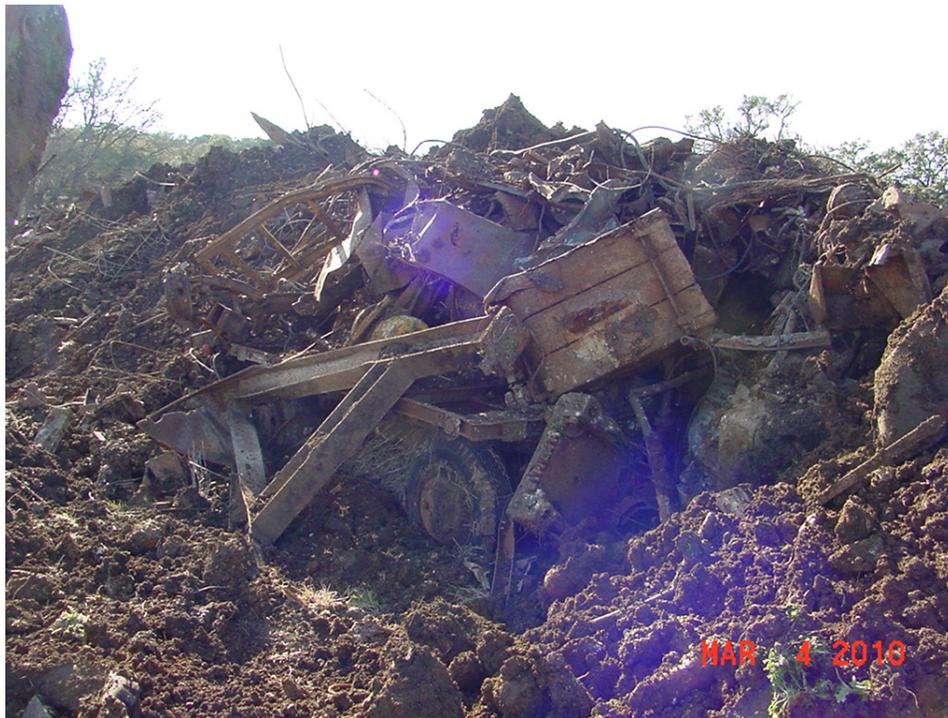
Photo 5. Debris and target vehicles found in Trench 1.

This trench contained most of the waste found during this removal effort including: a pickup truck frame that appeared to have been used for target practice (**Photo 5, Appendix A**), numerous pieces of cast iron plumbing pipe, concrete construction debris, an assortment of tires, miscellaneous metal debris, and 80 cubic yards (CY) of styrofoam trash. An electrical vault box (**Photo 6, Appendix A** and shown on Figure 5) located approximately 60 feet northwest of the northwest corner of Trench 1 was discovered in a Schoenstadt sweep of the area. It is assumed that this vault housed electrical equipment used to control targets. The vault was left in place

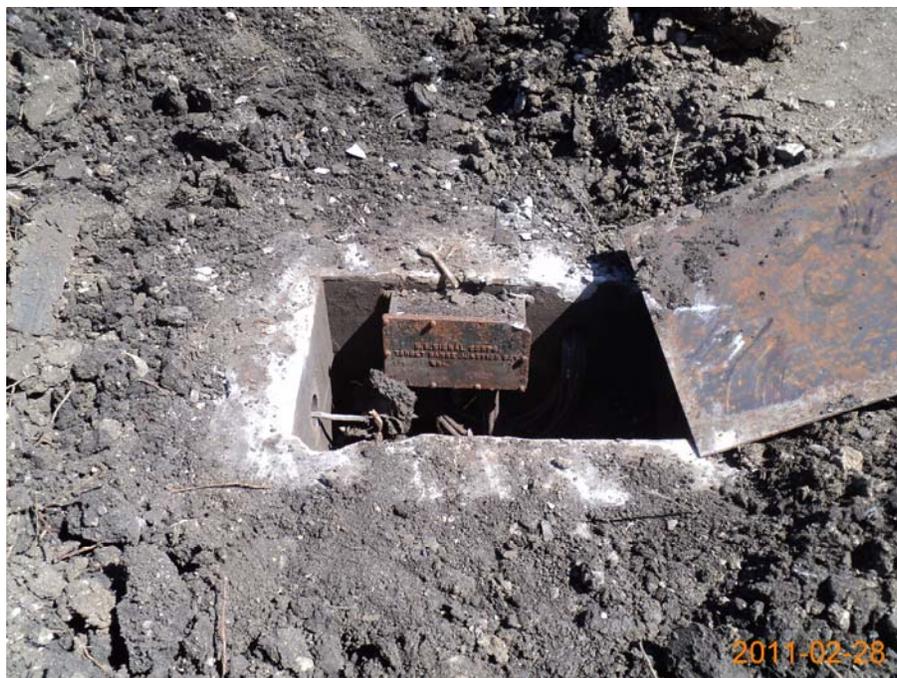
Photo 6. Electrical vault box uncovered northwest of Trench

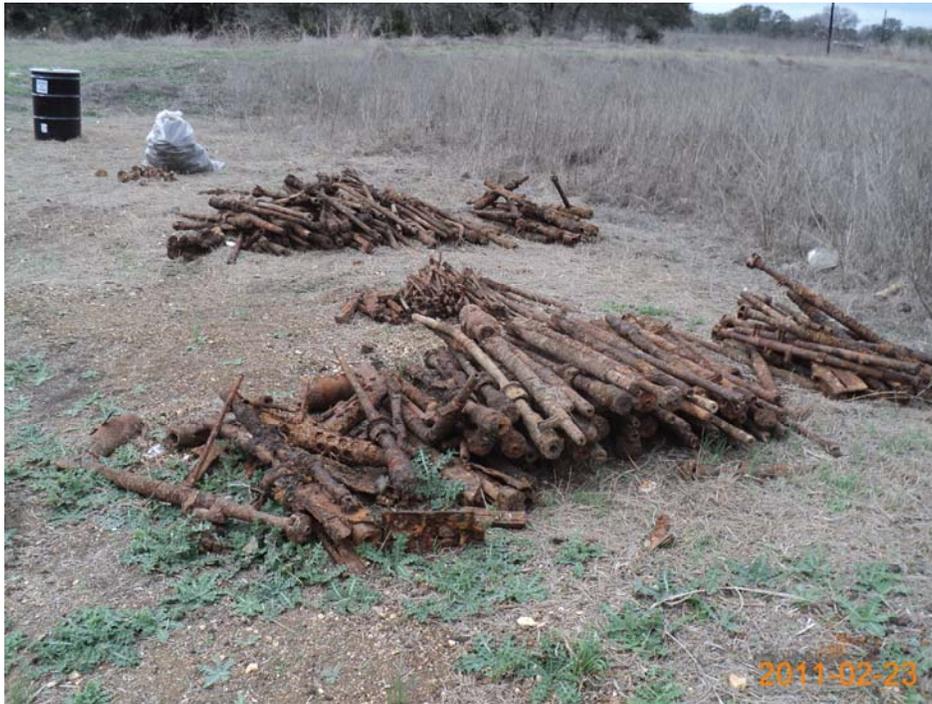
Photo 7. Gun barrels found in Trenches 2 and 3.

Trench 2 was excavated to approximately 220 feet long, 12 feet wide, and varied in depth from 8 to 10 feet. This trench contained machine gun barrels (**Photo 7, Appendix A**), live and expended small arms cartridge casings (.38-.50 caliber), miscellaneous metal debris, and approximately 200 CY of material containing asphalt shingles and other construction-type debris. The construction debris material was segregated from the rest of the stockpiled material and characterized for non-hazardous disposal at Covel Gardens Landfill in San Antonio, TX. The remaining soils, debris, and trash were disposed of as described in Section 3.1.2.2. Based on the dimensions of Trench 2, a total of approximately 1,173 CY of soil and waste were excavated.

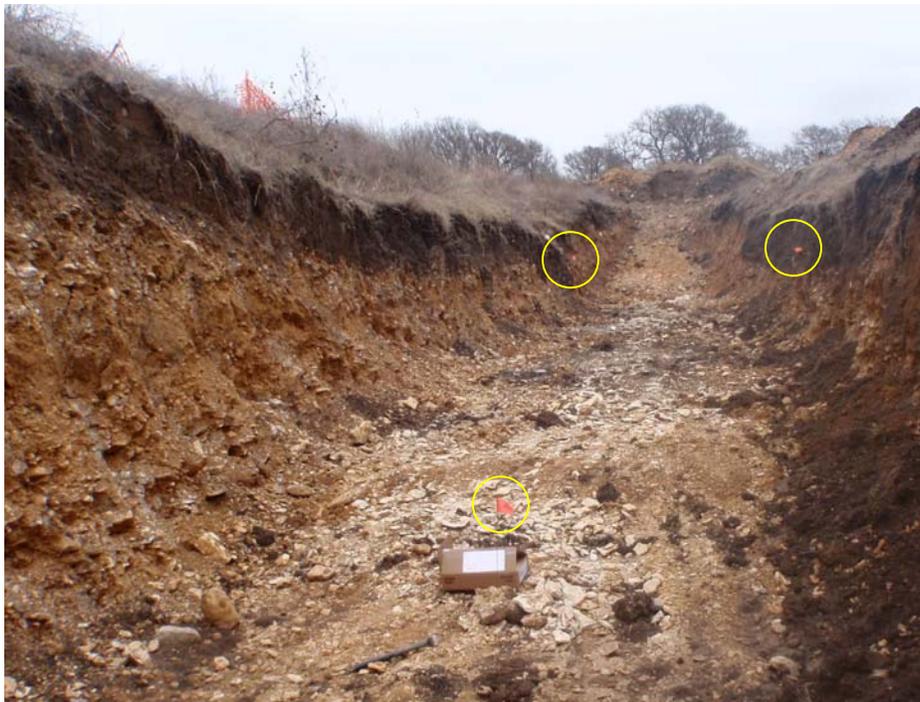
Photo 8. Confirmation sample locations (circled) in Trench 2, looking east.

Following completion of the excavation effort all trench bottoms and sidewalls were sampled (**Photo 8, Appendix A**) and the results are shown in Table 2.

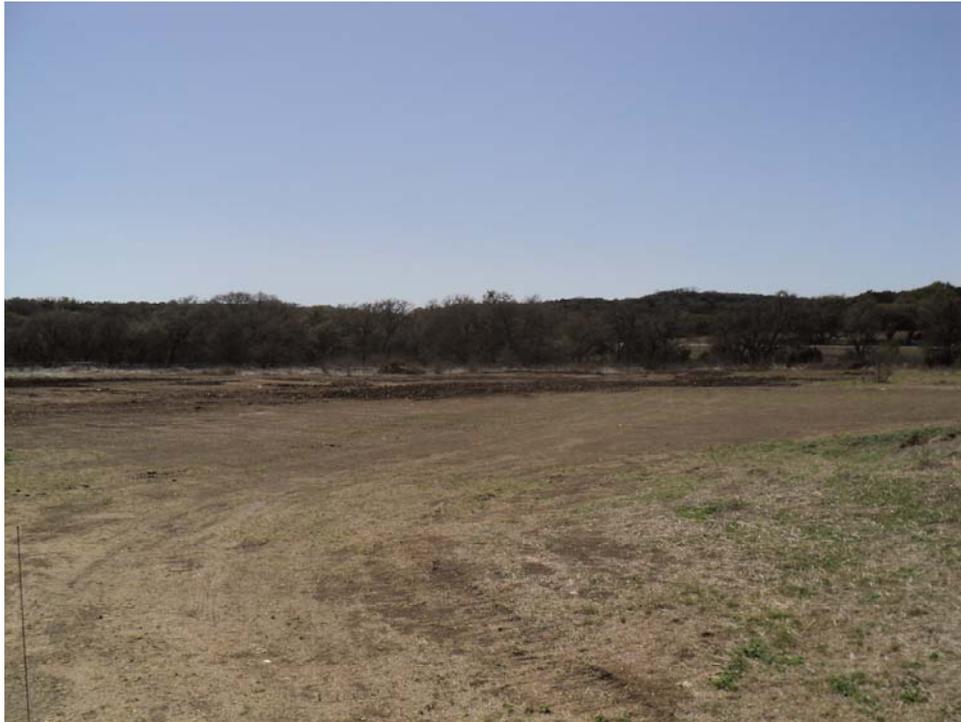
Photo 9. Post-excavation view of SWMU B-15/16, looking east.

and Metal Company in San Antonio, Texas. In addition, the 80 CY of Styrofoam were bagged and sent to the landfill as municipal trash. The remaining 160 CY of Class 2 non-hazardous soils were transported and disposed off-post at Waste Management, Inc. (WMI), Covell Gardens Landfill in San Antonio, Texas. The soil disposed of at Covell Gardens is represented by sample B1516-WC05 in Appendix F. The waste manifests and profile data, including the waste analytical results, are kept on file at the CSSA Environmental Office. Approximately 3,360 CY of non-impacted soils remaining at the site were sampled, analyzed by the lab to confirm they did not exceed Tier 1 PCLs or background metals concentrations, and used as trench backfill. Analytical waste characterization results for these soils are shown in Appendix F. The excavated trenches were backfilled and graded to provide a gentler slope into the depressions which will be planted with native grass and wildflower seeds (**Photo 9, Appendix A**).
