RELEASE INVESTIGATION REPORT

SOLID WASTE MANAGEMENT UNIT I-1

CAMP STANLEY STORAGE ACTIVITY

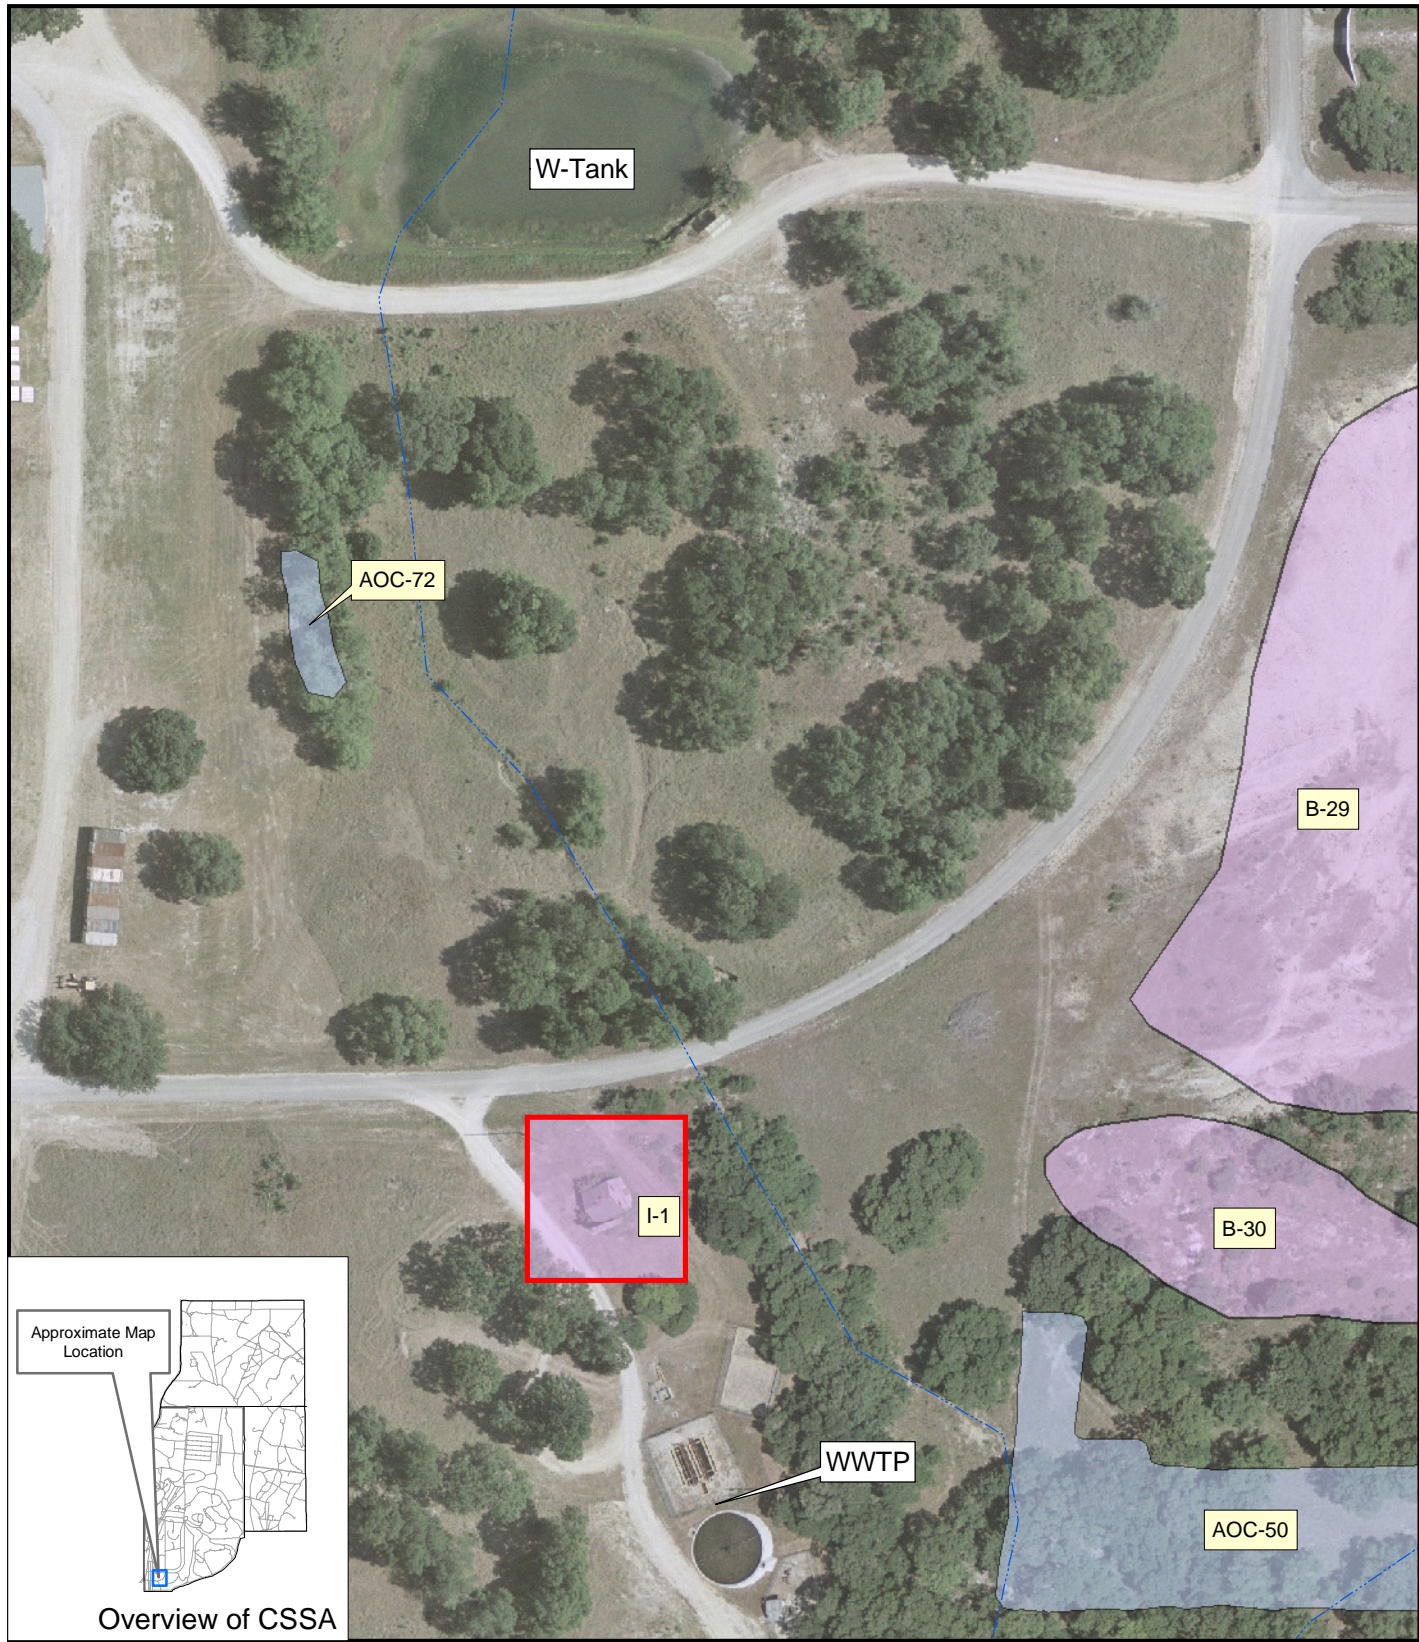
Figure 2
SWMU I-1
Site Location Map
Camp Stanley Storage Activity
Parsons

As shown on Figure 2, the nearest perennial surface water body is the “W-Tank,” a pond located approximately 500 feet north (upgradient) of the site. The pond is approximately 0.52 acre in size. There is a dam along the southern boundary of the pond. A small intermittent stream is below the dam. The stream only has water during and immediately after rain events. The creek bed runs to the south, less than 100 feet to the east of SWMU I-1. The creek bed is narrow, only approximately 5 feet wide.

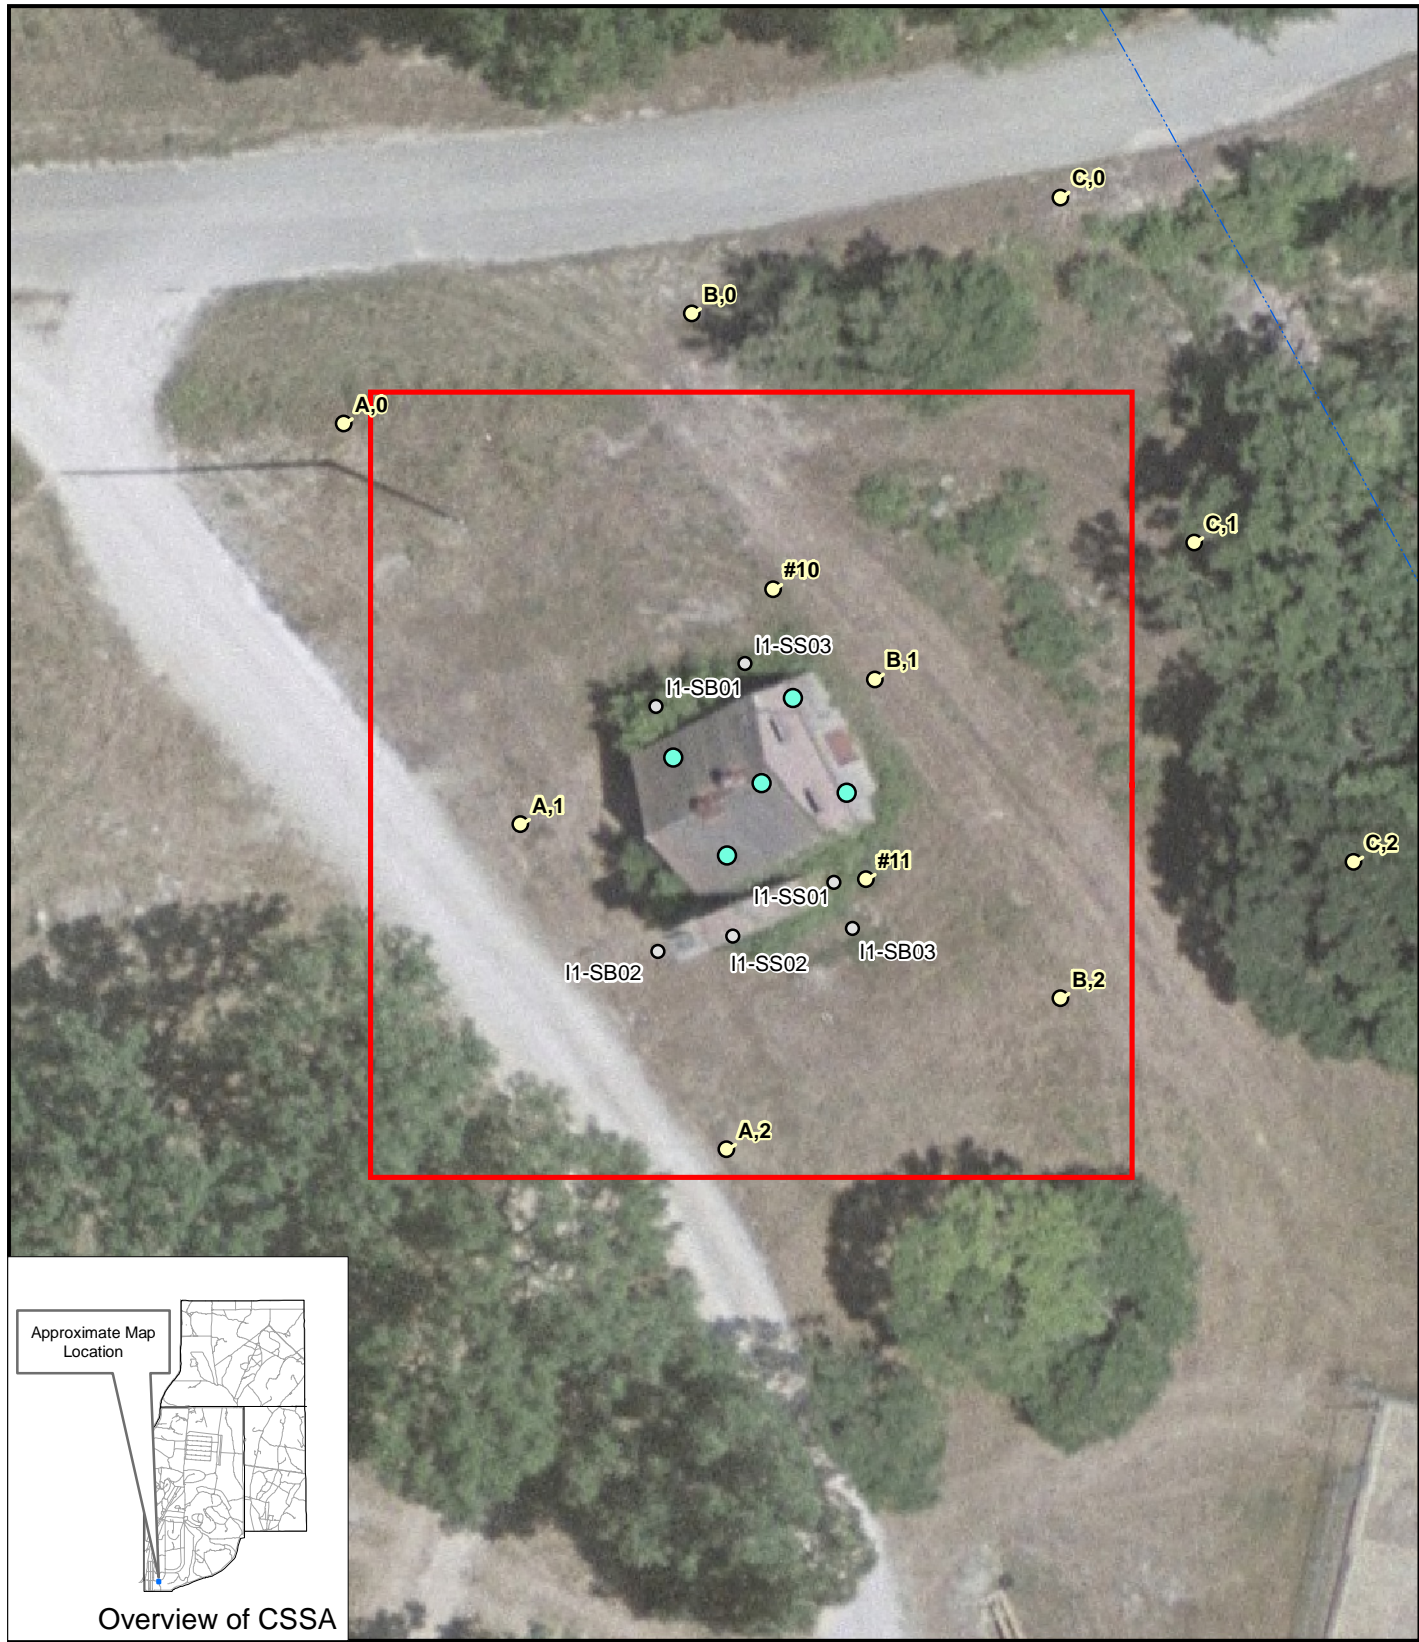
Figure 3
SWMU I-1
Sample Location Map
Camp Stanley Storage Activity

Boring logs for SWMU I-1 (I1-SB01, I1-SB02, and I1-SB03 [shown on Figure 3]) are provided in Appendix A. In general, these three boring logs show that the limestone bedrock occurs between approximately 3 to 13 feet below ground surface (bgs) depending on topography. Above the bedrock are clays and silts that are the result of weathering of the limestone parent material. Groundwater was not encountered in any of the borings.

In March 2000, three soil borings (I1-SB01, I1-SB02, and I1-SB03) were advanced and soil/rock samples were obtained at three discrete intervals from each boring. Boring I1-SB01 was advanced to 15 feet bgs, I1-SB02 was advanced to 6 feet bgs, and I1-SB03 was advanced to 14 feet bgs. The borings were drilled adjacent to Building 294 at locations where contamination would be expected if a release had occurred at the site. The boring locations are shown on Figure 3. Boring I1-SB01 was placed approximately 4 feet north of Building 294, while I1-SB02 was placed approximately 8 feet from the southwest corner of the building. Boring I1-SB03 was placed approximately 5 feet south of the incinerator building.

In April 2000, three surface soil samples were collected at SWMU I-1 and were analyzed for PCBs. The samples were collected adjacent to Building 294 at locations where contamination would be expected if a release had occurred at the site. No PCBs were detected in the samples. Sample locations (I1-SS01, I1-SS02, and I1-SS03) are shown on Figure 3. Analytical results are shown in Table 4.

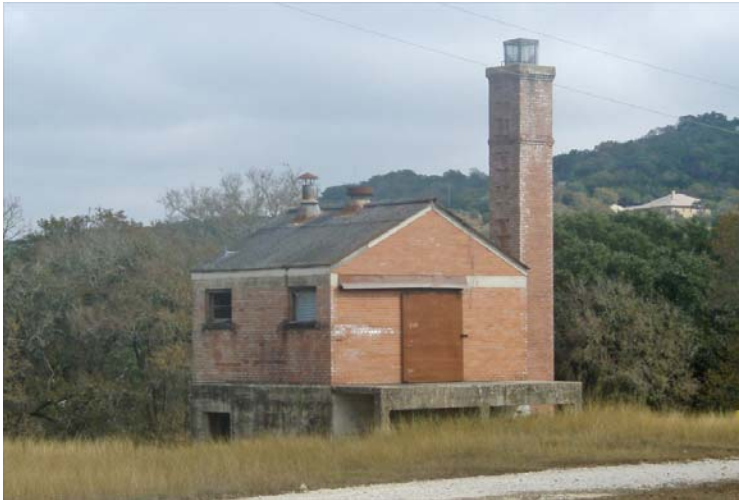
View of Building 294 looking east with gravel road in foreground.

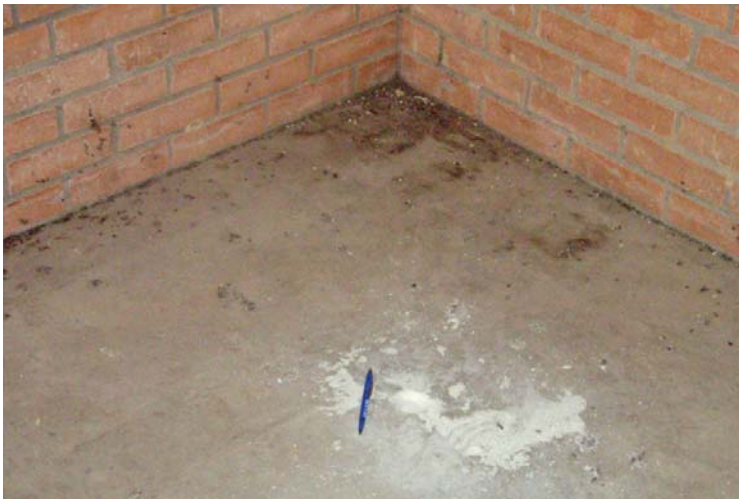
During a March 9, 2007 meeting discussing closure of SWMU I-1, USEPA, TCEQ and CSSA agreed that CSSA would collect a composite concrete sample from the concrete floor in Building 294 and perform analysis for PCBs at a certified laboratory. As suggested during the meeting, the USEPA Region I *Draft Standard Operating Procedure for Sampling Concrete in the Field* was used to guide the sampling. On October 12, 2007, a Parsons sampling team used a hammer drill to complete five 1-inch diameter holes to a depth of 3 inches in the concrete floors of Building 294 (shown on Figure 3). The powdered/chipped concrete generated during the drilling of the five borings was composited into a single sample container, labeled, and sent to Agriculture & Priority Pollutants Laboratory, Inc. (APPL) for PCB analysis. Analysis was by USEPA *Test Methods for Evaluating Solid Waste* (SW-846) Method 8082. Pictures of Building 294, as well as two of the five boring locations, are shown in Appendix C.

One of the five concrete sample locations.

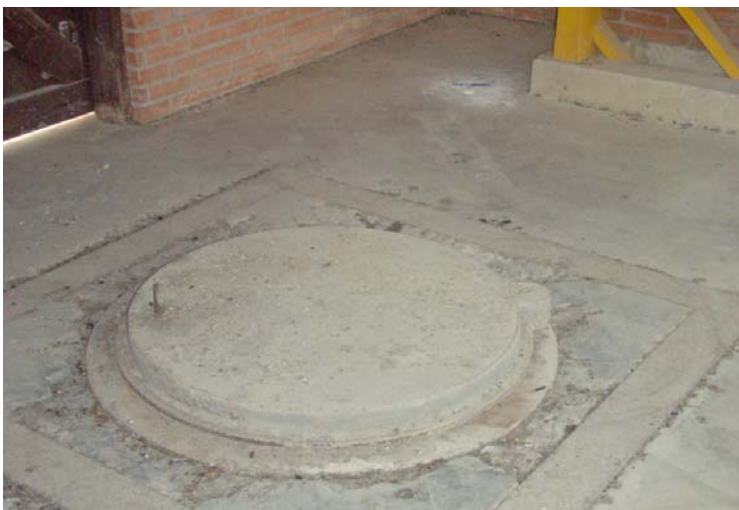
Manway access on second floor of Building 294 with one of five concrete sample locations in the upper center of photo.
