# RELEASE INVESTIGATION REPORT

## AREAS OF CONCERN 67 and 68 (AOCs-67/68) CAMP STANLEY STORAGE ACTIVITY

### **Camp Stanley Storage Activity Boerne, Texas**

July 2010

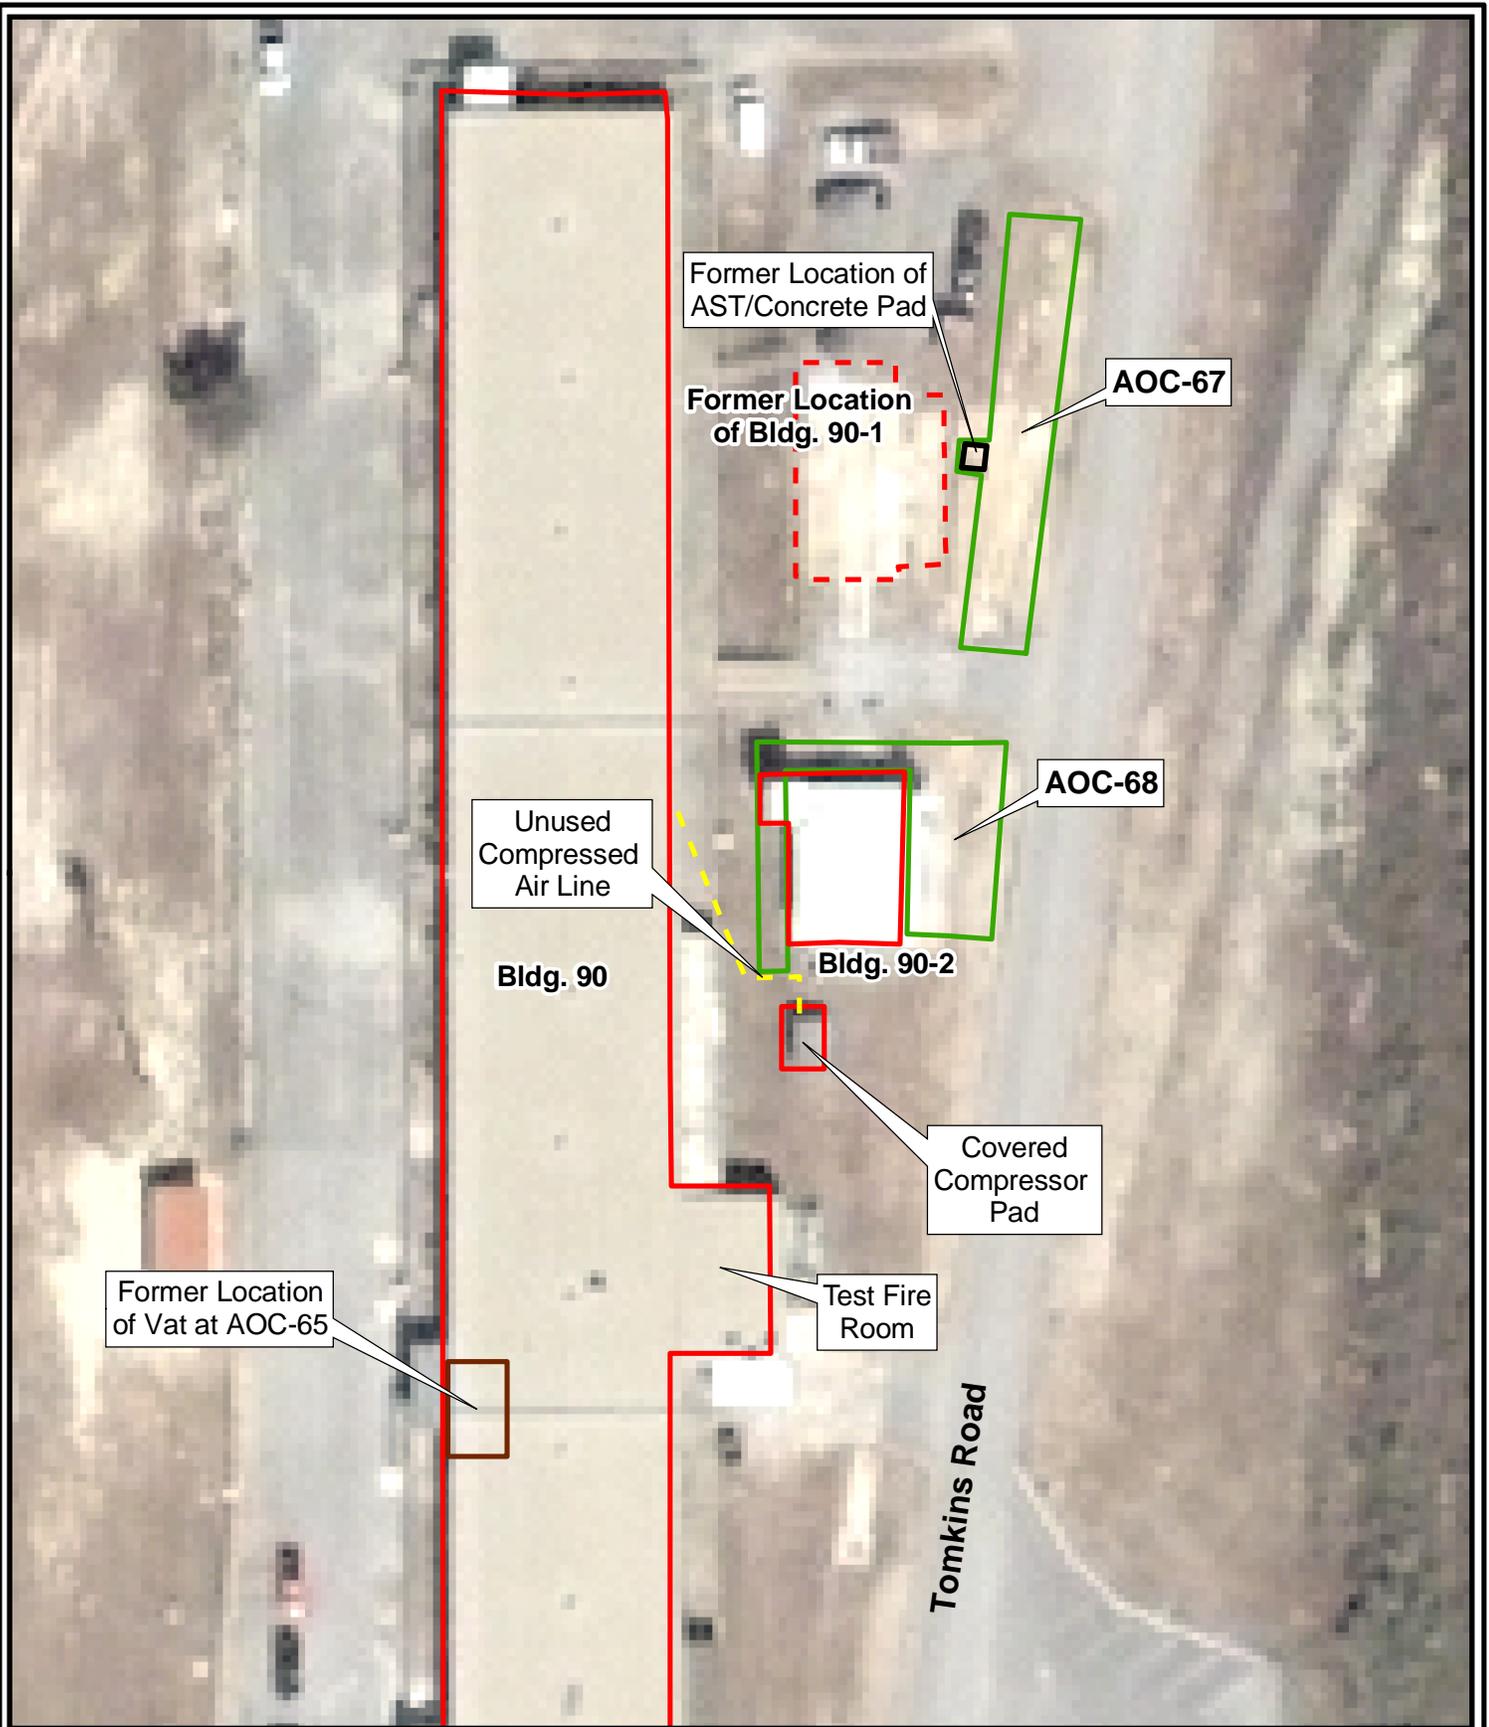
**Figure 3**  
 AOCs-67/68  
 Site Vicinity Map  
 Camp Stanley Storage Activity  
**PARSONS**

Lead (dust and fine particles of sand containing lead) has possibly been distributed in the area due to past test firing practices at Building 90 (see Figure 3). The test fire room is used for weapon maintenance quality checks. Until 2004, guns, pistols, machine guns, *etc.*, were fired into a sand bank in the test fire room. The ventilation system, which was a roof vent, allowed the lead-contaminated dust and sand to escape from the room to the surrounding area. In 2003, the sand was removed from the test fire room and properly disposed. The sand bank was replaced with a projectile trap system consisting of steel plates. A HEPA filtration system designed for 99.99% removal efficiency was also installed. The projectiles and air pollution control dust are now collected and recycled.

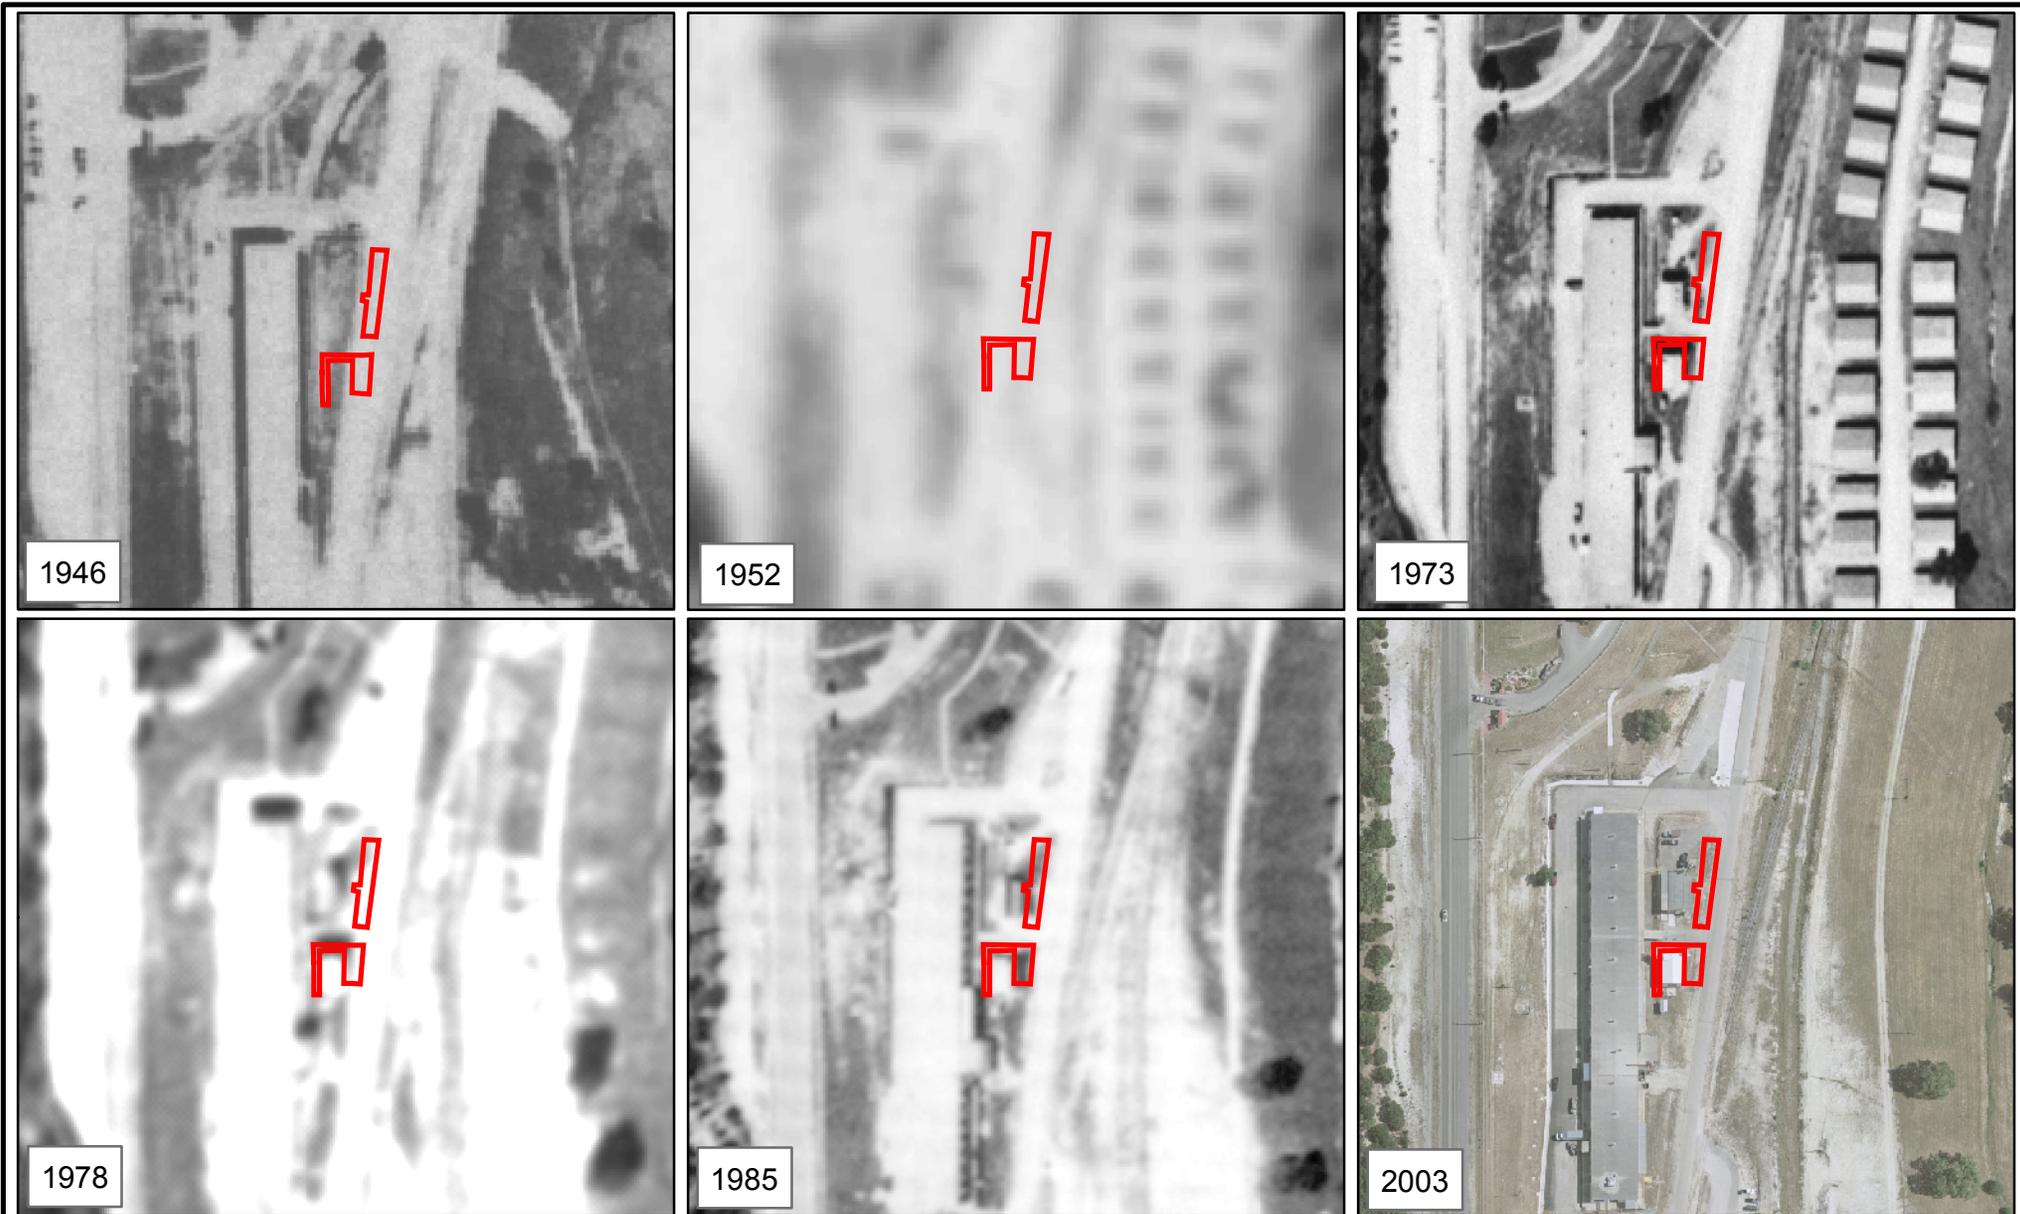
Figure 4  
AOCs-67/68  
Aerial Photographs  
Camp Stanley Storage Activity

AOC-67 is approximately 0.047 acre in size and is directly east of the former location of Building 90-1 (the former ordnance materials bluing shop). Building 90-1 was damaged by fire in early 2004 and subsequently demolished. AOC-67 consisted of a north-south drainage ditch and a three-sided concrete storage area (open on one side with a concrete pad) that was built into the slope between the drainage ditch and Building 90-1. The concrete storage area and pad measured approximately 4 feet by 10 feet. The dimensions of the ditch were approximately 100 feet by 20 feet. The former location of Building 90-1 is shown on Figure 3. Photos 1 through 4 show former Building 90-1, the concrete storage area, and the drainage ditch.

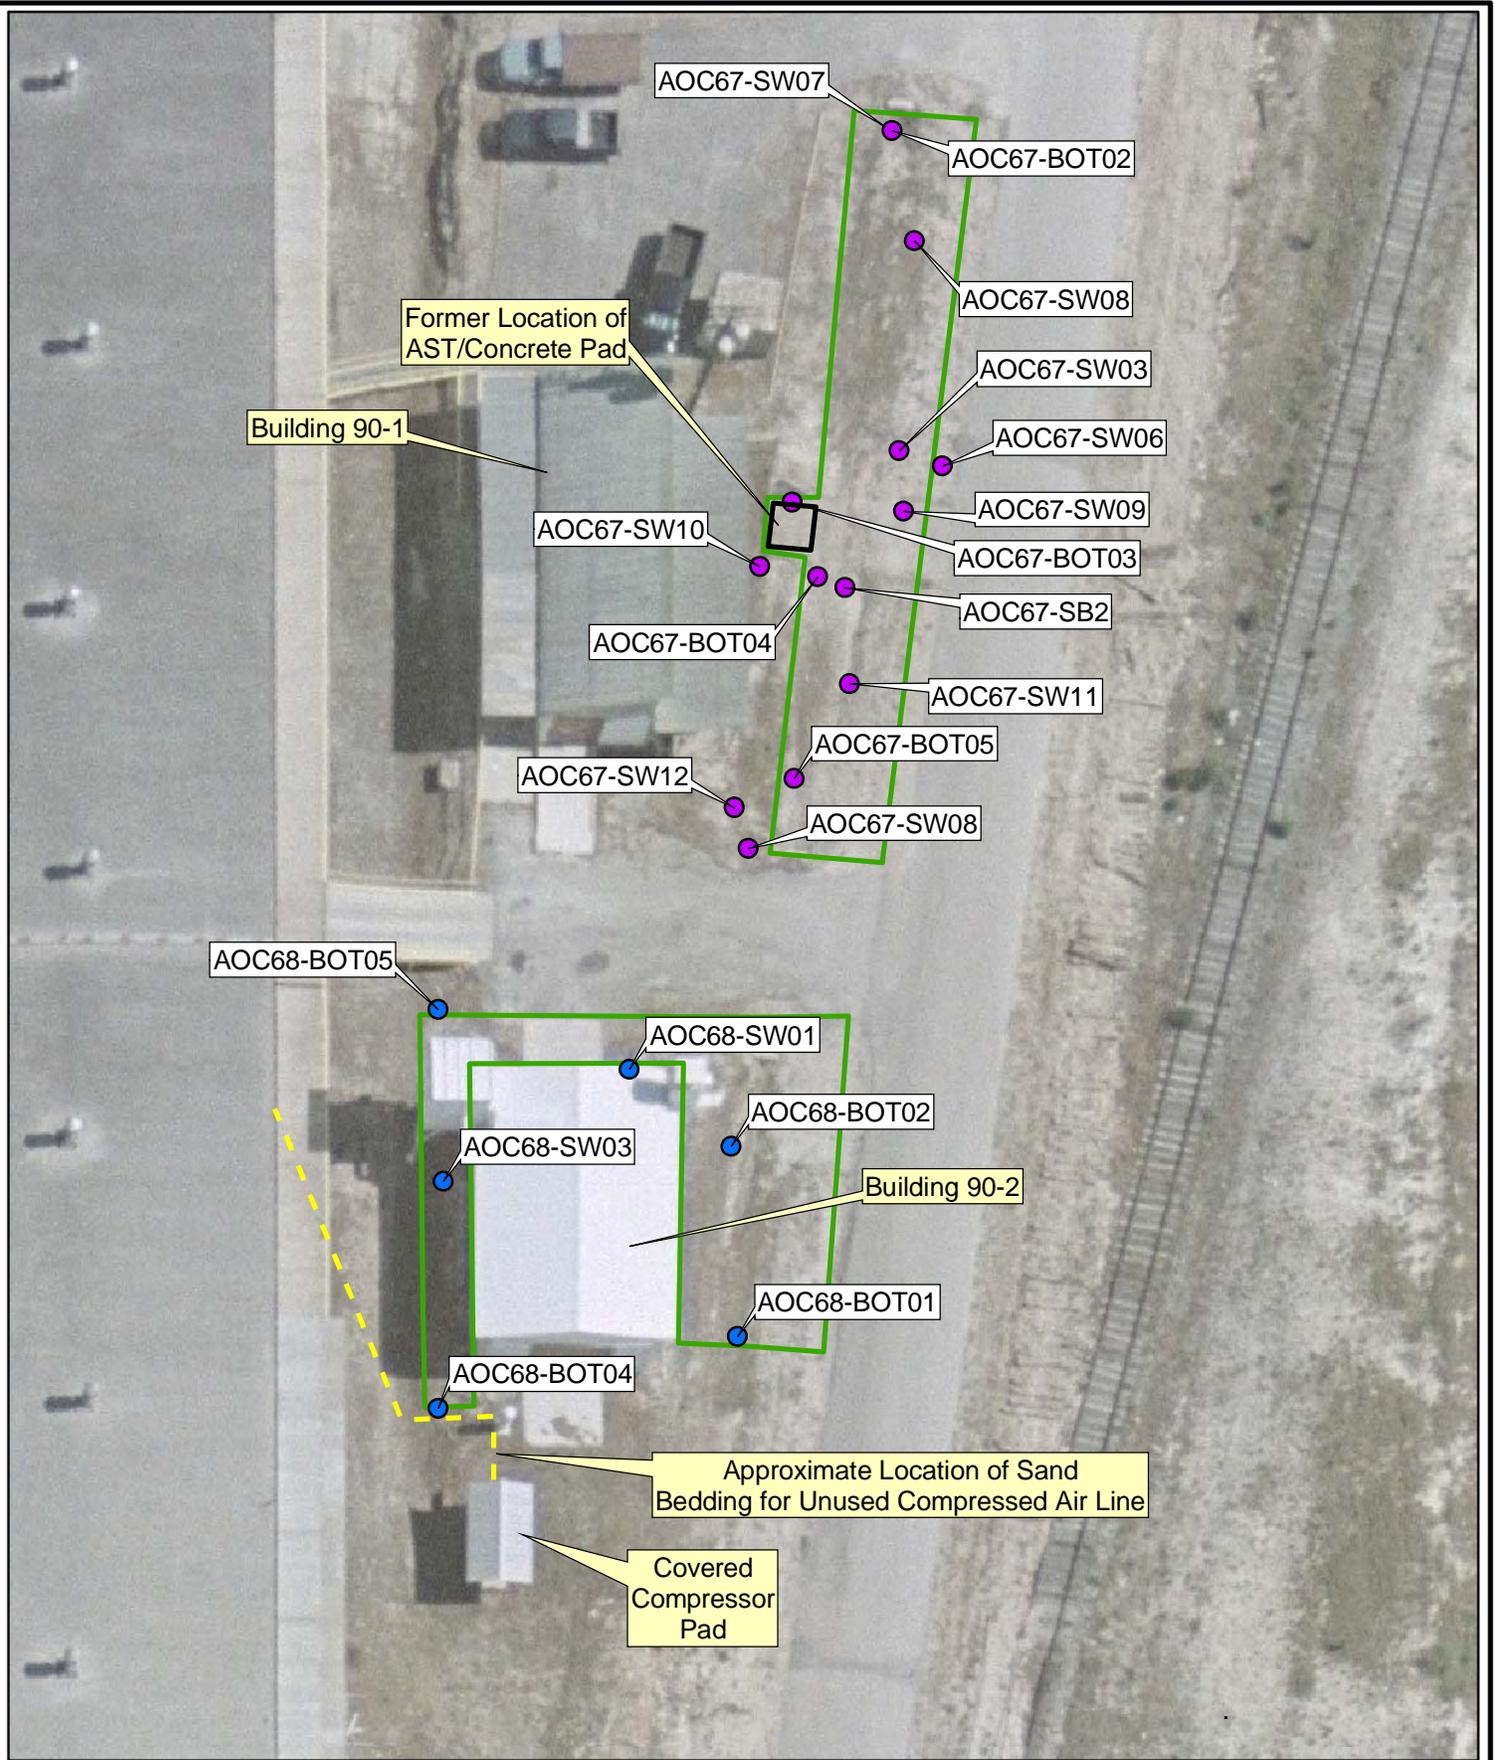
**Figure 5**

As stated above, all of the sampling, excavation and removal activities described in this section are summarized in Table 1. The list of the analytical results for soils remaining at the site is provided in Table 2. Sample locations for soils remaining at the site are shown on Figure 5. The clearance areas where soils were excavated and removed are also shown on Figure 5. Waste characterization (WC) sampling and off-post removal activities are described in Section 3.1.2.3. Additional information about past activities and investigations at the sites can be found in the [CSSA EE \(Volume 3, AOC-67; AOC-68\)](#). Photos 5 through 26 show the excavation, removal, and confirmation sampling activities for AOCs-67/68.

AOCs-67/68 Sample Locations  
Camp Stanley Storage Activity

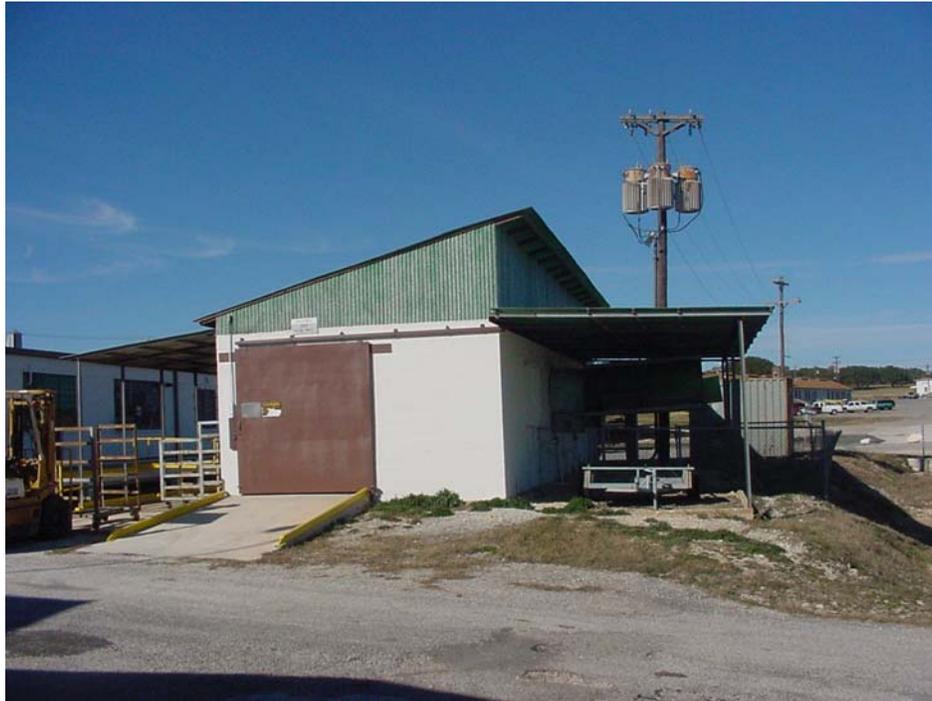
**Photo 1. Bldg. 90-1 and AOC-67 drainage ditch to the east (facing north).  
(Photo taken 12-01.)**

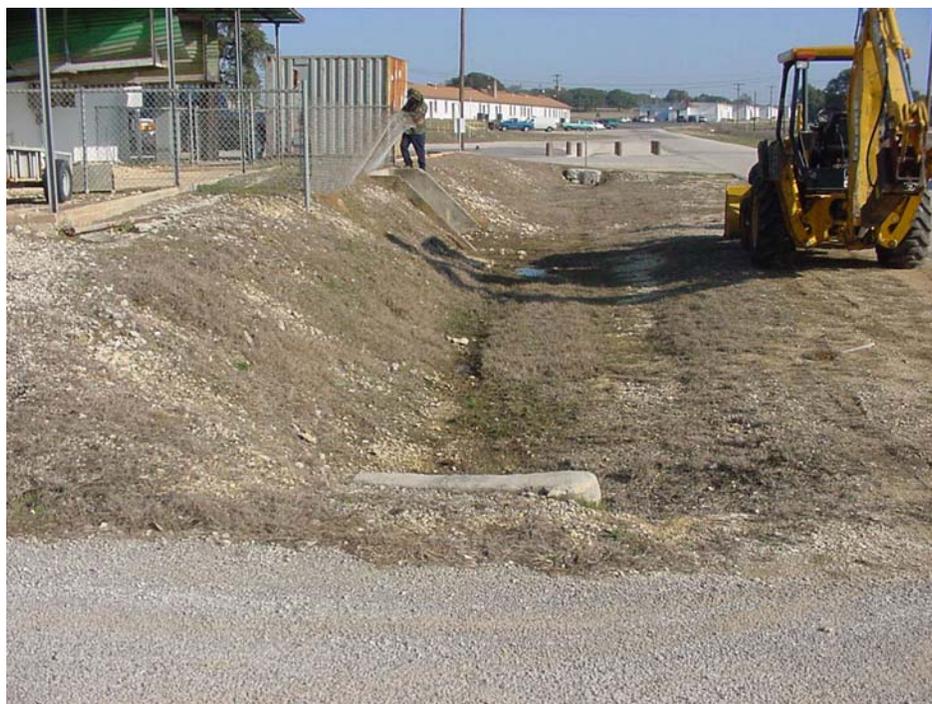
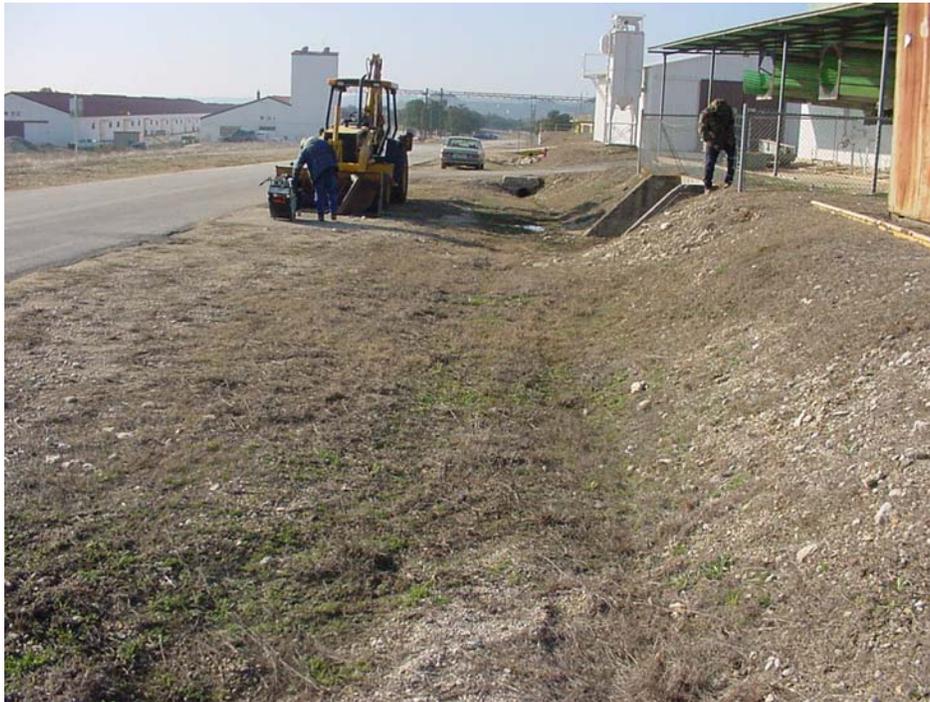
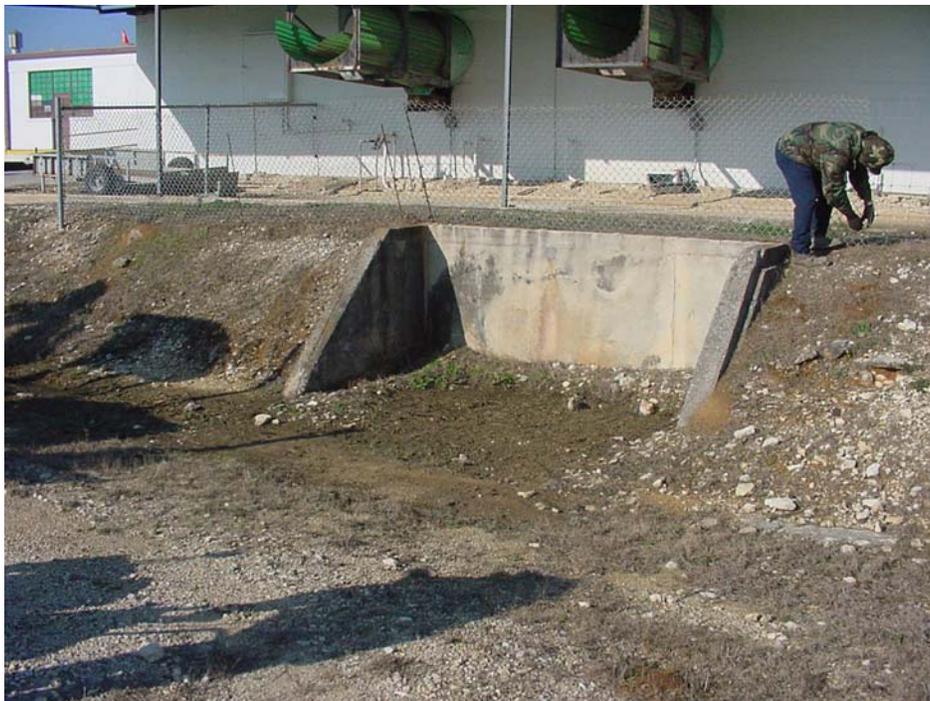
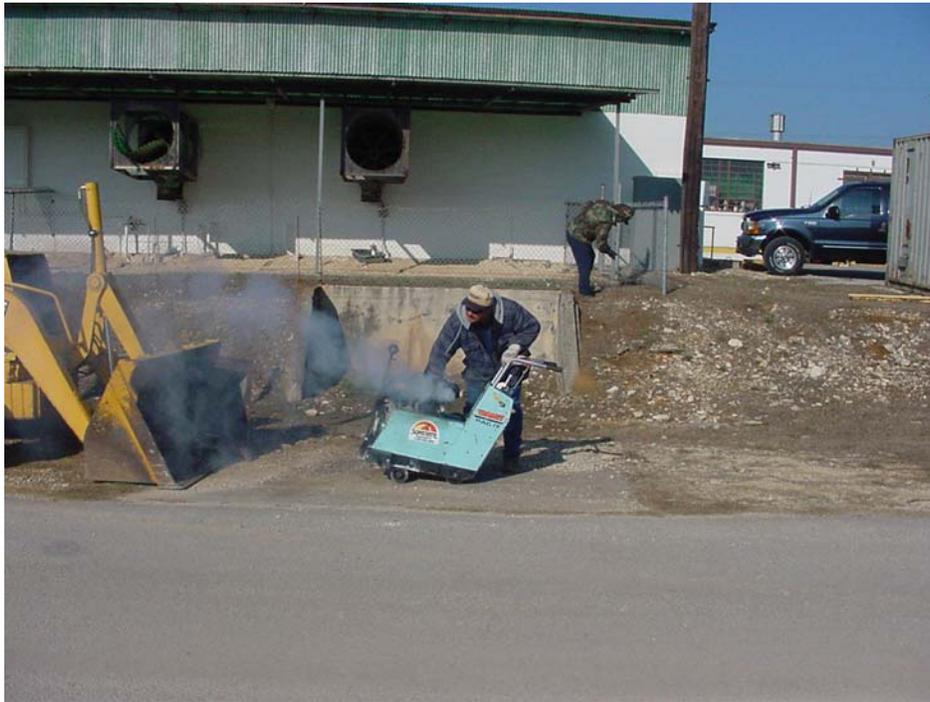
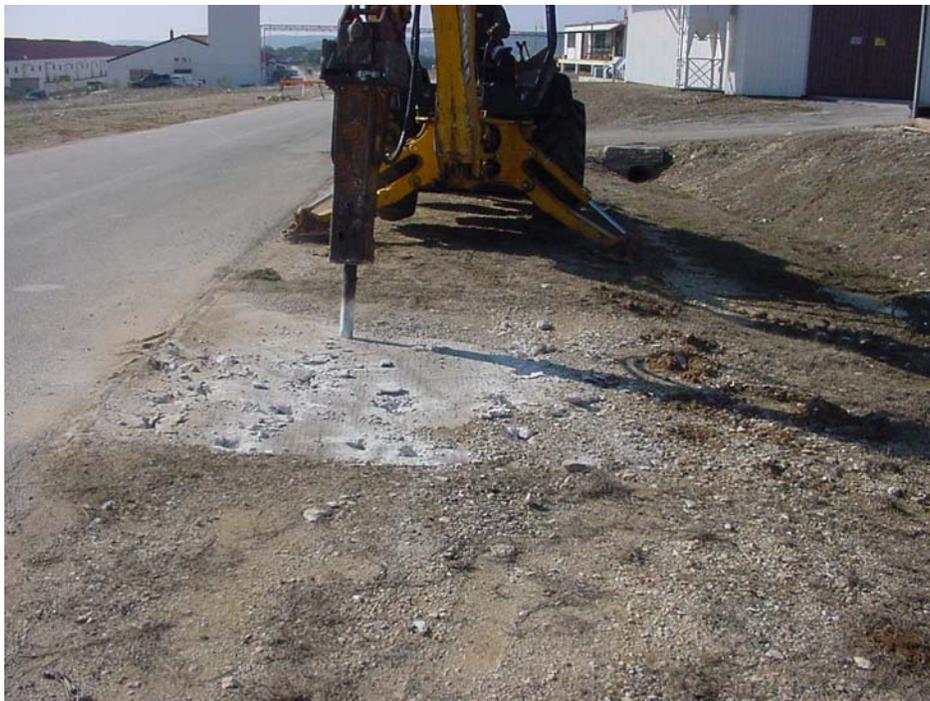
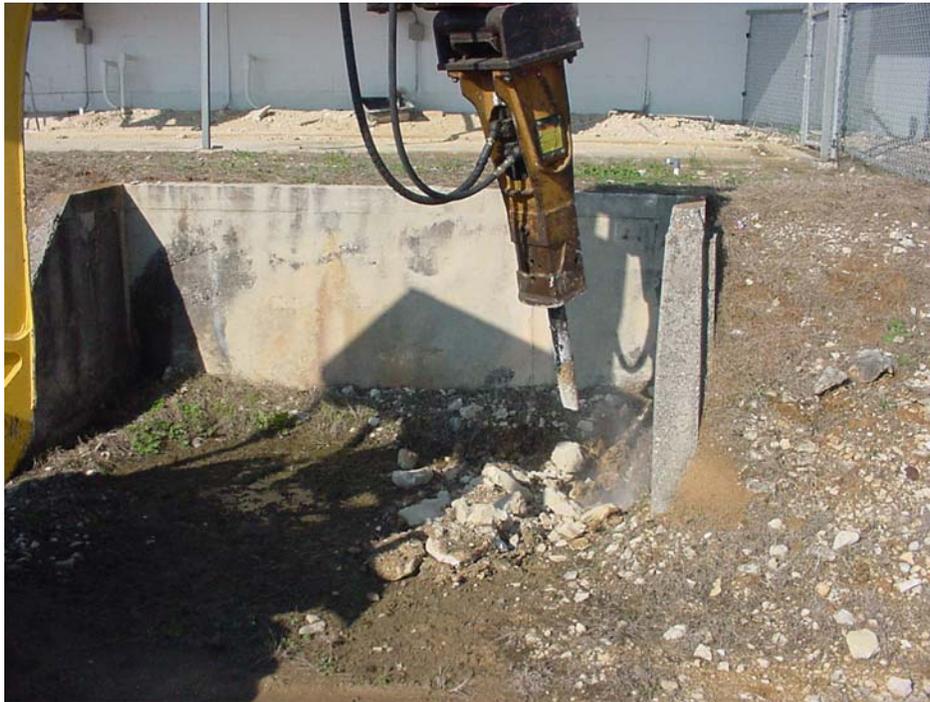
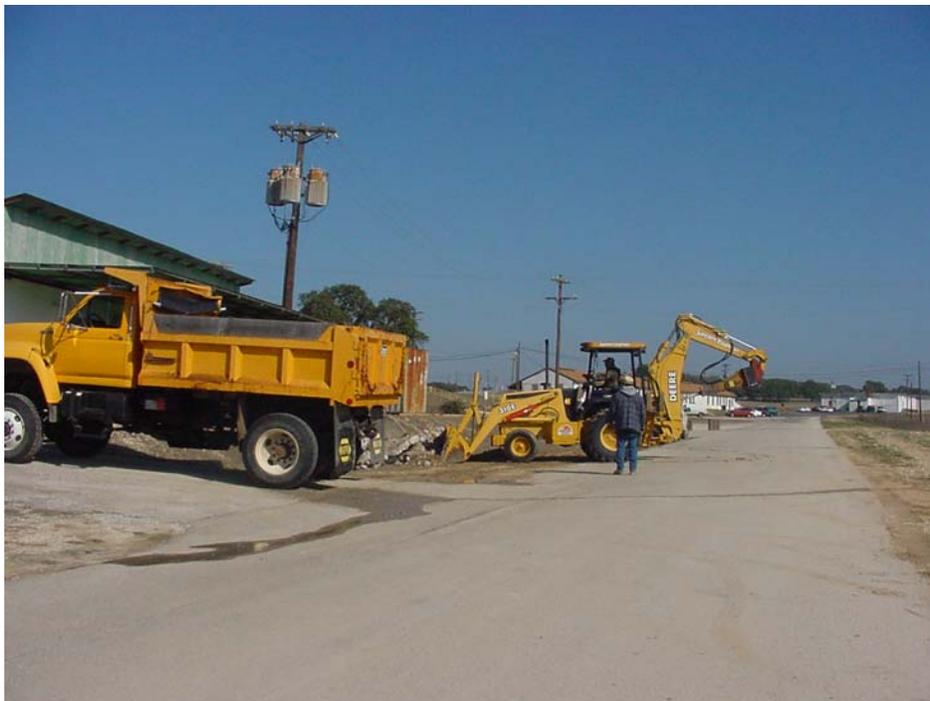
**Photo 2. AOC-67 drainage ditch – preparing for 1<sup>st</sup> excavation activities (facing north).  
(Photo taken 2-26-04.)**

**Photo 3. AOC-67 drainage ditch – preparing for 1<sup>st</sup> excavation activities (facing south).  
(Photo taken 2-26-04.)**

**Photo 4. AOC-67 three-sided concrete storage area – preparing for 1<sup>st</sup> excavation activities.  
(Photo taken 2-26-04.)**

**Photo 5. AOC-67 saw cut of concrete for demolition and removal – 1<sup>st</sup> excavation activities.  
(Photo taken 2-26-04.)**

**Photo 6. AOC-67 demolition of concrete – 1<sup>st</sup> excavation activities.  
(Photo taken 2-26-04.)**

**Photo 7. AOC-67 demolition of concrete pad and three-sided concrete storage area – 1<sup>st</sup> excavation activities. (Photo taken 2-26-04.)**

**Photo 8. AOC-67 loading excavated material for off-post disposal – 1<sup>st</sup> excavation and removal activities. (Photo taken 2-26-04.)**

Feb 26, 2004 (AOC-67)  See Photos 2 – 8.	1 <sup>st</sup> excavation and removal activities. The three-sided concrete structure and pad were also demolished and removed and soil samples were collected from the surrounding soils. WC sample collected. AOC67-WC01	Waste characterization showed the material met Class 2 non-hazardous criteria (30 TAC §335 Subchapter R).	Excavated material, including concrete debris, was loaded and moved to a temporary stockpile in the SWMU B-29 area. Excavated material included approximately 160 CY of soil and 40 CY of concrete. Material was hauled off post on March 9, 2004.
March 8, 2004 (AOC-67)	1 <sup>st</sup> confirmation sampling at five locations (four SW samples, one BOT sample, and one FD sample). AOC67-SW01 AOC67-BOT01 AOC67-SW02 AOC67-SW03 AOC67-SW04 and FD	Metals (barium, chromium, copper, lead, zinc), VOCs.	Lead above PCL at three locations. DCM also above PCL at BOT01, but concentration related to lab contamination and sample location was excavated and removed based on the location of lead at the site. See Section 3.1.2.2 of RIR for more detail. No other sample results exceeded PCLs. AOC67-SW01 (lead) AOC67-BOT01 (DCM as lab contaminant) AOC67-SW02 (lead) AOC67-SW04 and FD (lead) These four sample locations and the area near these locations were further excavated (see below, April 27, 2004).

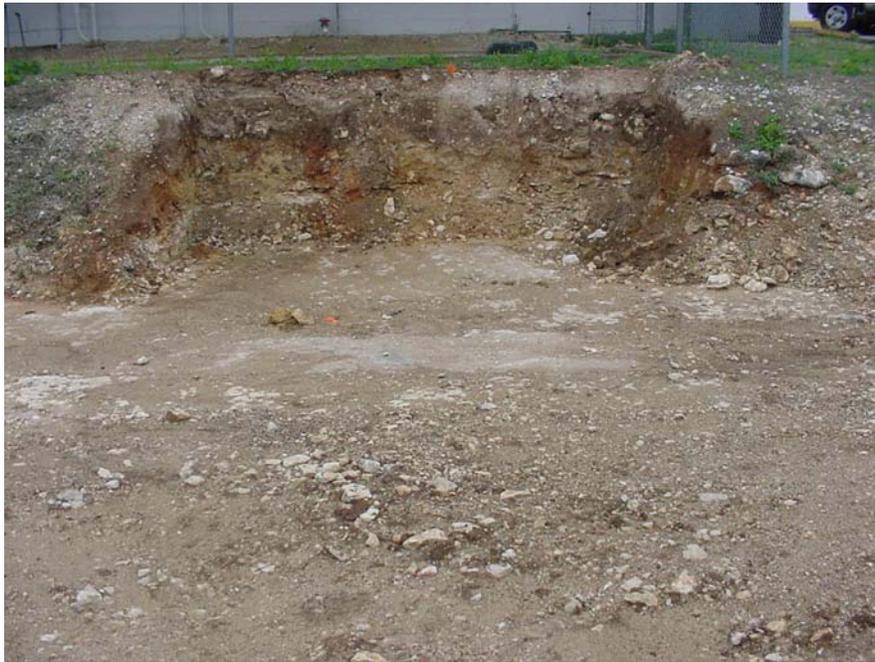
**Photo 9. AOC-67 following 1<sup>st</sup> excavation, removal and confirmation sampling activities. Two sample locations shown with orange flags. (Photo taken 3-25-04.)**

**1<sup>st</sup> Confirmation Sampling.** The first round of confirmation sampling at AOC-67 was performed on March 8, 2004, and included four sidewall (SW) samples, one bottom (BOT) sample, and one FD sample collected from the excavated area. Samples were analyzed for metals (barium, chromium, copper, lead, and zinc) and VOCs. From this sampling, three of the four sidewall sample locations had lead above the PCL/action level (*i.e.*, the TCEQ-approved background level for lead at CSSA). Methylene chloride, also known as dichloromethane (DCM) also exceeded its PCL in one sample. It is noted that the presence of DCM in this sample is attributed to laboratory contamination. DCM is a common laboratory contaminant and there is no known usage of DCM at CSSA. It is also noted that the sample location with DCM was excavated and removed based on the location of lead contamination at the site.

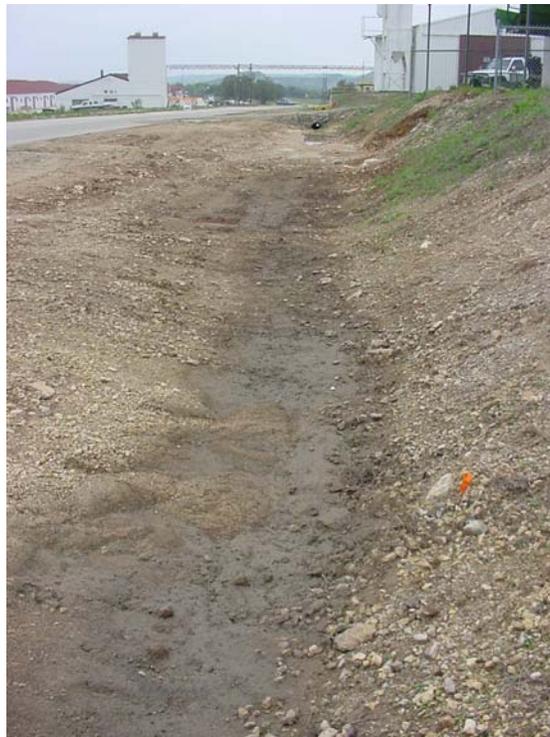
**Photo 10. AOC-67 following 1<sup>st</sup> excavation, removal and confirmation sampling activities. One sample location shown with orange flag (facing south). (Photo taken 3-25-04.)**

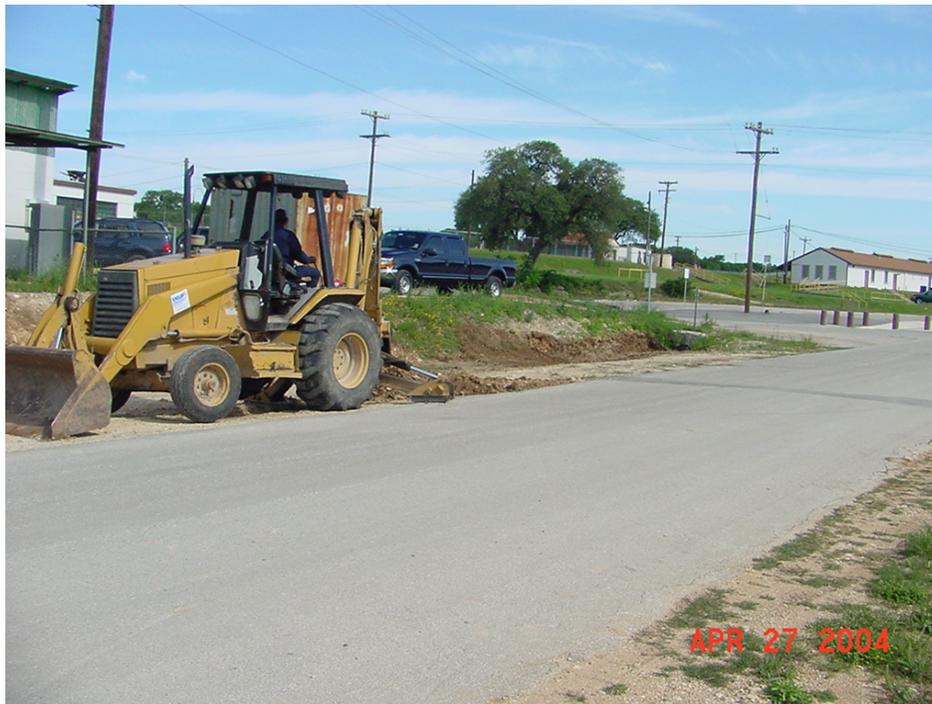
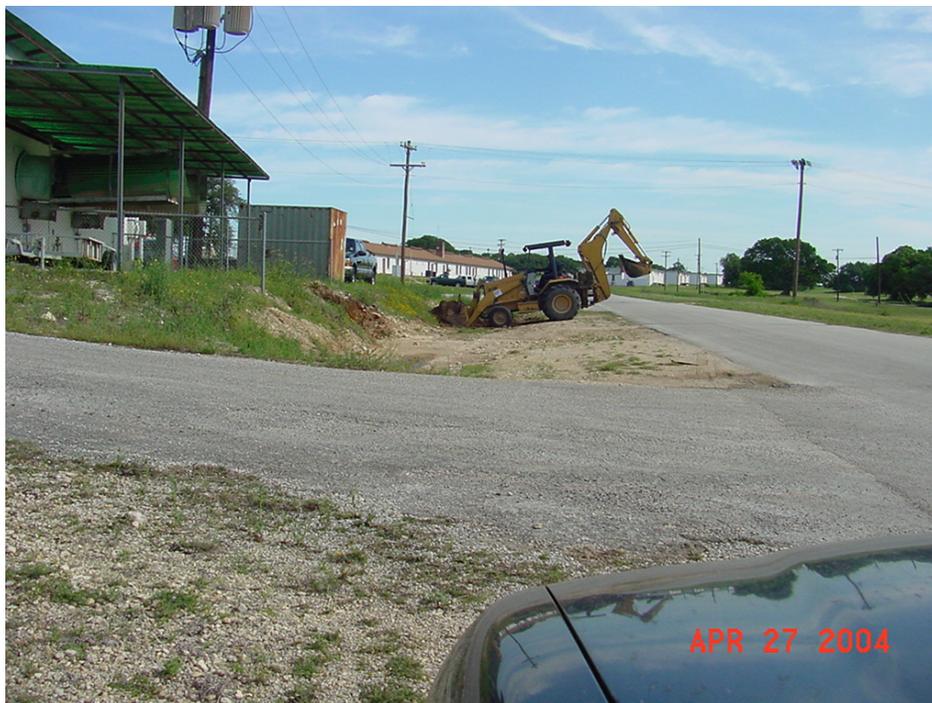
**Photo 11. AOC-67 during 2<sup>nd</sup> excavation activities.  
(Photo taken 4-27-04.)**

**Photo 12. AOC-67 during 2<sup>nd</sup> excavation activities.  
(Photo taken 4-27-04.)**

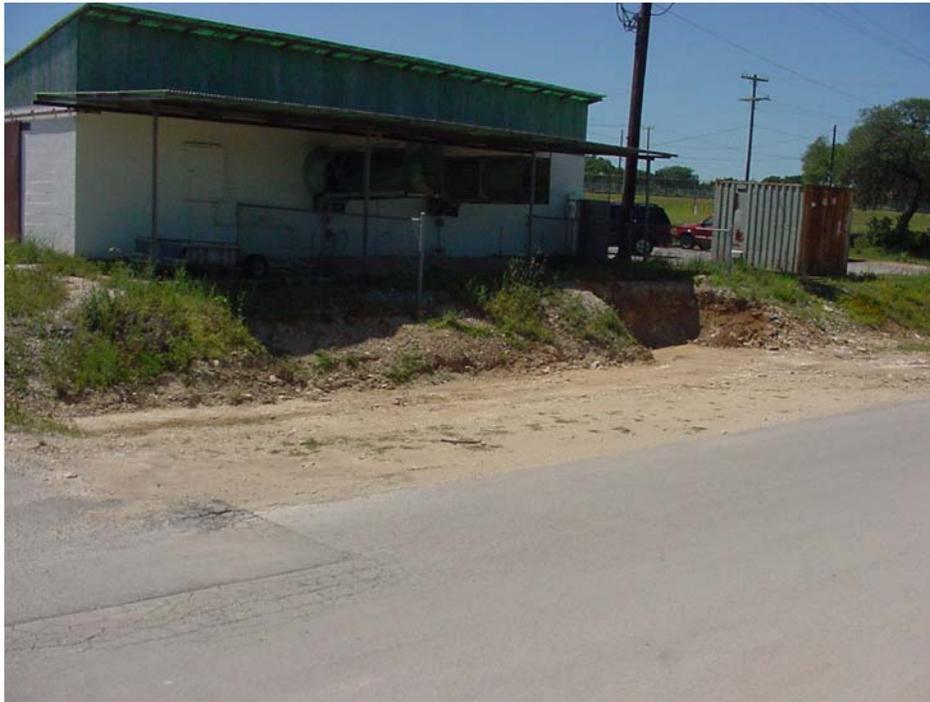
**Photo 13. Building 90-1 and AOC-67 following 1<sup>st</sup> and 2<sup>nd</sup> excavation, removal and confirmation sampling activities (facing northwest). (Photo taken 5-4-04.)**

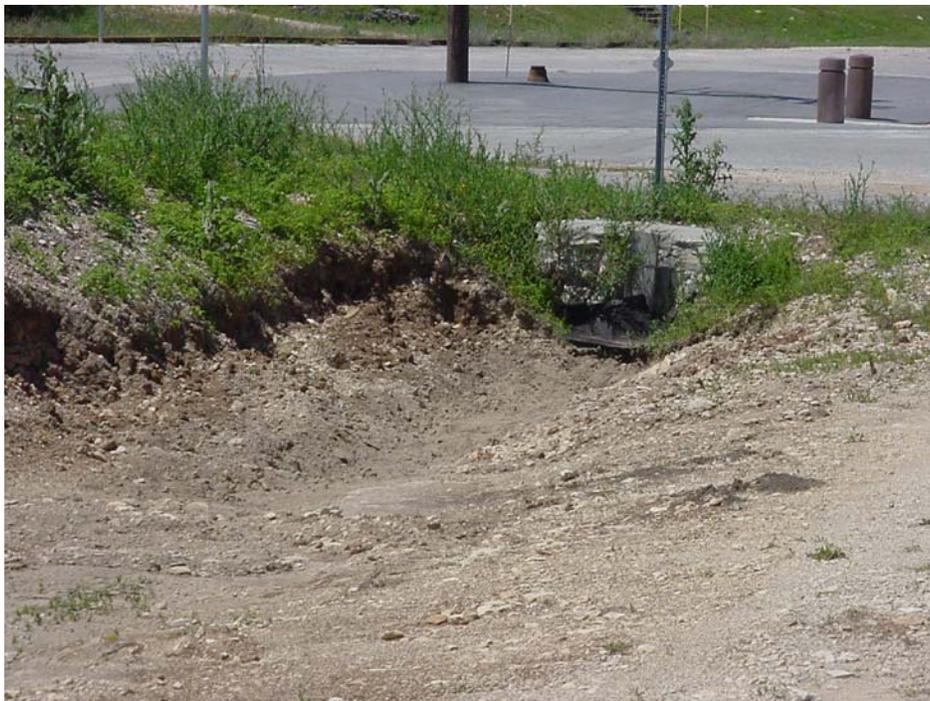
**Photo 14. AOC-67 following 1<sup>st</sup> and 2<sup>nd</sup> excavation, removal and confirmation sampling activities (north end). (Photo taken 5-4-04.)**

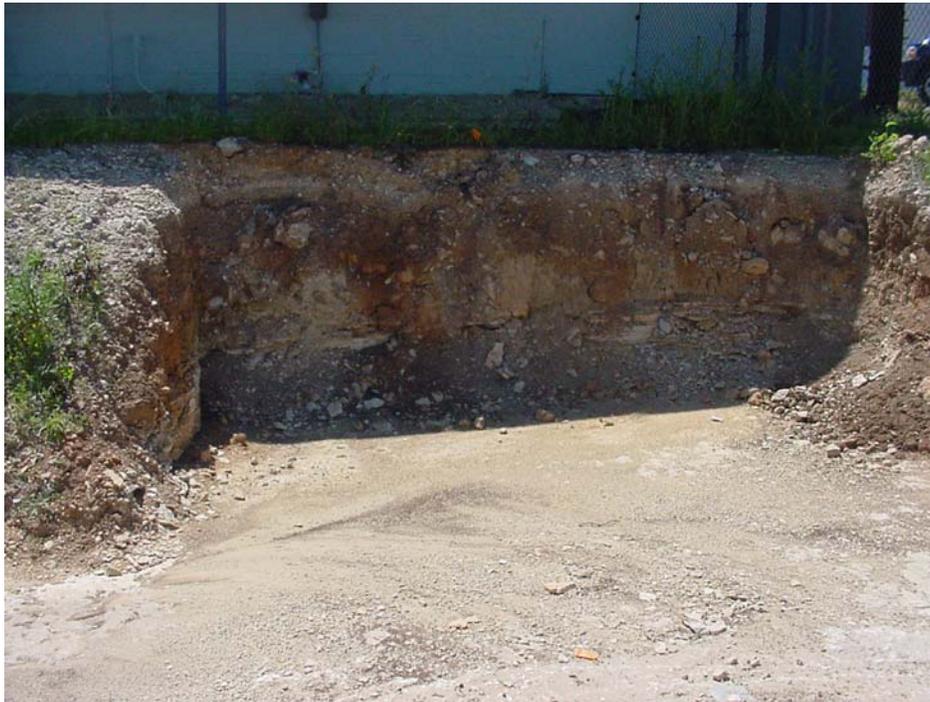
**Photo 15. AOC-67 view of bedrock at the former three-sided concrete storage area.  
(Photo taken 5-4-04.)**

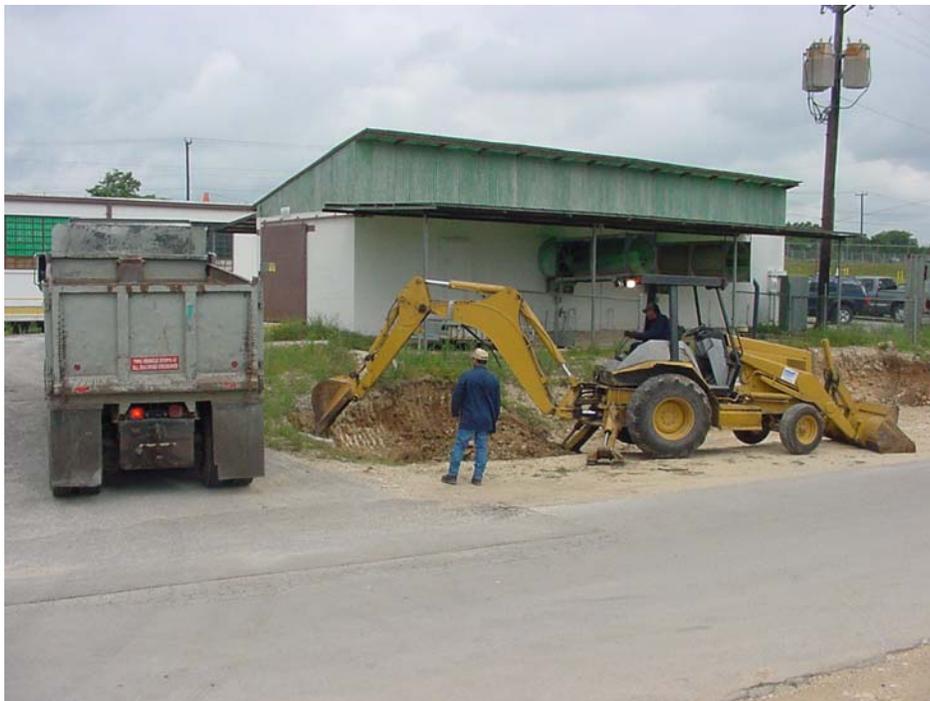
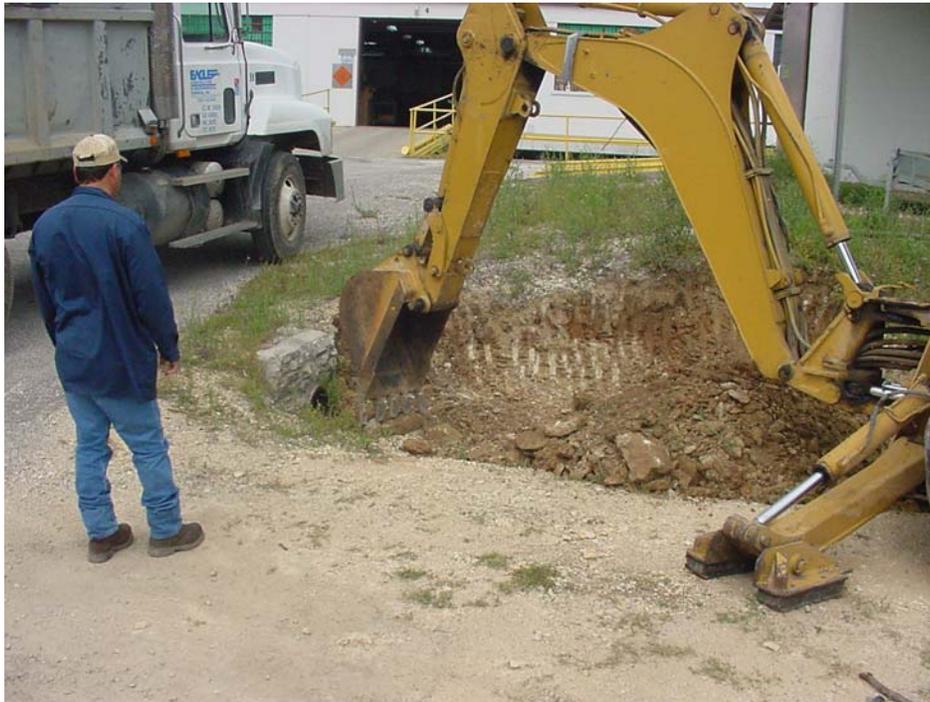
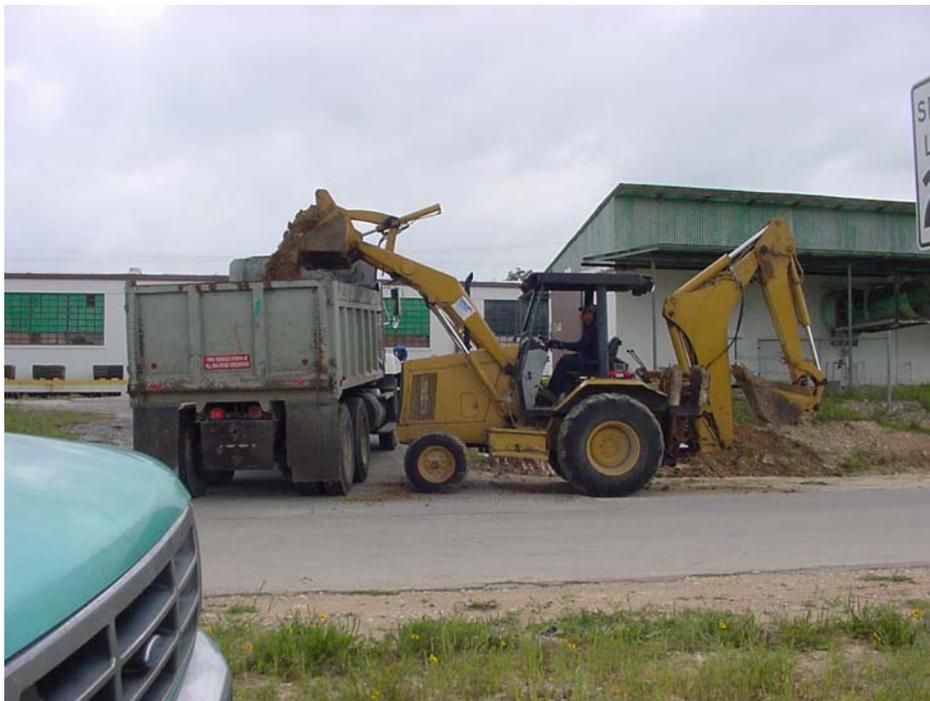
**Photo 16. AOC-67 3<sup>rd</sup> excavation (over-excavating and re-scraping activities).  
(Photo taken 5-5-04.)**

**Photo 17. AOC-67 3<sup>rd</sup> excavation (over-excavating and re-scraping activities).  
(Photo taken 5-5-04.)**

**Photo 18. AOC-67 3<sup>rd</sup> excavation (over-excavating and re-scraping activities).  
(Photo taken 5-5-04.)**

May 11, 2004 (AOC-67)	3 <sup>rd</sup> confirmation sampling at one location (SW sample). AOC67-SW08	Lead.	Lead above PCL at the sample location. AOC67-SW08 (lead) This sample location and the area near this location was further excavated (see below, May 25, 2004).
May 25, 2004 (AOC-67)	Staging transportation of excavated material from 2 <sup>nd</sup> and 3 <sup>rd</sup> excavations to off-post landfill.	Waste characterization showed the material met Class 2 non-hazardous criteria (30 TAC §335 Subchapter R).	A total of approximately 90 CY of excavated material taken off post for disposal at WMI, Covel Gardens Landfill in San Antonio, Texas.
Dec 4 – 6, 2007 (AOCs-67/68)	4 <sup>th</sup> excavation activities. (Excavation and removal combined with AOC-68 activities.)  WC sample collected. AOC67/68-WC01	Waste characterization showed the material met Class 2 non-hazardous criteria (30 TAC §335 Subchapter R).	The removal work between December 4 and December 6, 2007 was combined with the 5 <sup>th</sup> (final) excavation activities at AOC-67 (see February 27, 2008 below) and the initial excavation and removal activities at AOC-68 (see below).

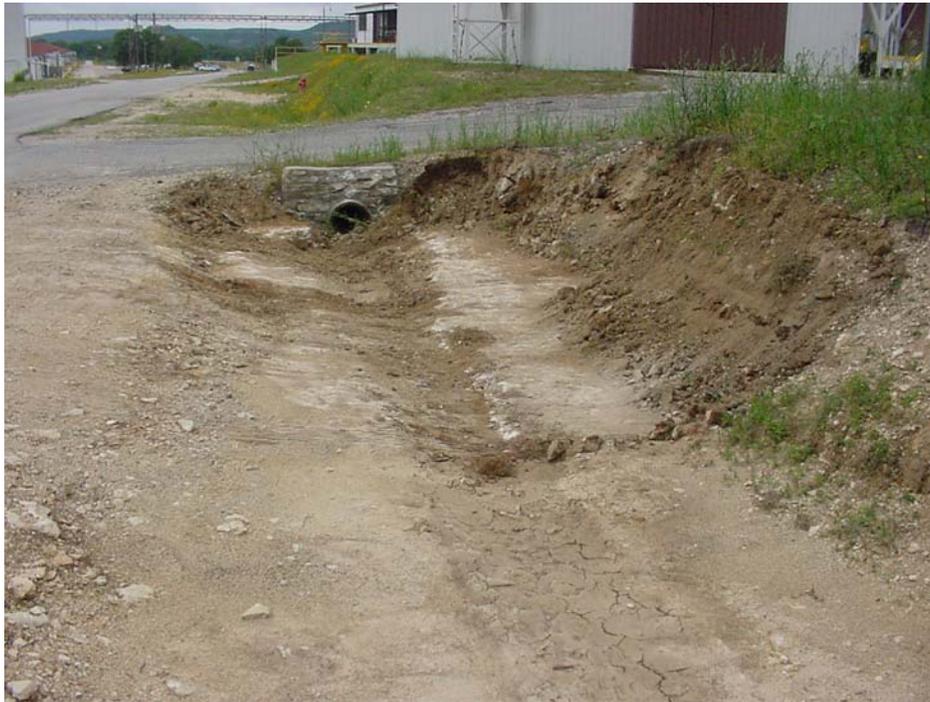
**Photo 19. AOC-67 following 3<sup>rd</sup> excavation (over-excavating and re-scraping activities).  
(Photo taken 5-5-04.)**

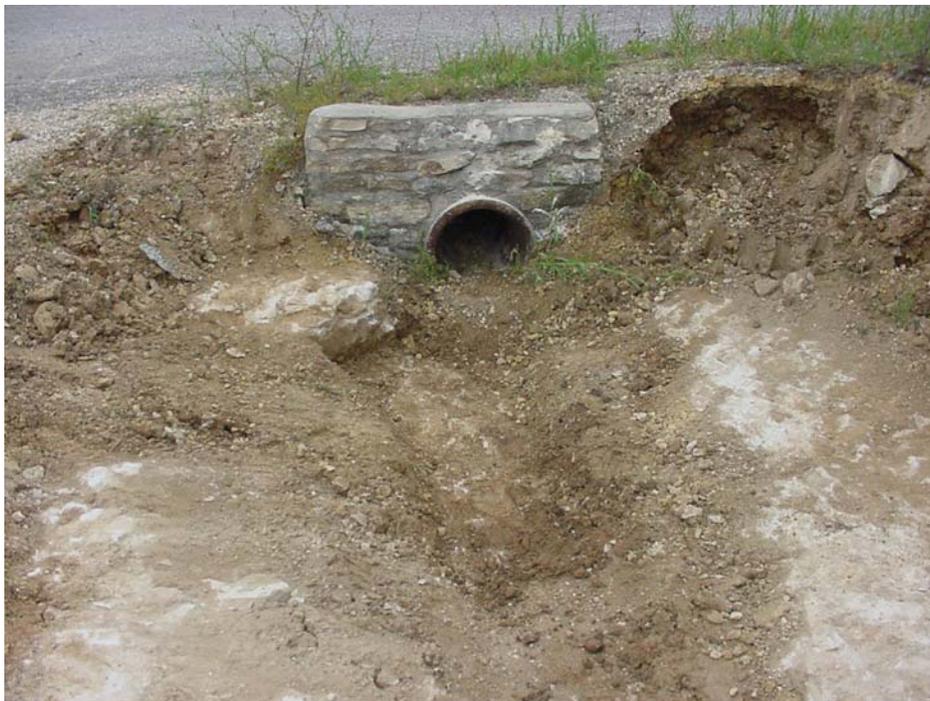
**Photo 20. AOC-67 bedrock at south end of former drainage ditch.  
(Photo taken 5-5-04.)**
