# RELEASE INVESTIGATION REPORT

## AREAS OF CONCERN 67 and 68 (AOCs-67/68) CAMP STANLEY STORAGE ACTIVITY

### **Camp Stanley Storage Activity Boerne, Texas**

July 2010

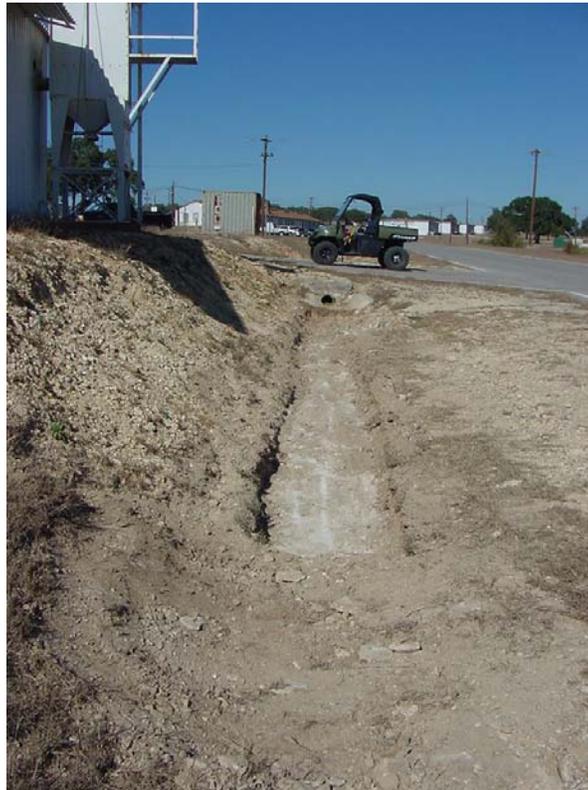
**Photo 21. AOC-68 drainage ditch (east side of Bldg. 90-2 facing north). (Photo taken 11-19-08.)**

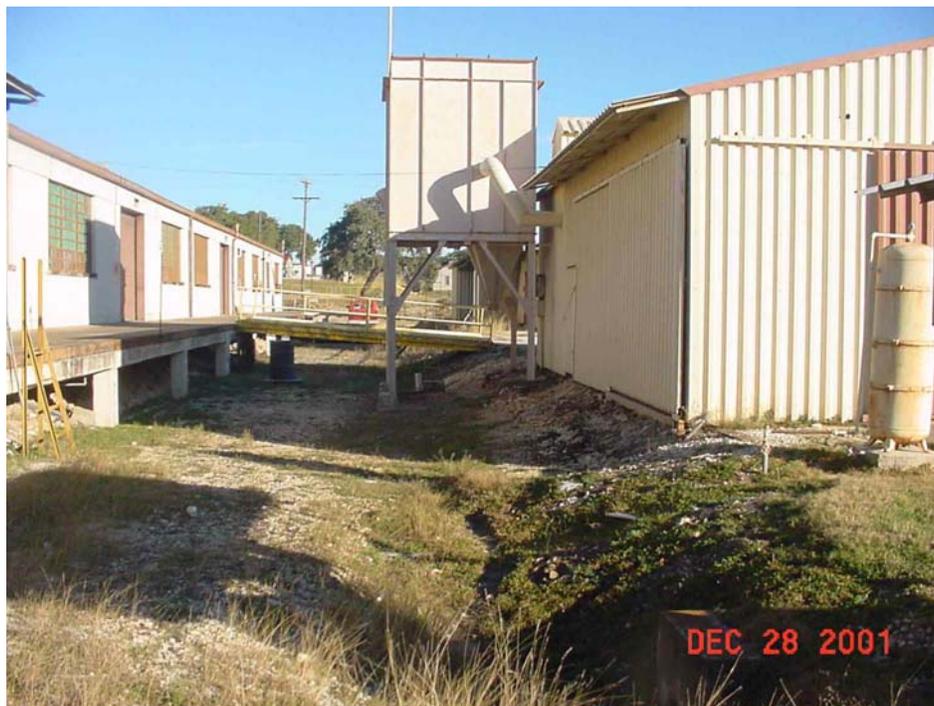
**Photo 22. Bldg. 90-2 and AOC-68 (west side of Bldg. 90-2 facing north). (Photo taken 12-28-01.)**

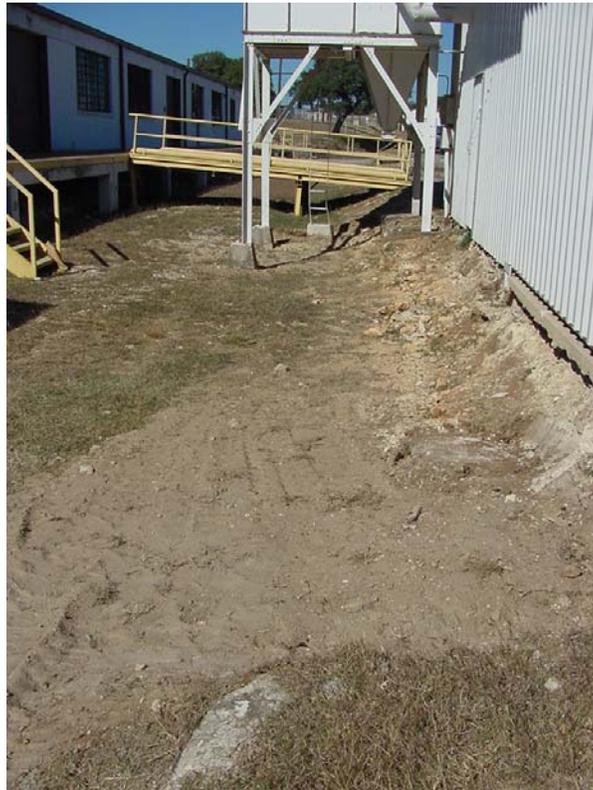
**Photo 23. AOC-68 (west side of Bldg. 90-2 facing north). (Photo taken 11-19-08.)**

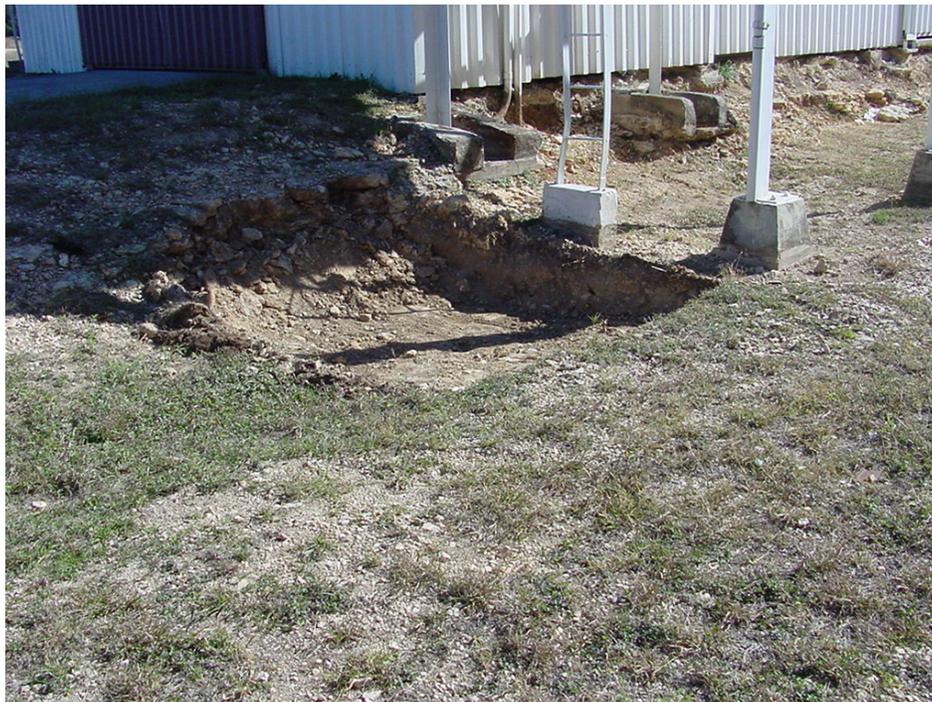
**Photo 24. AOC-68 north portion of excavation (facing east). (Photo taken 11-19-08.)**

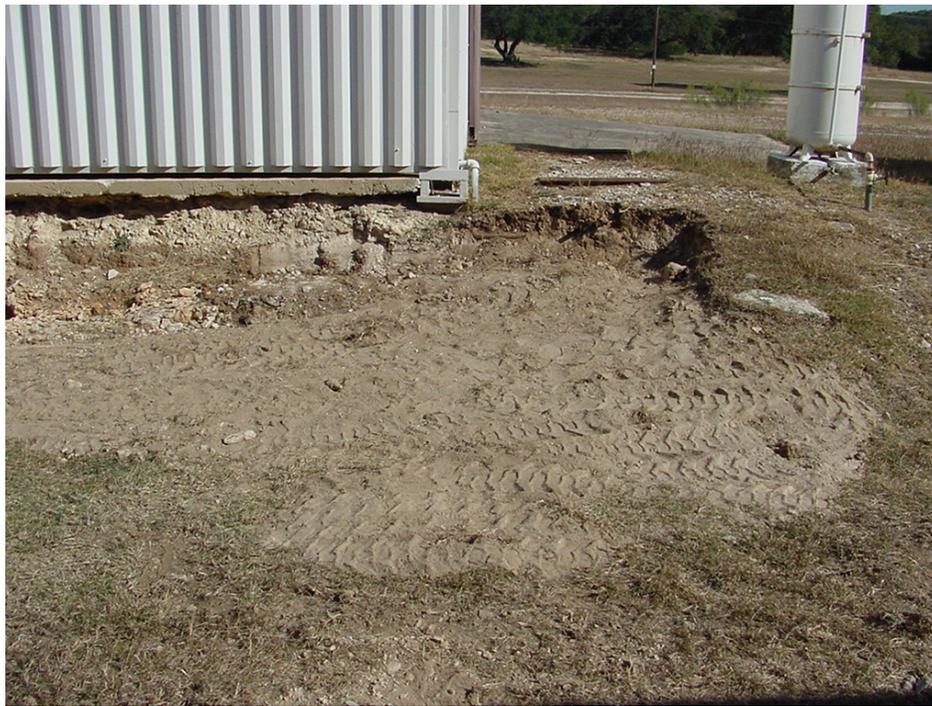
**Photo 25. AOC-68 south portion of excavation (facing east). (Photo taken 11-19-08.)**

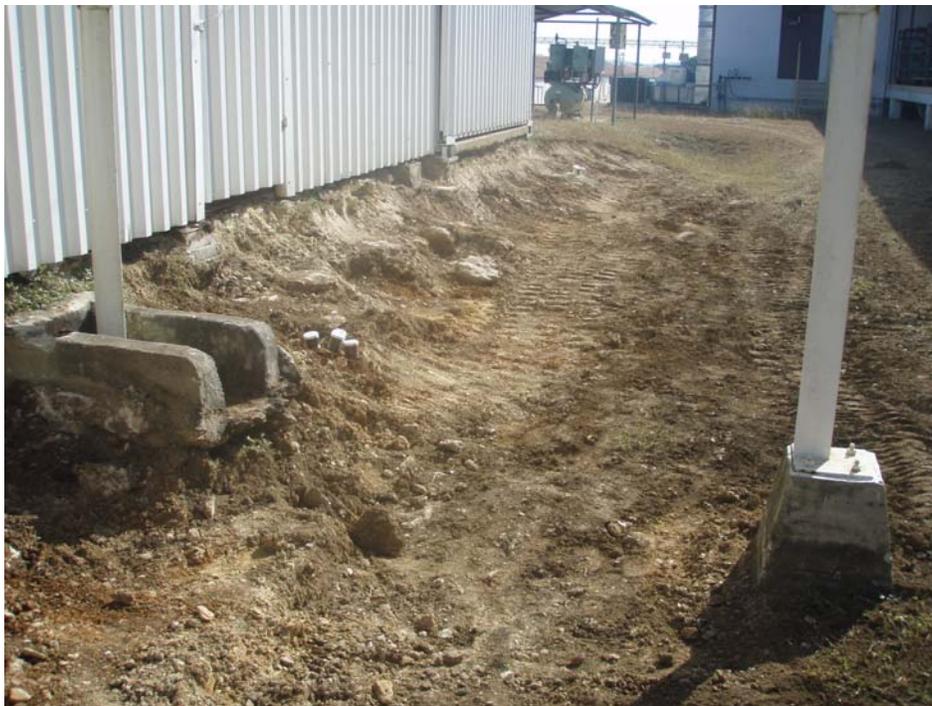
**Photo 26. AOC-68 southwest portion of excavation (facing southwest); covered air compressor and pad in background. (Photo taken 9-2-09.)**

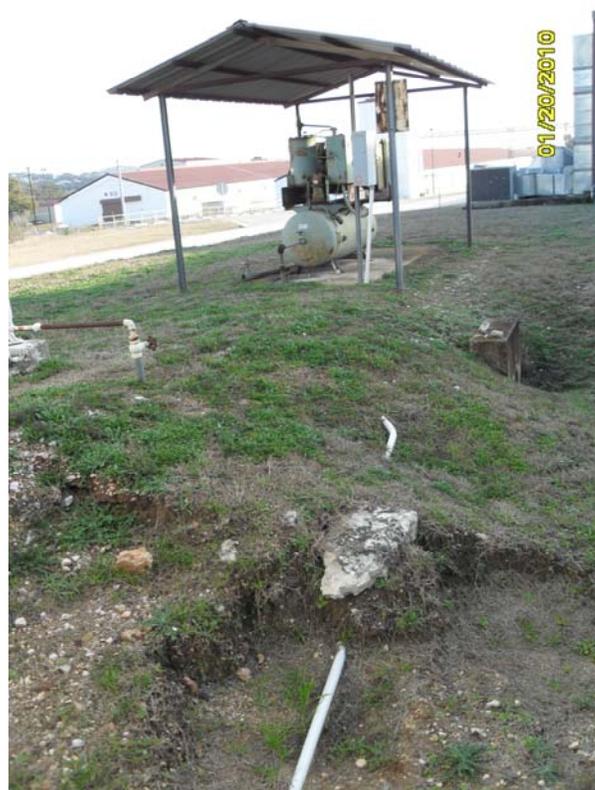
**Photo 27. AOC-68 (facing southwest); compressor and compressed air line at southwest boundary of AOC-68. (Photo taken 1-20-10.)**

- As part of the AOC-68 investigation, an air compressor line bedded with sand and bullet fragments from the Building 90 test fire room was uncovered. Samples from this area found elevated levels of lead and cadmium. However, because this trench is located at the southwest extent of the AOC-68 footprint and because the contamination is not related to the Wheelabrator operation, it is considered part of the overall Building 90/AOC-65 site and is not addressed as part of this closure request.
