SWMU Investigations and Closures – Ecological Risk Assessment for North Pasture

Technical Interchange Meeting

September 2007

Camp Stanley Storage Activity
Boerne, TX

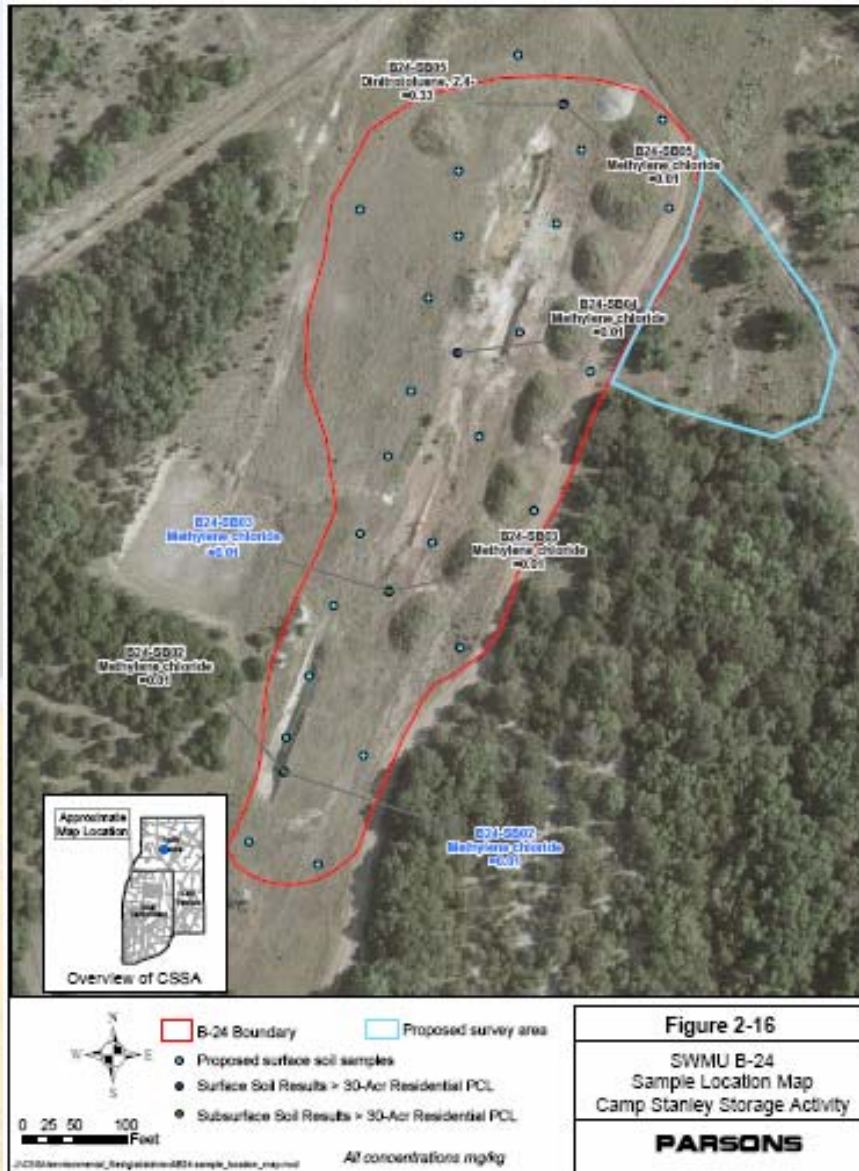
SWMU B-24 Investigation Results

Max Value (mg/kg)	Eco Screening (mg/kg)	Residential Tier 2 Human Health (mg/kg)
Lead	42.9	50	500
DNT	0.33	NA	0.157
