**RELEASE INVESTIGATION REPORT**  
**RANGE MANAGEMENT UNIT 4**  
**CAMP STANLEY STORAGE ACTIVITY**

**Camp Stanley Storage Activity**  
**Boerne, Texas**

**PARSONS**

**October 2013**

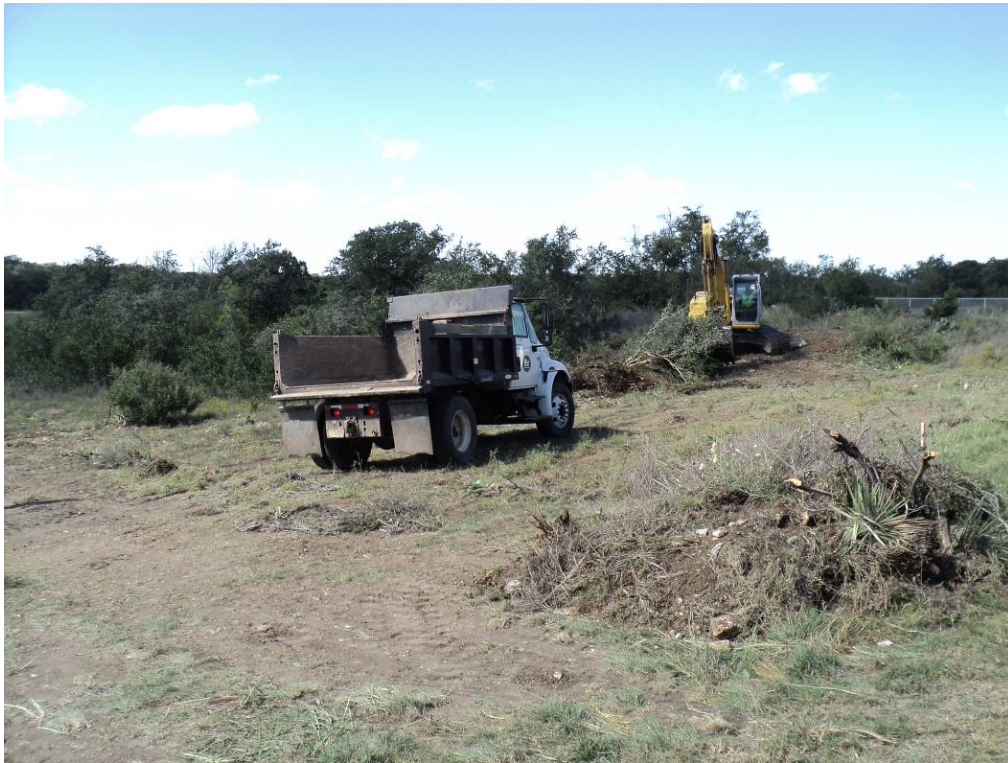
**Photo 1. Clearing trees and brush.**

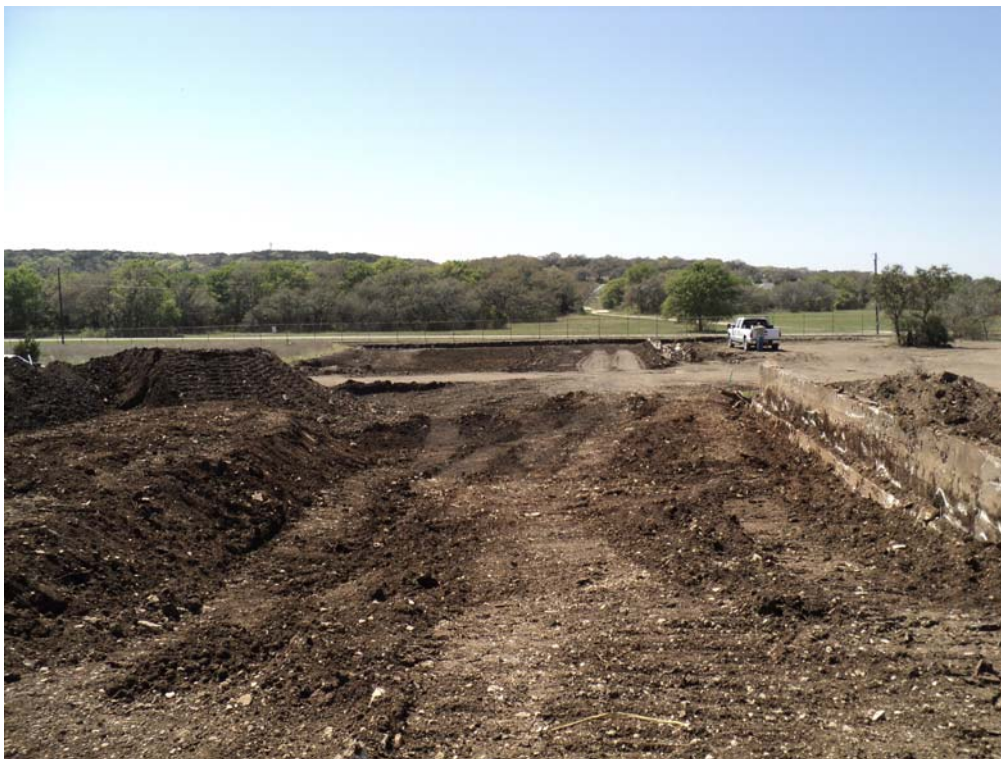
**Photo 2. Excavation process, looking west.**

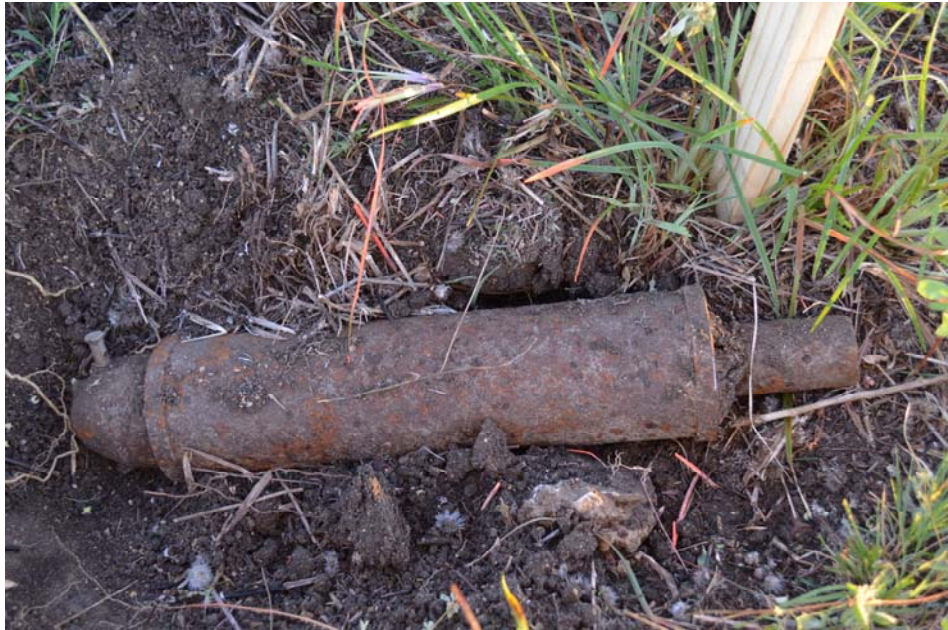
**Photo 3. Stokes mortar.**

Item Number	Condition	Item Discription	Depth (inches)	Area	Disposition
RMU4-MD-01	MEC <sup>1</sup>	Stokes, 3 inch, Unfuzed	0	RMU-4	CSSA
RMU4-MD-02	MEC <sup>1</sup>	Stokes, 3 inch, Unfuzed	2	RMU-4	CSSA
RMU4-MD-03	MD <sup>2</sup>	Stokes, 3 inch, Practice, Unfuzed	4	RMU-4	Scrap
RMU4-MD-04	MEC <sup>1</sup>	Stokes, 3 inch, Unfuzed	2	RMU-4	CSSA
RMU4-MD-05	MEC <sup>1</sup>	Stokes, 3 inch, Unfuzed	0	RMU-4	CSSA
RMU4-MD-06	MEC <sup>1</sup>	Stokes, 3 inch, Unfuzed	4	RMU-4	CSSA
RMU4-MD-07	MEC <sup>1</sup>	Stokes, 3 inch, Unfuzed	2	RMU-4	CSSA
RMU4-MD-08	MEC <sup>1</sup>	Stokes, 3 inch, Unfuzed	10	RMU-4	CSSA
RMU4-MD-09	MEC <sup>1</sup>	Stokes, 3 inch, Unfuzed	6	RMU-4	CSSA
RMU4-MD-10	MEC <sup>1</sup>	Stokes, 3 inch, Unfuzed	4	RMU-4	CSSA
RMU4-MD-11	MEC <sup>1</sup>	Stokes, 3 inch, Unfuzed	10	RMU-4	CSSA
RMU4-MD-12	MEC <sup>1</sup>	Stokes, 3 inch, Unfuzed	2	RMU-4	CSSA
RMU4-MD-13	MEC <sup>1</sup>	Stokes, 3 inch, Unfuzed	6	RMU-4	CSSA

1- These items appear to be Practice mortars that have functioned resulting in the fuze being missing from the mortar, however, there are no external differences between the practice and the HE version of these mortars. These mortars will be collected and secured in the MEC connex located at SWMU B-4 and turned over to CSSA for disposition upon completion site remediation.

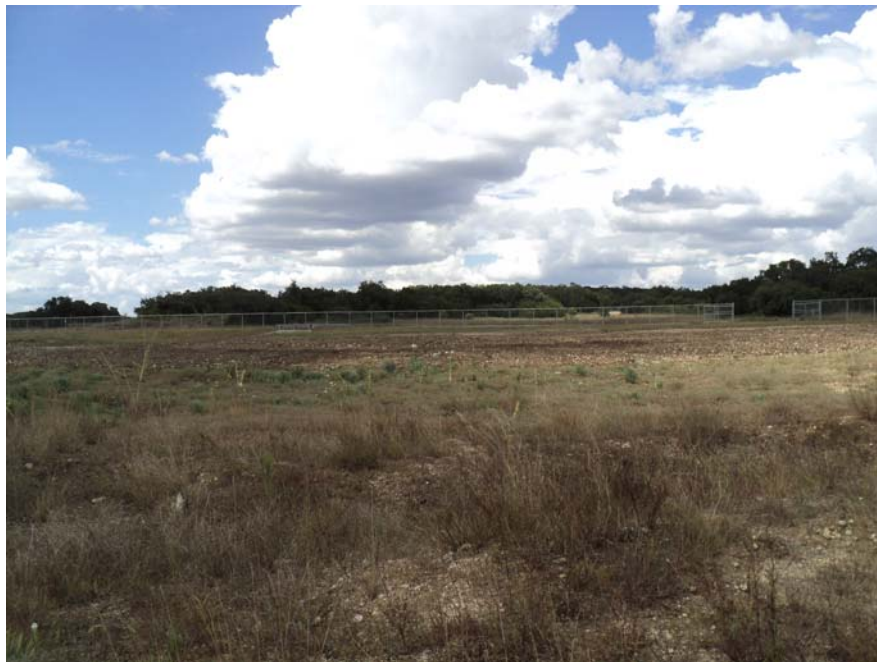
**Photo 4. Restored site, looking north.**
