# RCRA Facility Investigation Report for Camp Stanley Storage Activity

Camp Stanley Storage Activity  
Boerne, Texas

**PARSONS**

December 2014

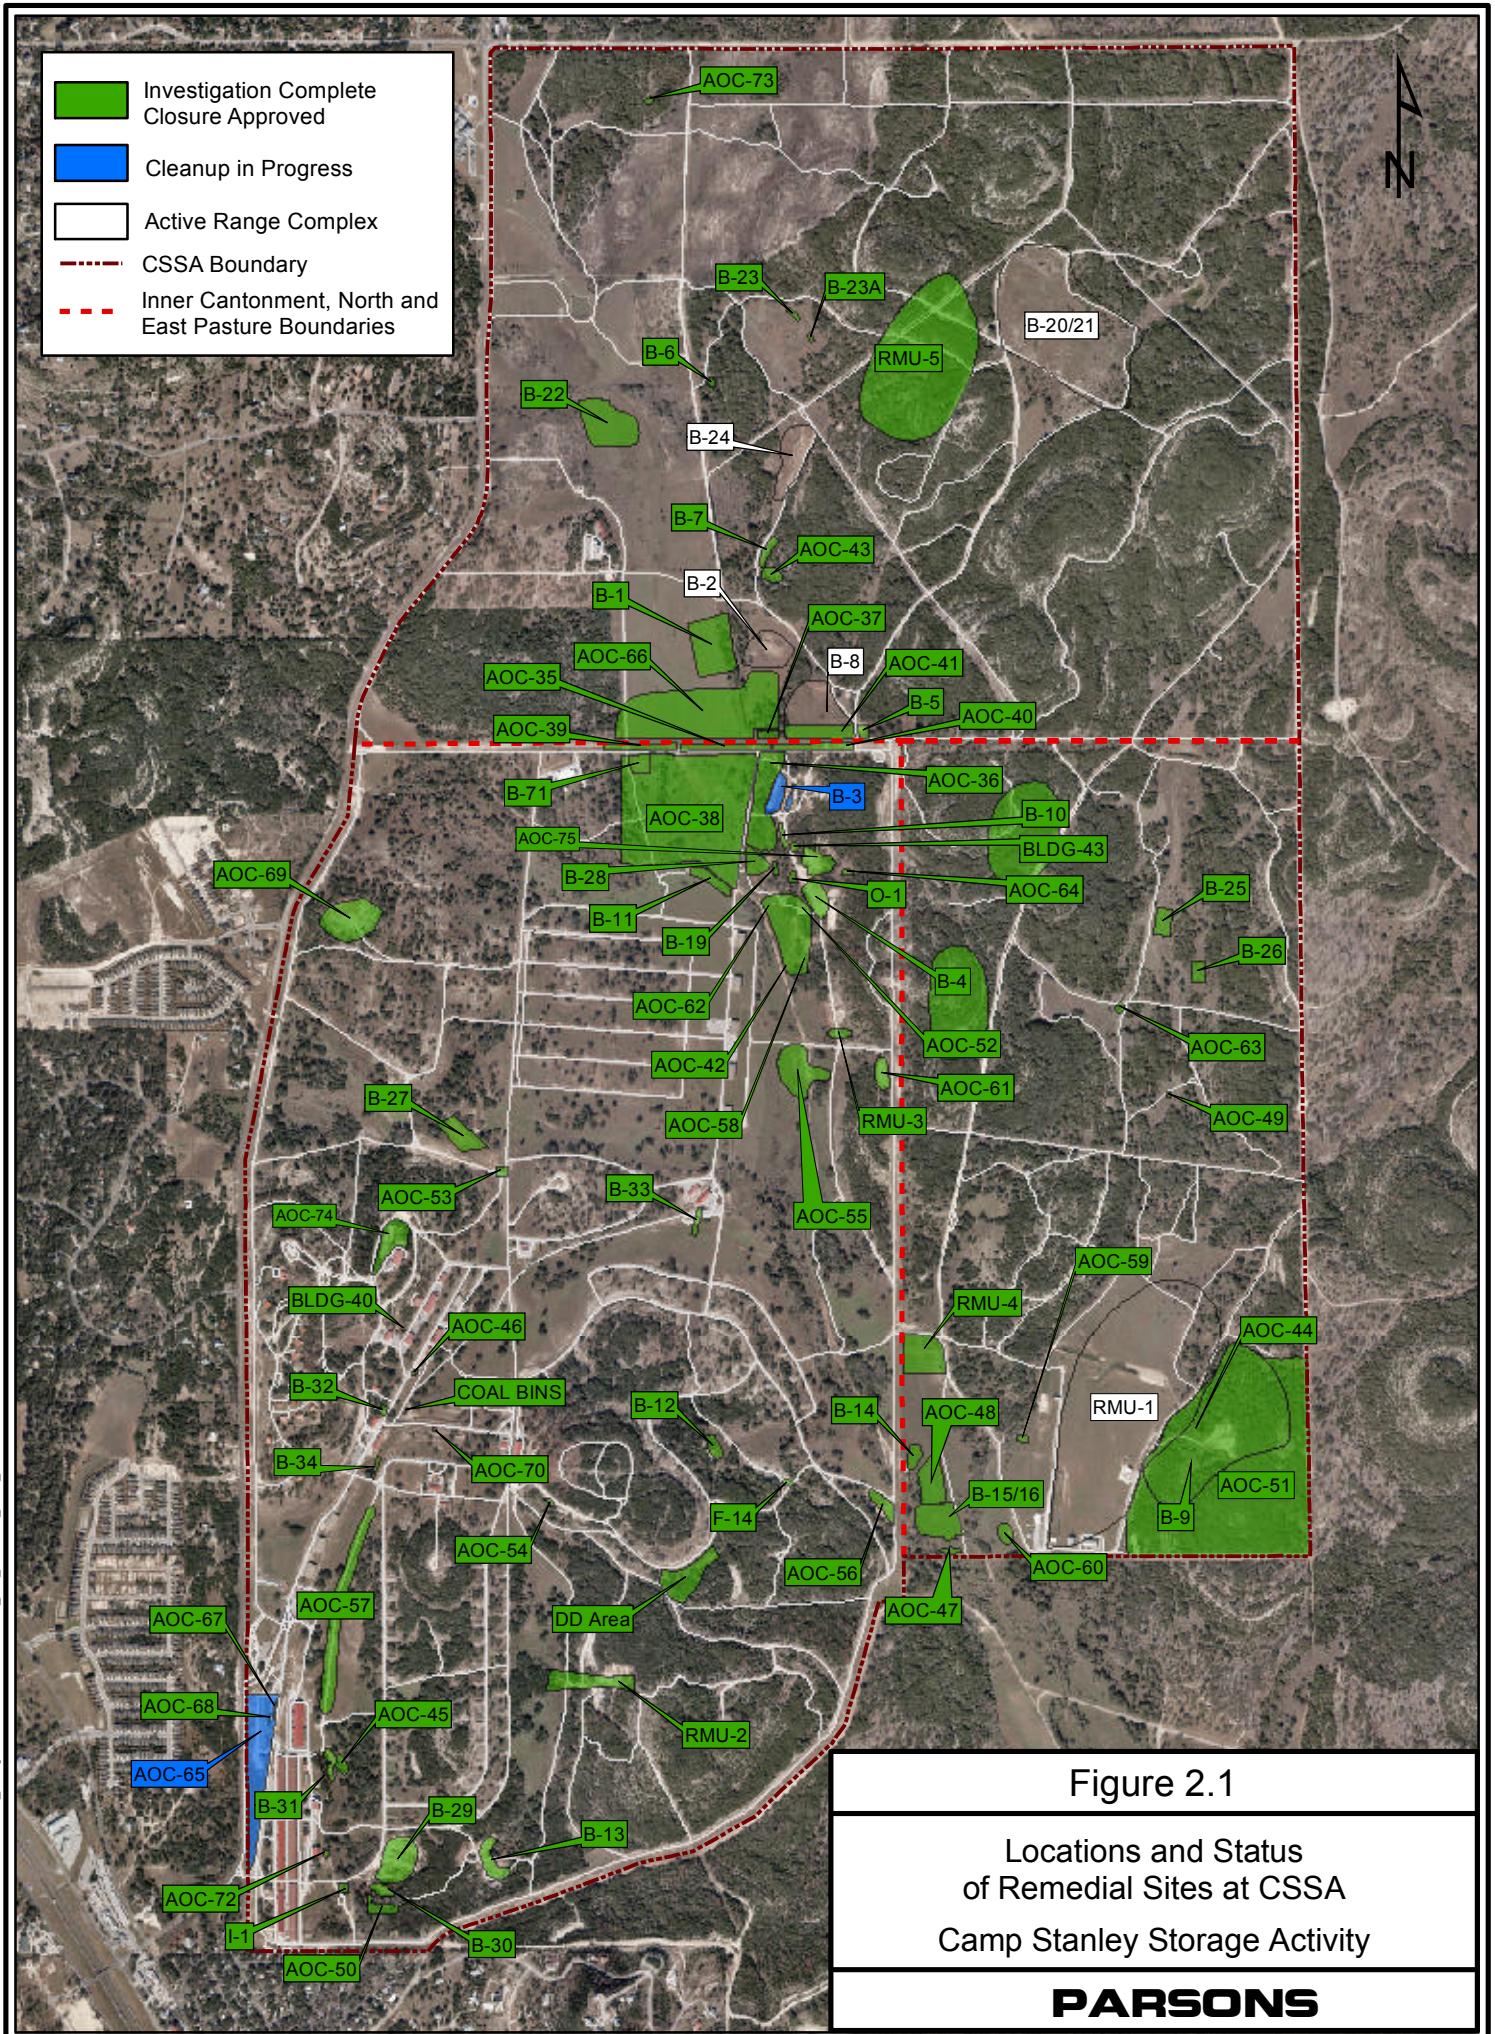
Figure 2.1

## Locations and Status of Remedial Sites at CSSA

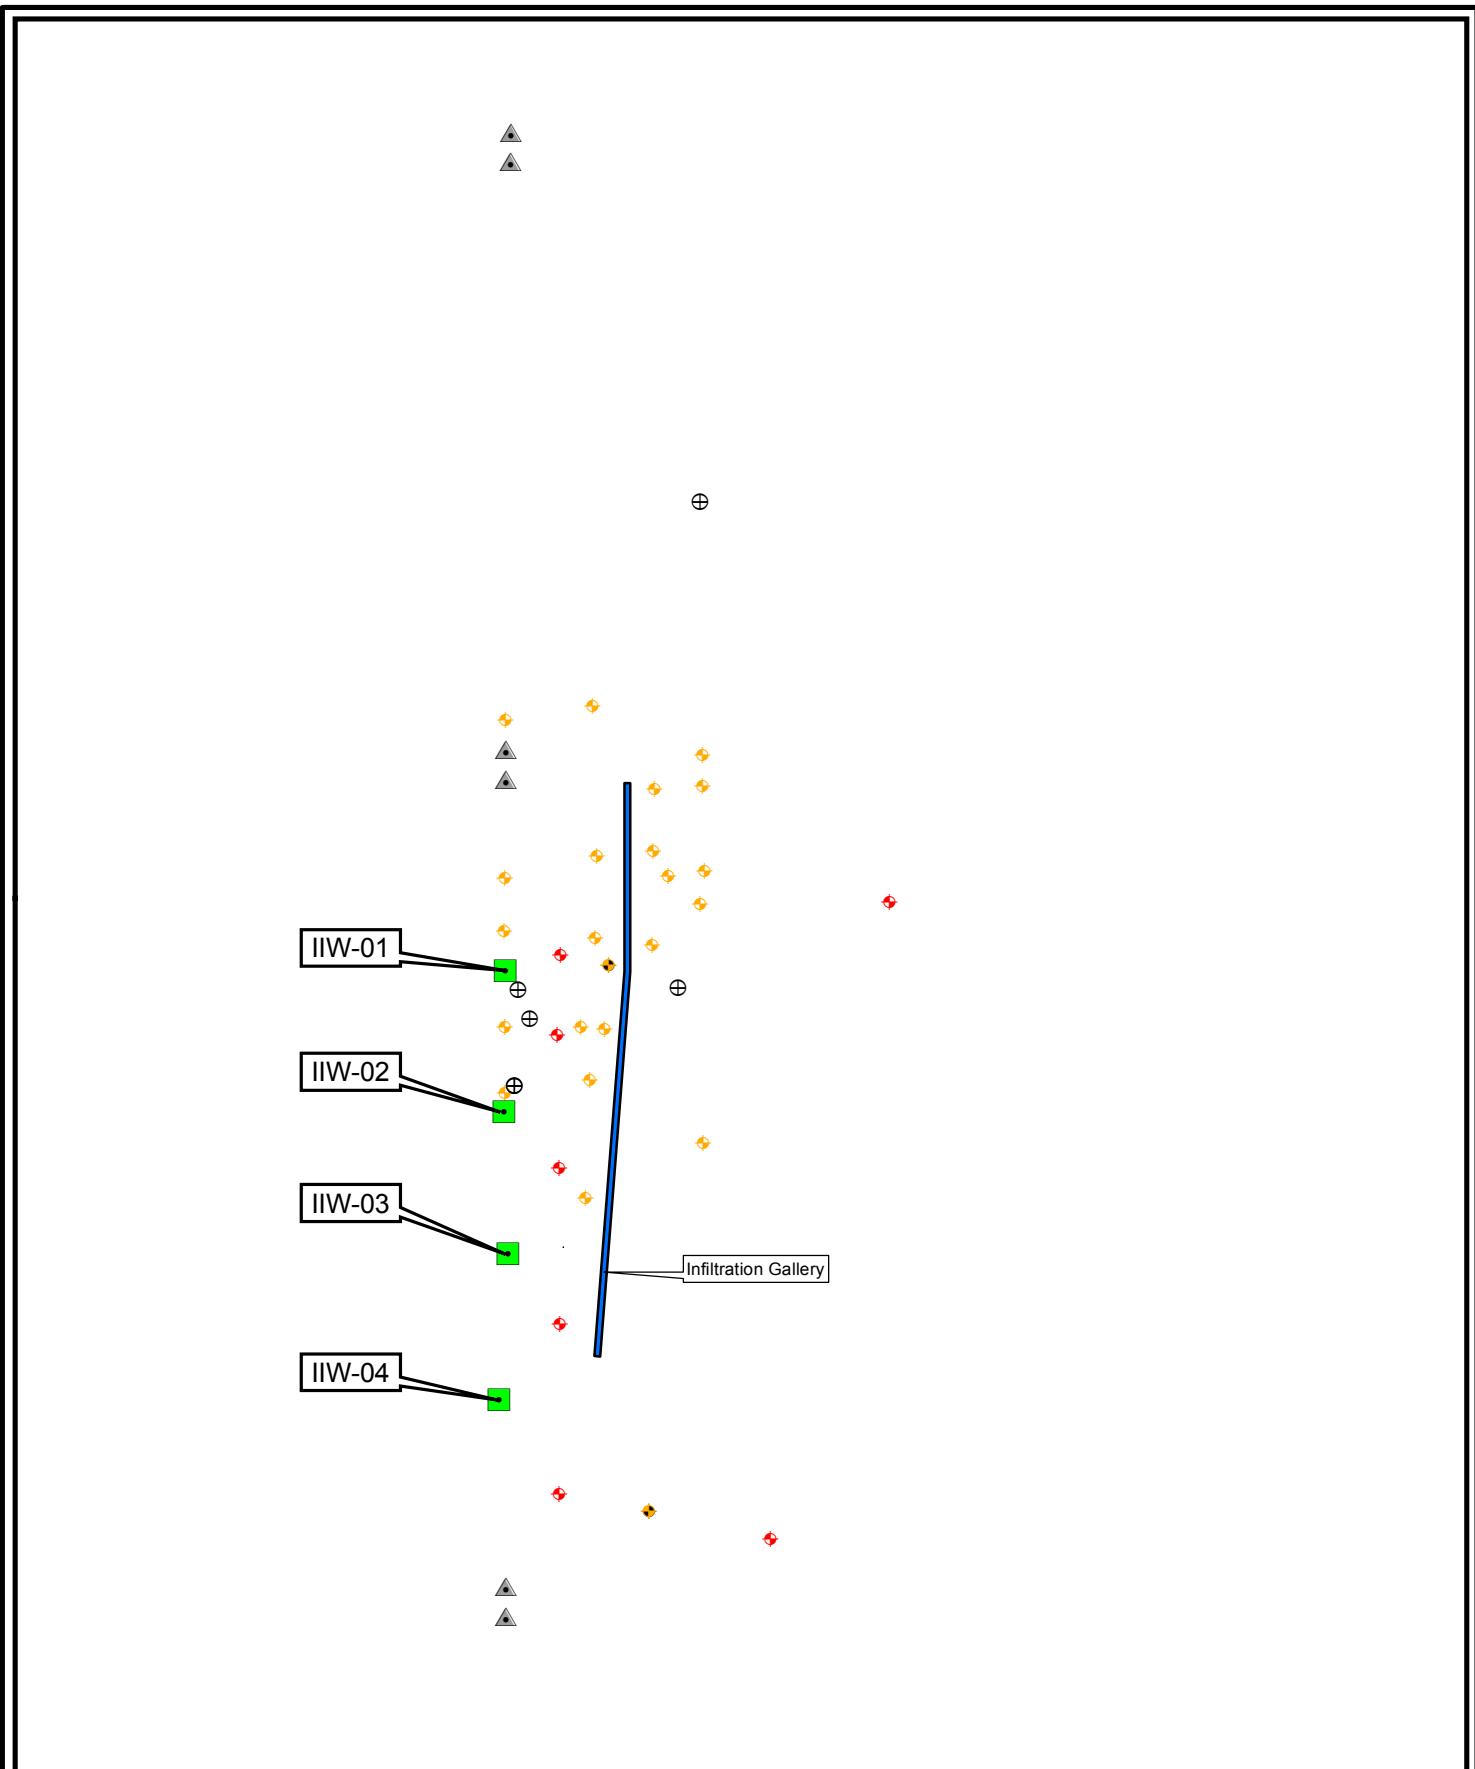
Monitoring Locations

- ⊕ Monitoring Well
- ◇ VEW
- ◆ Treatability Study Well
- ◆ Westbay® - Multiport Monitoring Well
- ▲ Peizometer

Sodium persulfate activated via high pH was selected for application within the discrete galleries due to reaction life-span, solution density, and oxidation potential. In 2013, four injection wells in the upper portion of the bedrock vadose zone were installed along the post boundary to create a reactive curtain for intercepting potential PCE migration off-post (**Figure 2.4**).

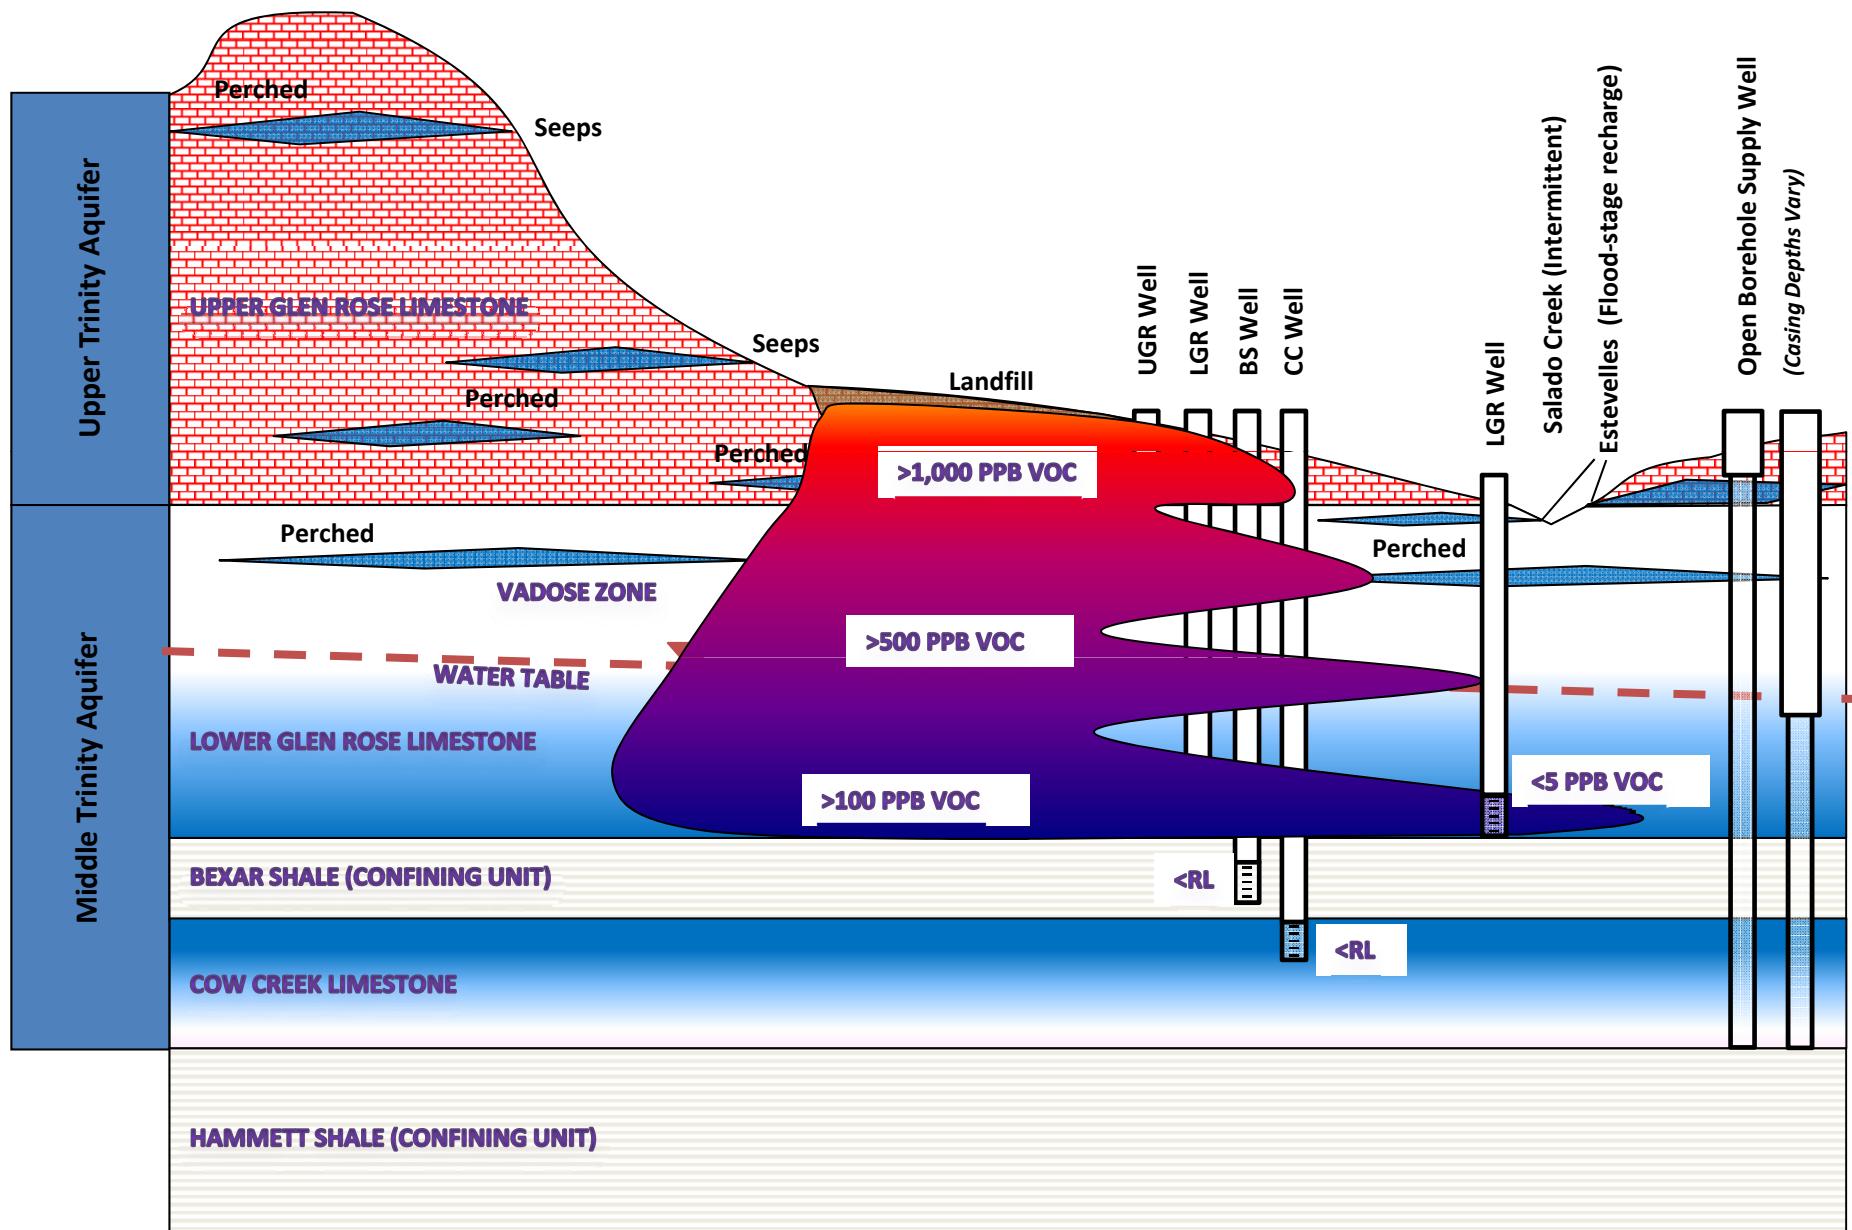
# Figure 2.5 CSSA Hydrogeologic Conceptual Site Model

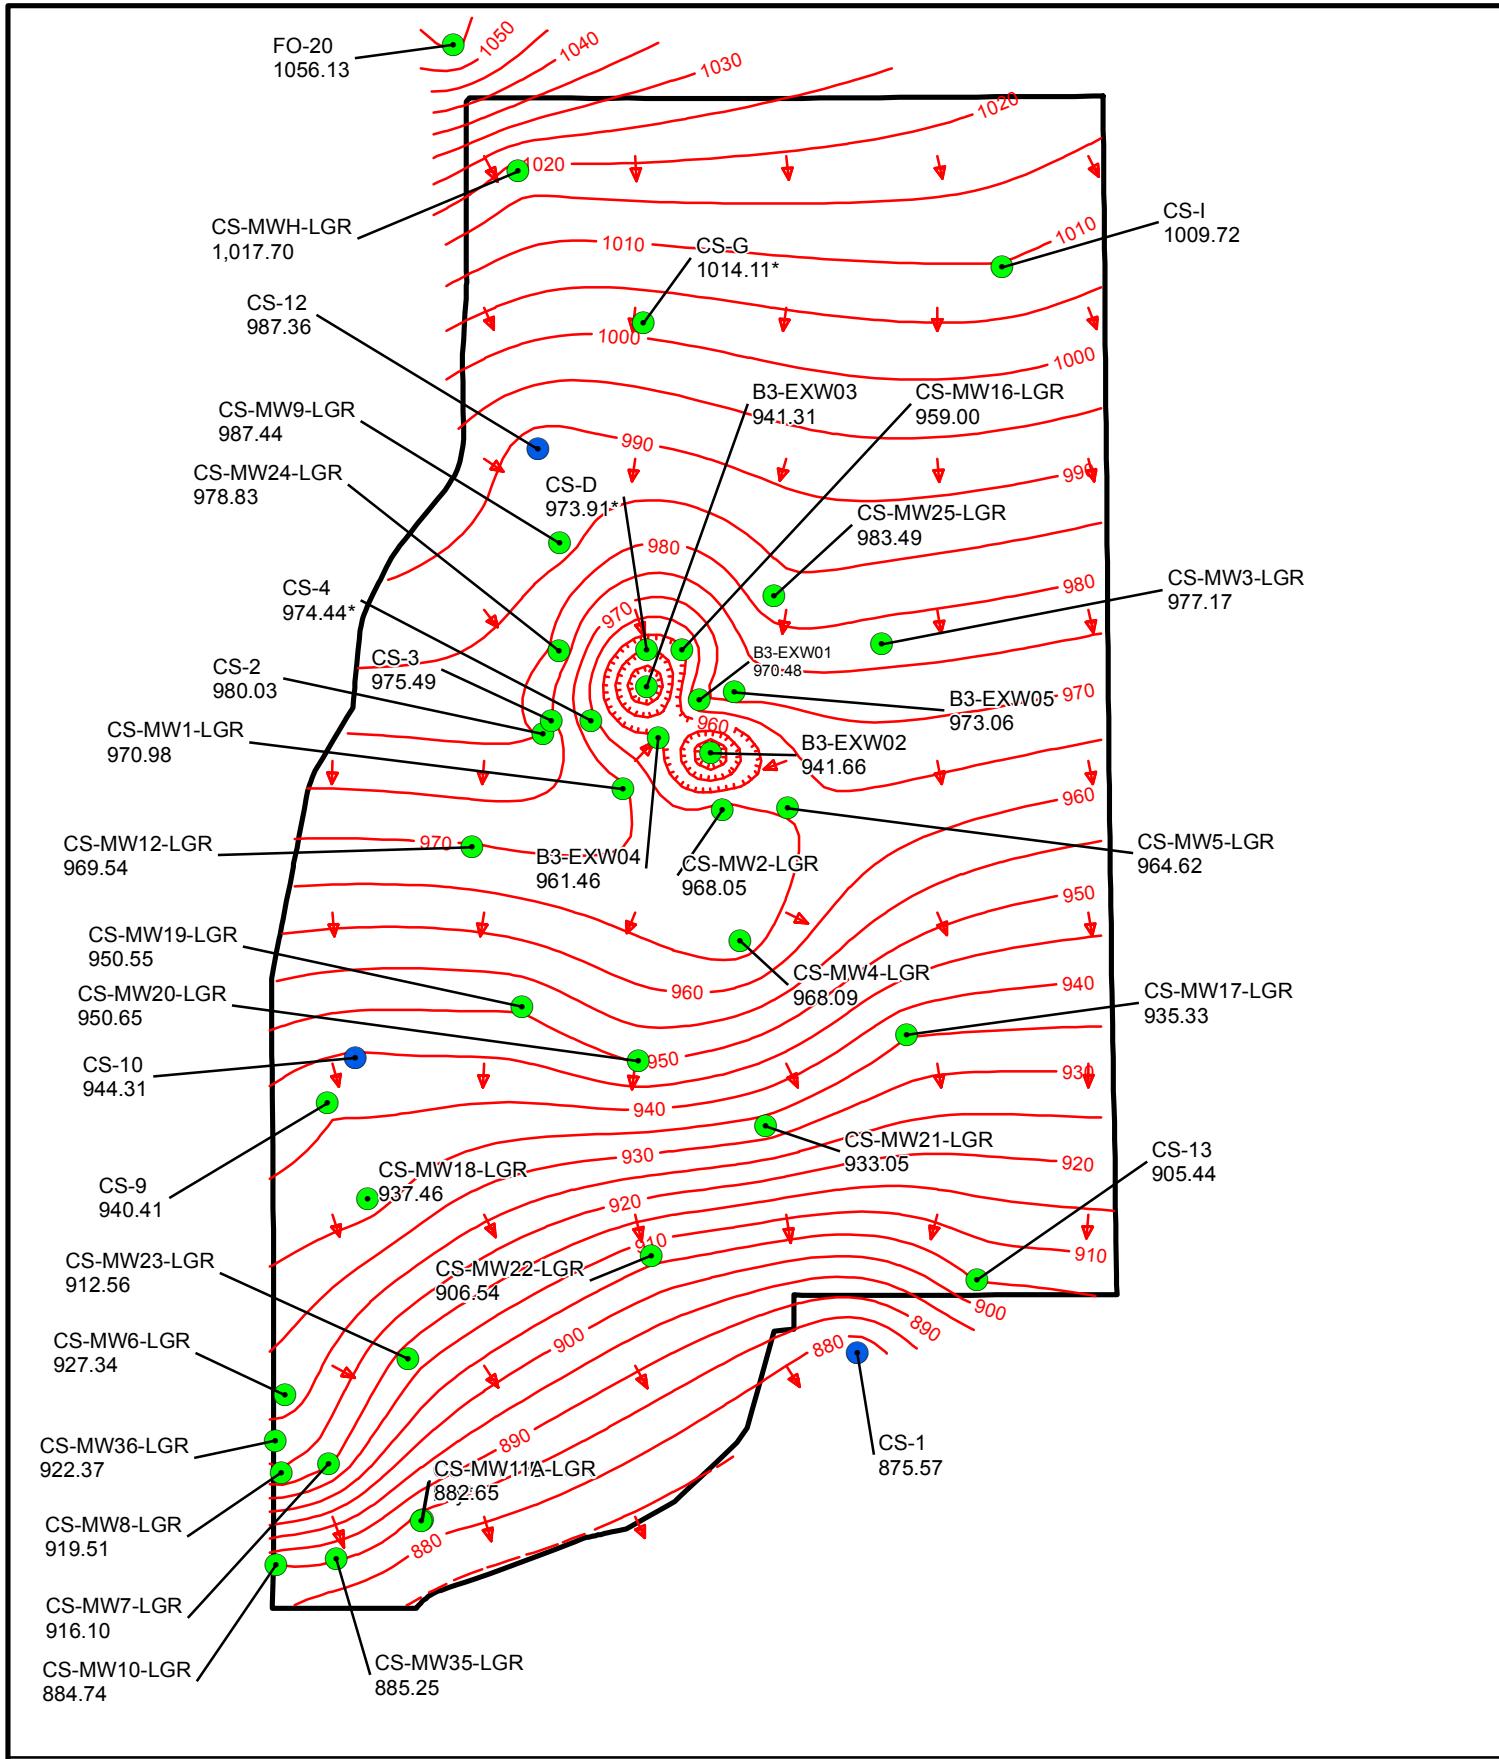
- Flow direction
- Outer fence
- LGR Groundwater Contours
- LGR Wells and groundwater elevation (ft above msl)
- Drinking water wells (may be completed in LGR, BS, and/or CC)

Based on observation well measurements, regional groundwater flow is generally to the south-southeast (**Figure 2.6**). The LGR typically has a southward gradient that deviates around mounding that occurs at CSSA near the central and northern portions of the facility (CS-MW4-LGR).

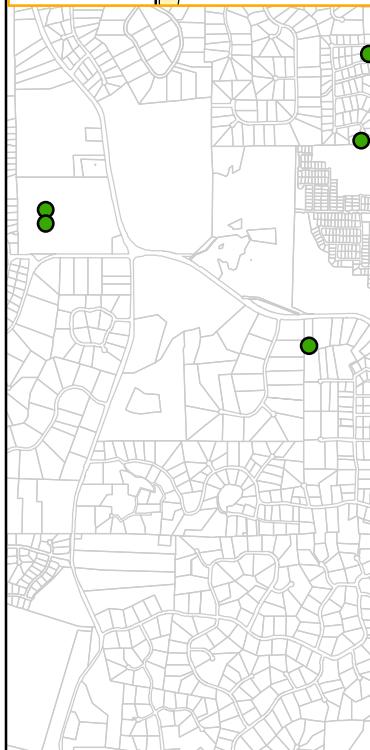
Figure 2.7

## Groundwater Sampling Locations within the HCSM Area

In 1998 planning for the installation of several clustered monitoring wells throughout CSSA was also initiated. The intention of the well clusters was to assist in the ongoing characterization of groundwater contamination at CSSA. The wells provided for monitoring of the major water-bearing zones in the LGR, BS, and CC portions of the Middle Trinity aquifer. To date, 39 new monitoring wells have been installed exclusively within the LGR, BS, or CC portions of the Middle Trinity aquifer (**Figure 2.7**).

As a result of the 1999 well survey, CSSA initiated an offsite well sampling program in December 1999 (**Figure 2.7**). Based on this sampling, it was discovered that PCE and/or TCE was present in both public and private drinking water wells to the west and SW of the facility. These events lead to the search for another area of contaminant release, which ultimately lead to AOC-65, a solvent vat area in Building 90 where solvent had been used in the past.

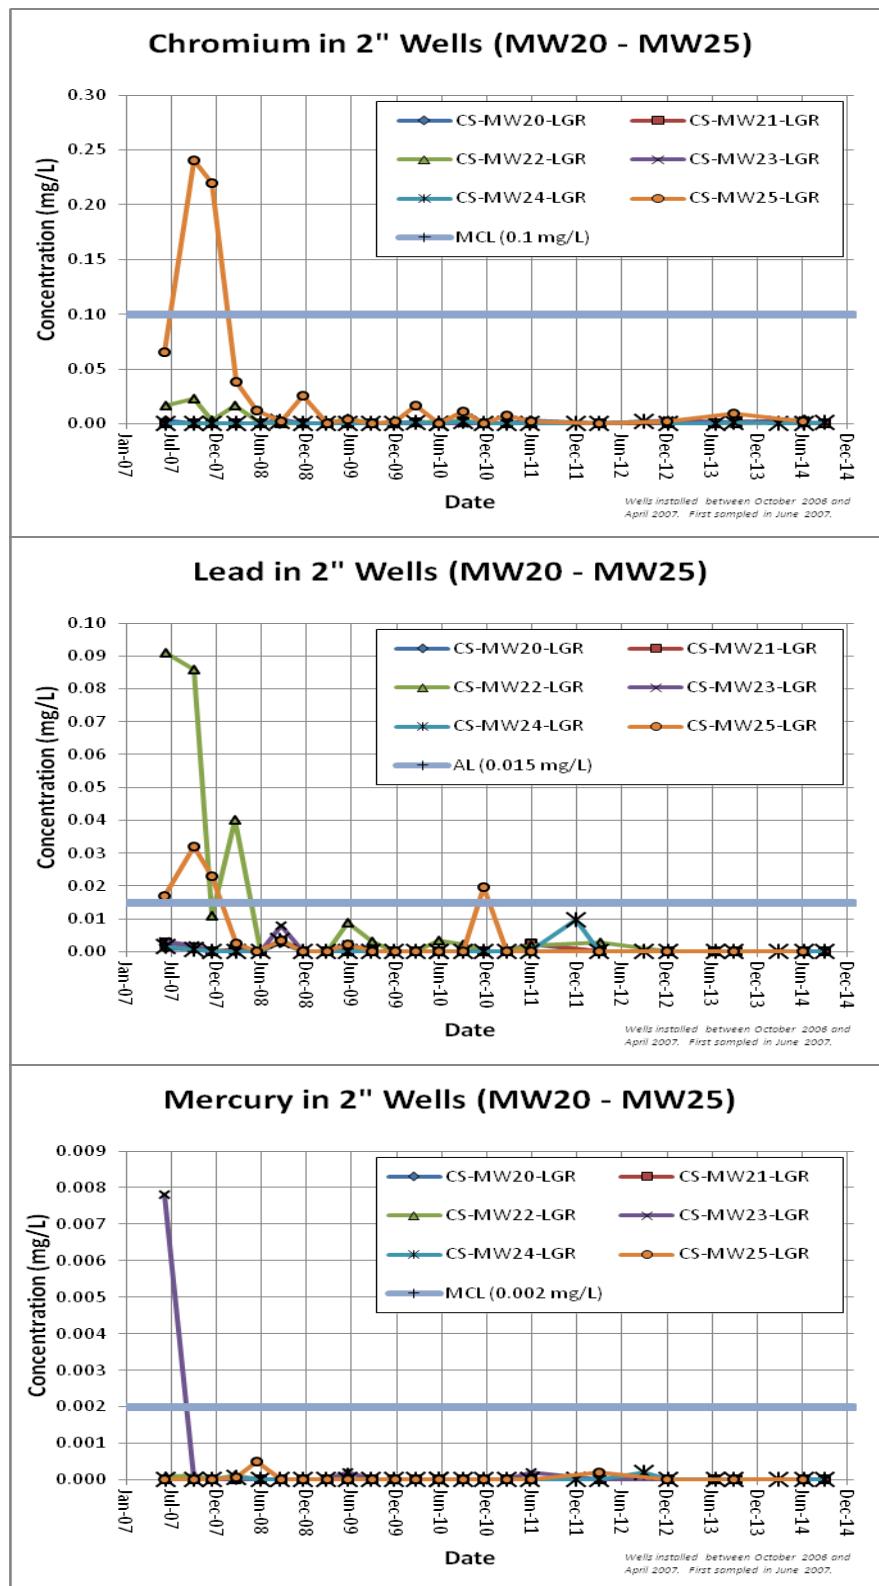
**Figure 3.7 Occurrences of Inorganics in 2-inch Wells (2007-2014)**

Another commonality between these six wells is that they are the only 2-inch diameter LGR monitoring wells on-post. This set of wells was a departure from the traditional 4-inch monitoring wells usually installed at CSSA. The benefit the lower cost 2-inch wells provided was installation of an increased number of monitoring points. From an installation perspective, the 2-inch and 4-wells differed by well development methodology. The traditional 4-inch wells are developed with high capacity submersible pumps after the installation of the well casing and gravel pump. However, the depth and narrow diameter of the 2-inch wells precluded the use of a high capacity development pump. Therefore, each boring for the 2-inch well was developed by air lifting and high capacity pumping prior to the installation of the well materials. This difference in well development styles may account for an attenuation trend that is noted in Figure 3.7 as the natural groundwater conditions was restored to the screened intervals of these wells.

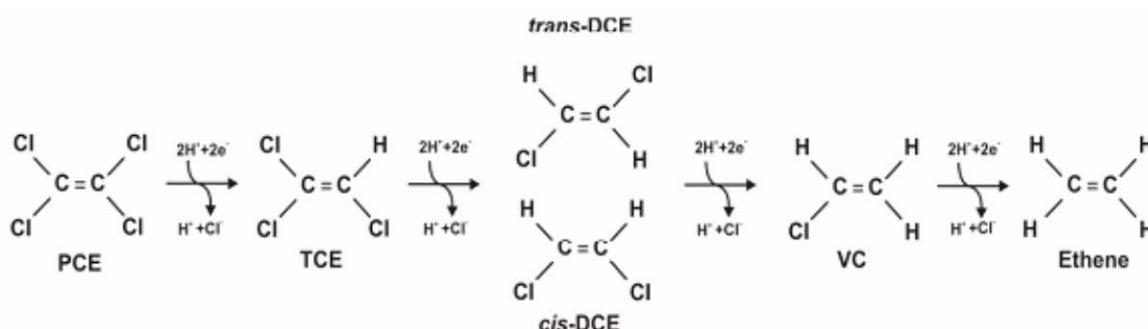
**Figure 3.8 Transformation Pathways for PCE within Environmental Systems**

The process listed in **Figure 3.8** shows PCE converting to TCE via reductive dehalogenation. Likewise, TCE is reductively dehalogenated to either 1,1-DCE, *cis*-1,2-DCE, or *trans*-1,2,-DCE with hydrogen ( $H_2$ ) and hydrochloric acid (HCl) by-products. In general, reductive dehalogenation of tetra- and tri-halogenated carbon atoms (PCE and TCE, respectively) is easier than di- or monohalogenated molecules, which is why many metabolic reactions appear to stall at the generation of DCE isomers. In the presence of favorable conditions, the DCE isomers can reductively dehalogenate to vinyl chloride, which is then easily converted to ethane via further reductive dehalogenation.
