FIGURE 5
GEOLOGY OF CSSA
JUNE 1996
CAMP STANLEY STORAGE ACTIVITY

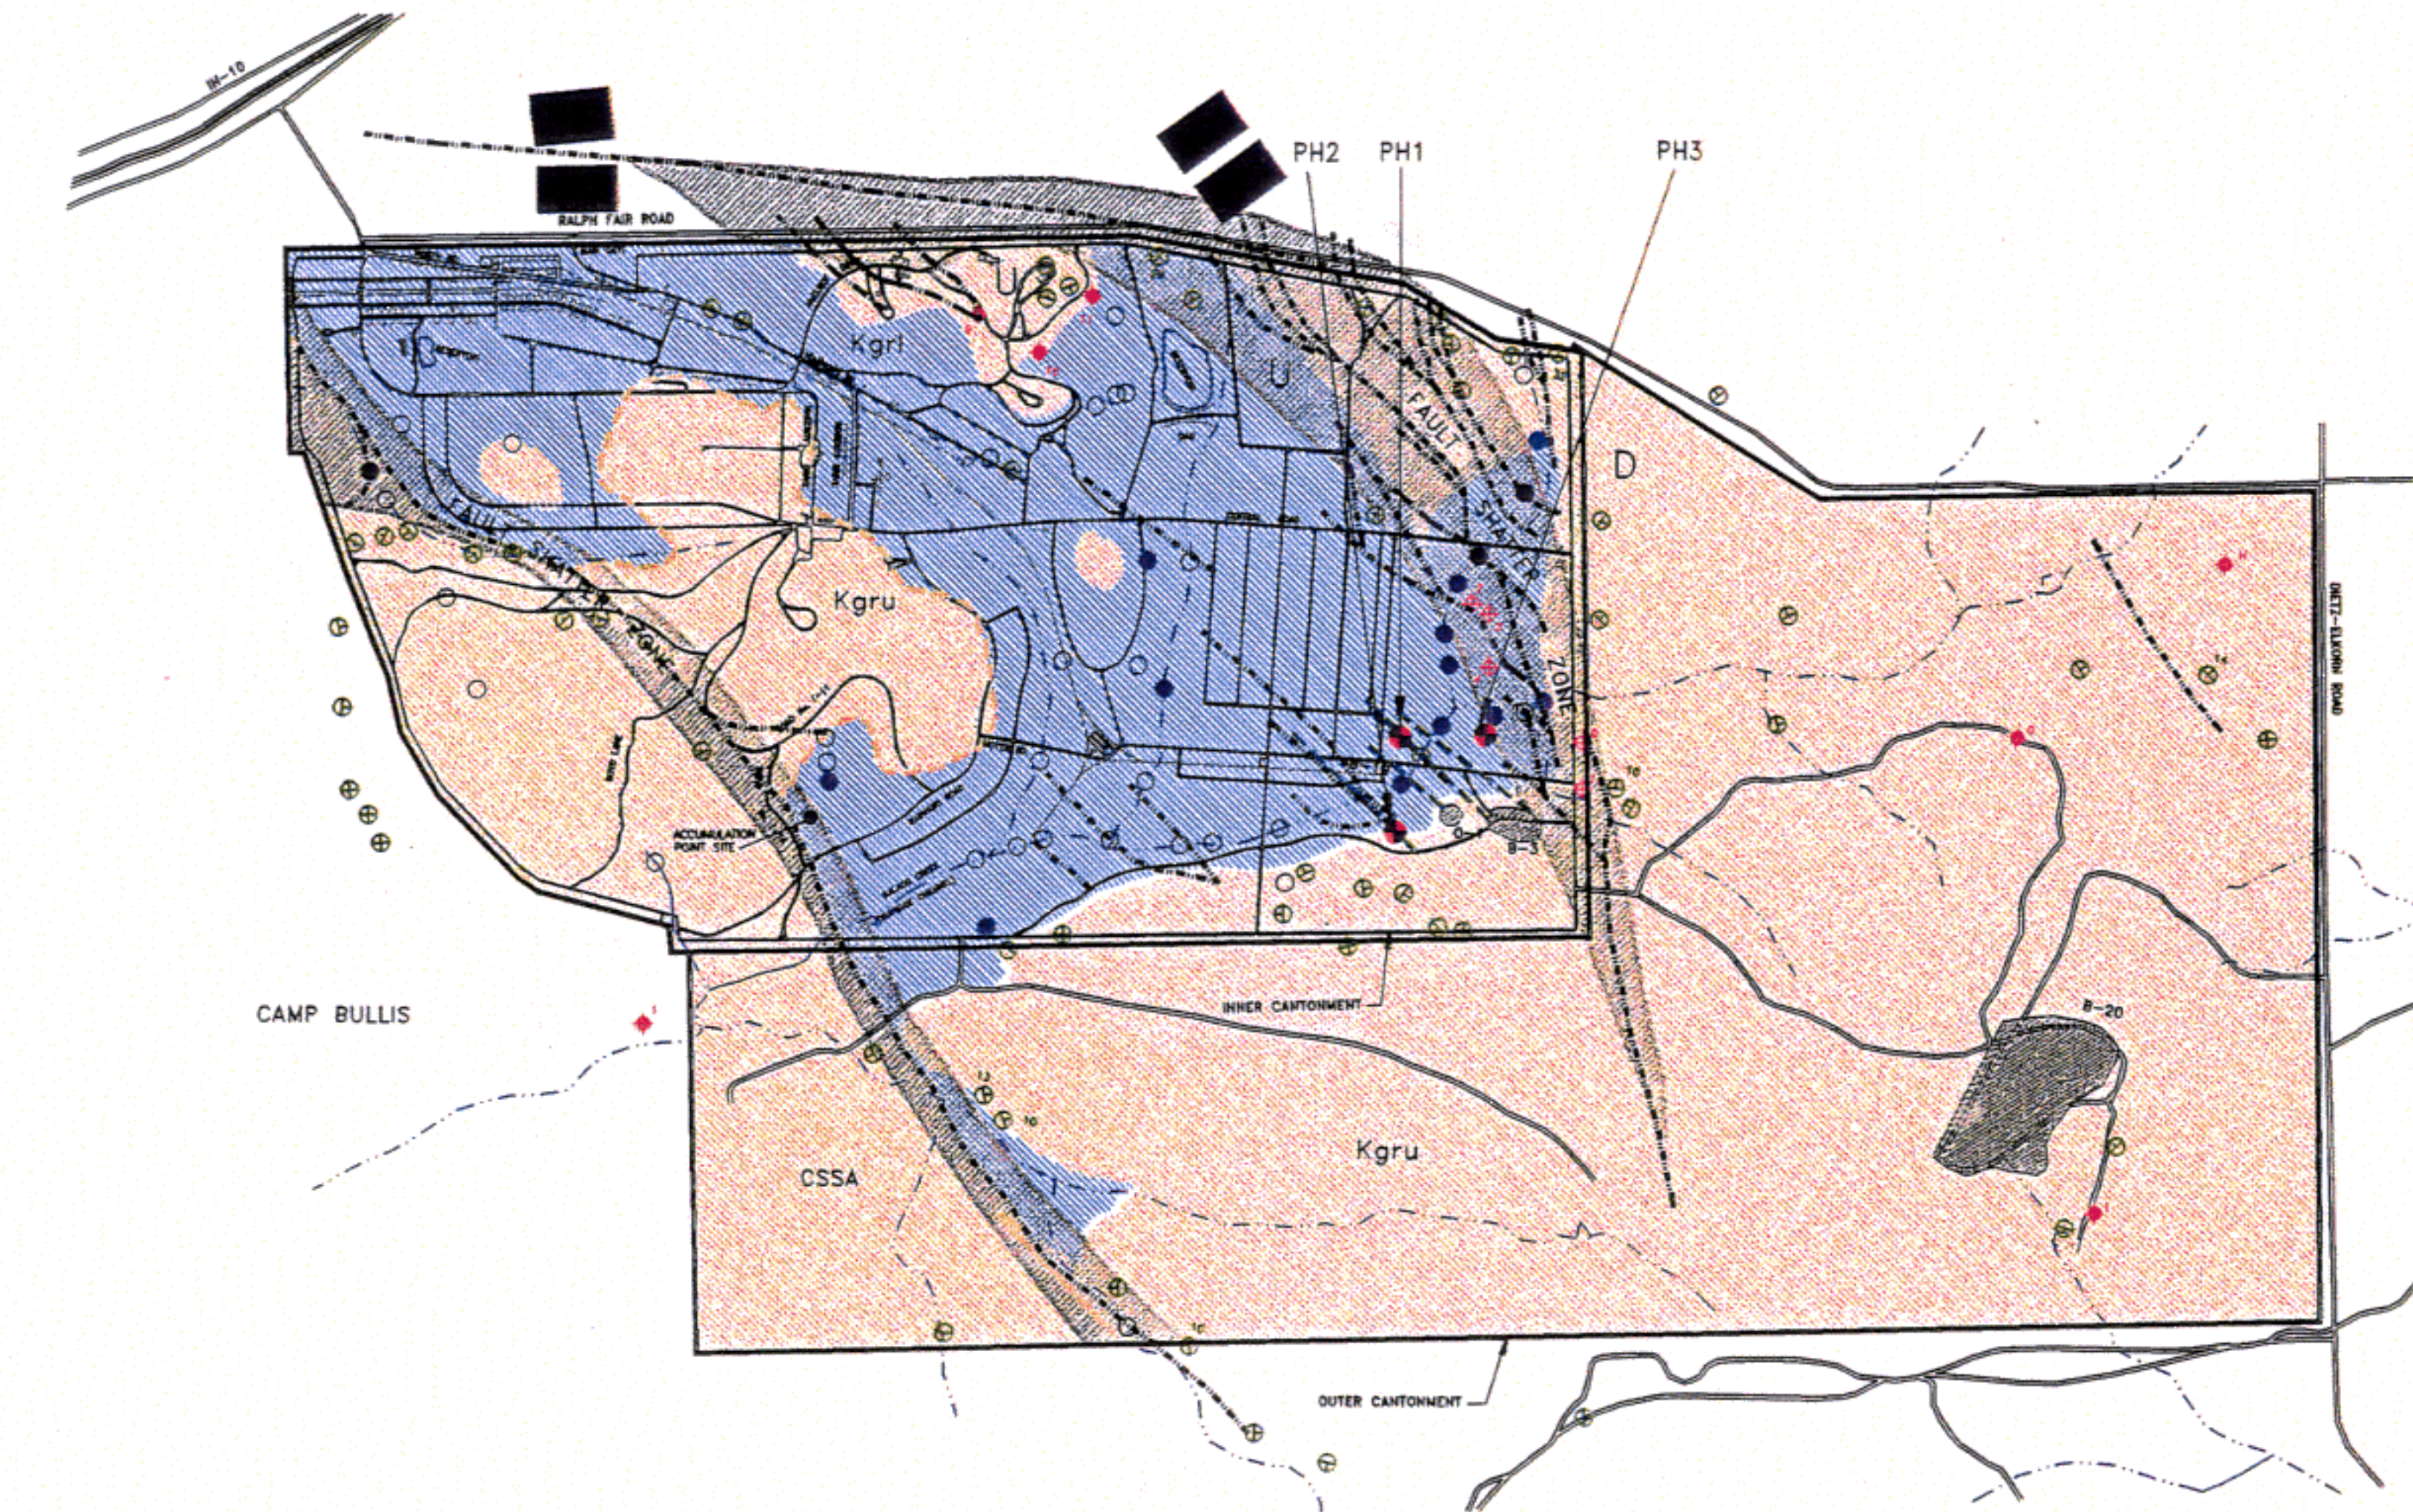
FAULTS FROM HEFNER, RENE G. ENVIRONMENTAL GEOLOGY AND LAND USE CAPABILITY OF THE WESTERN CAMP BULLIS, NORTHEASTERN CASTLE HILLS, NORTHERN HELOTES, AND VAN RAUB QUADRANGLES IN NORTHWEST BEXAR COUNTY, TEXAS. THE UNIVERSITY OF TEXAS AT SAN ANTONIO, M.A. THESIS (UNPUB.) 1993
