Figure B26-3

Geologic Setting

Camp Stanley Storage Activity

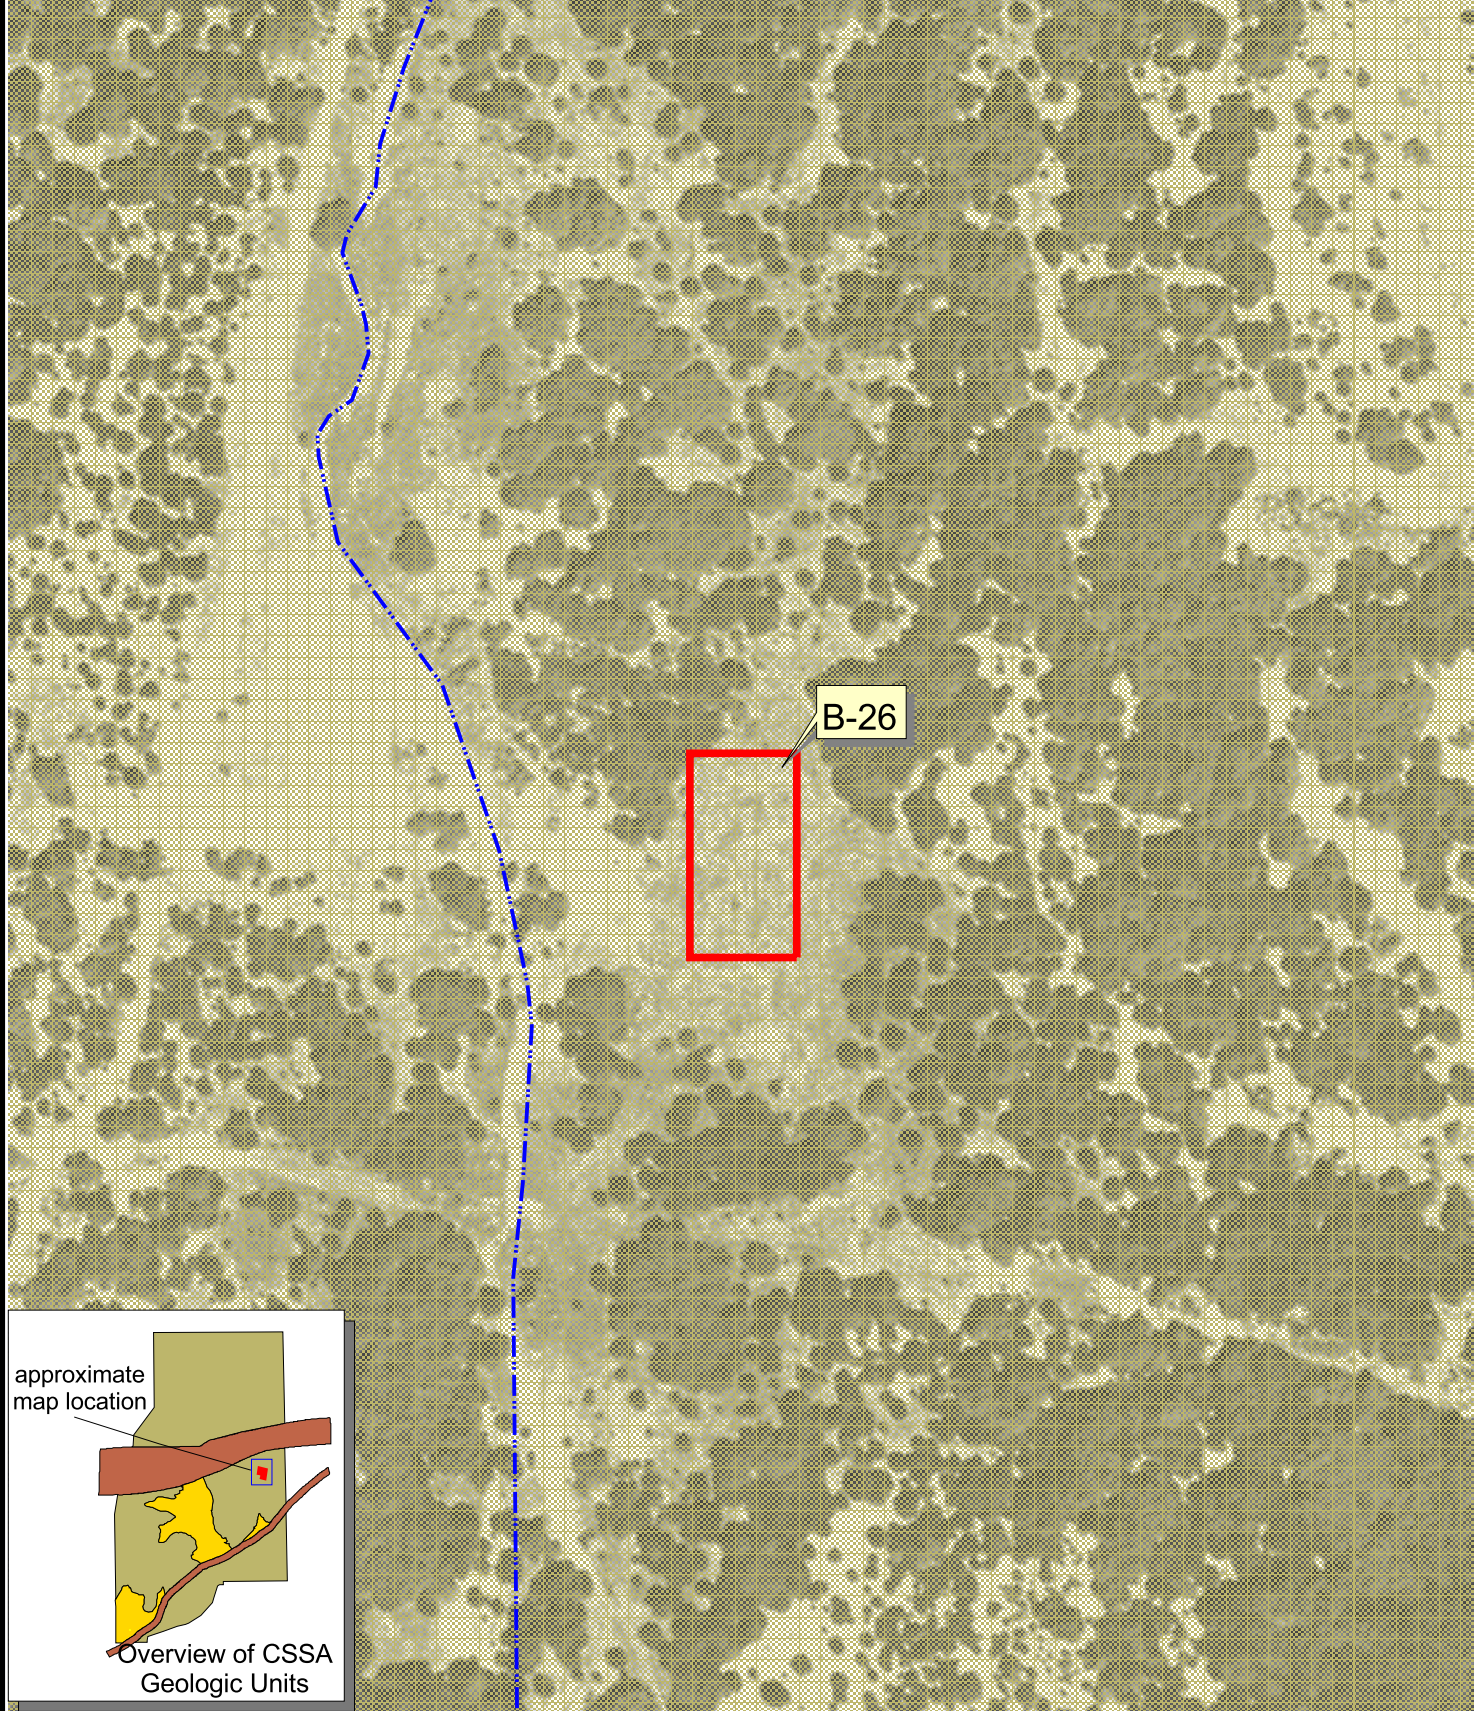
Note: Geologic Units were mapped by Parsons ES, 1995.  
Aerial Photo Date: 1998
