SECTION 2 BACKGROUND

2.1 SITE SUMMARY

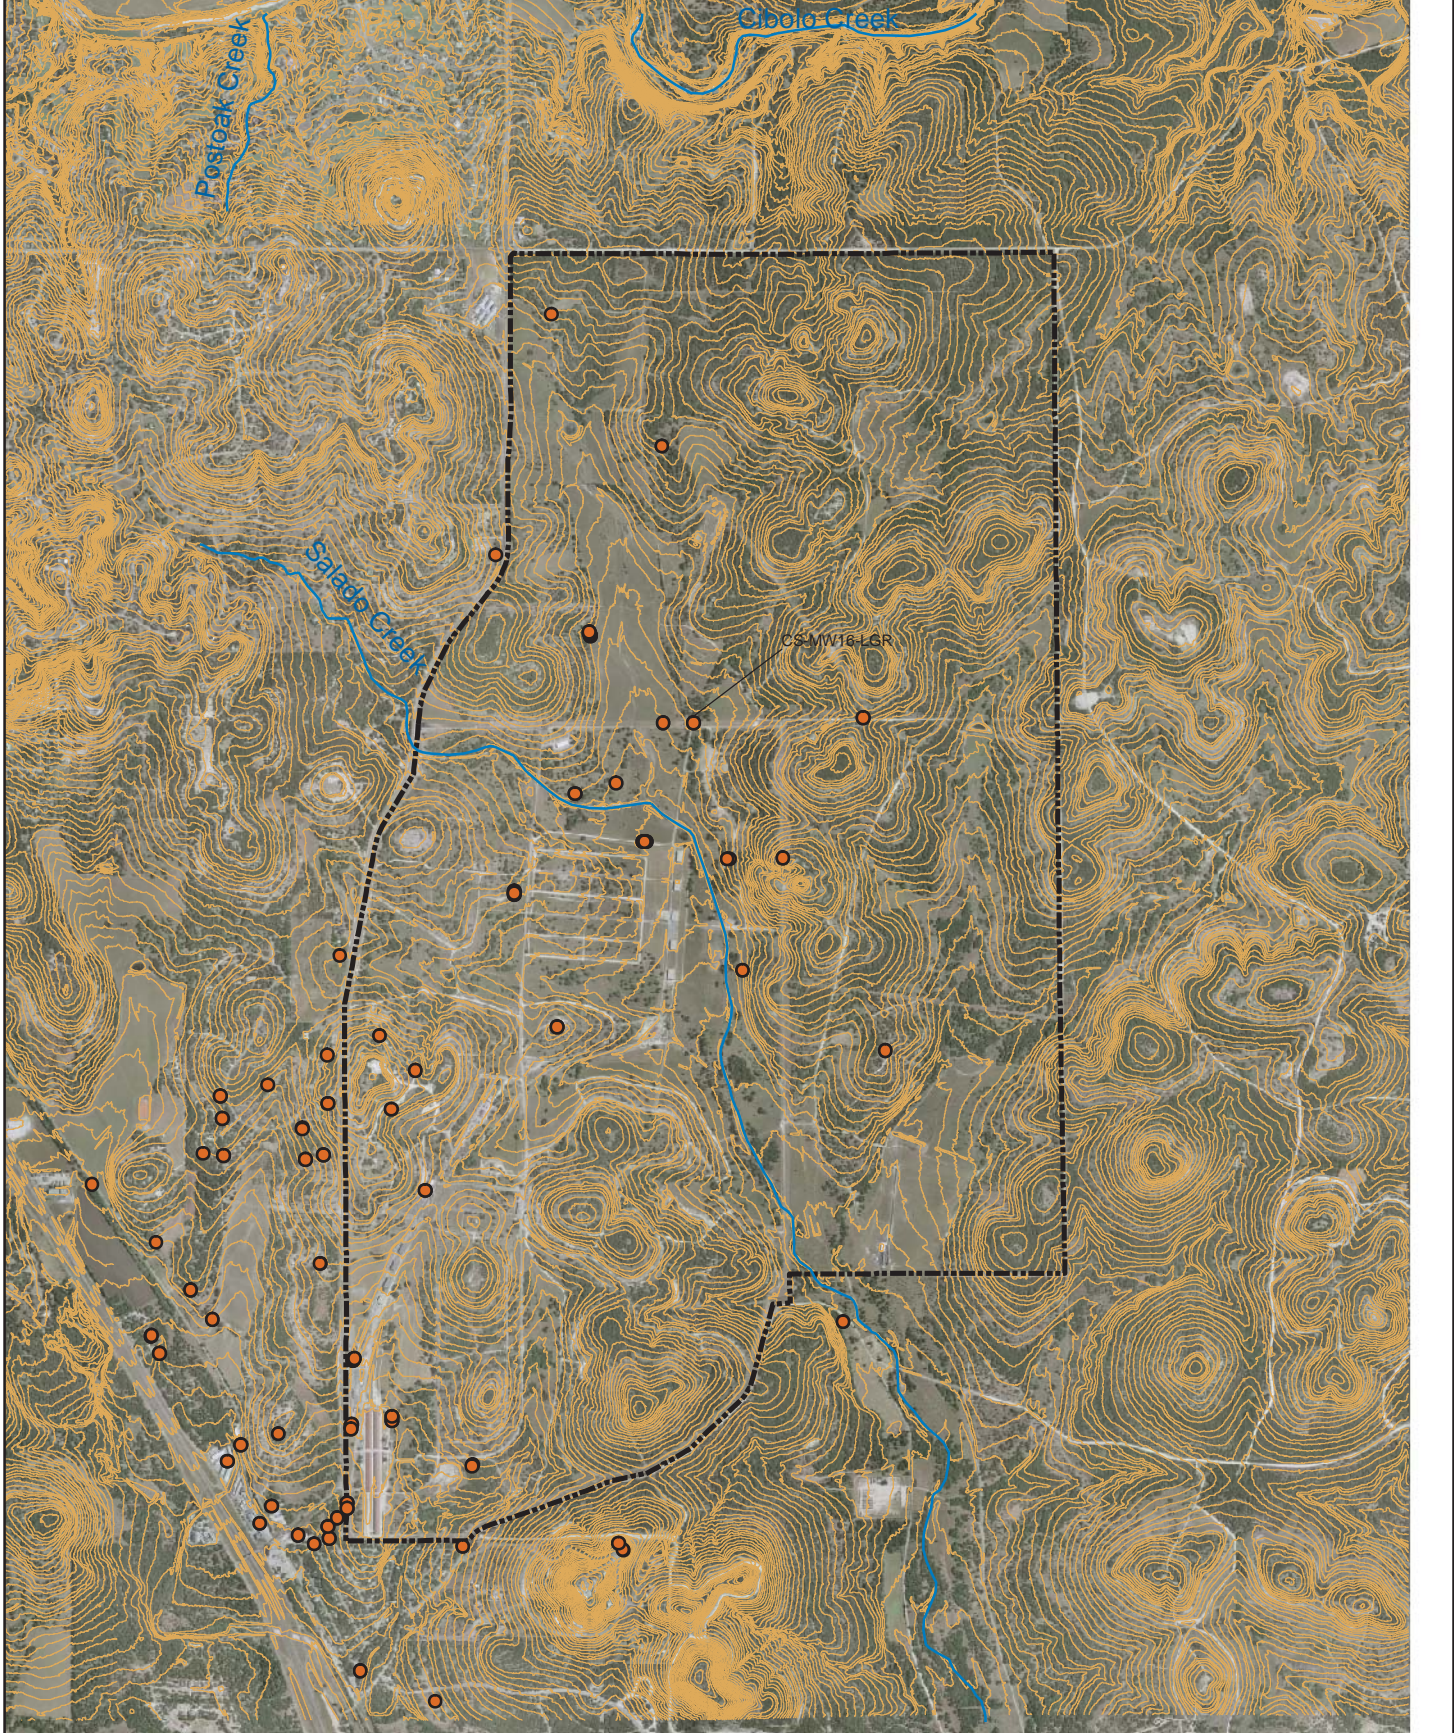
Figure 2.1
Camp Stanley and Surrounding Area

- Water Wells Sampled
- Creeks
- Topographic Contours (1m)

The CSSA installation consists of 4,004 acres immediately east of Farm to Market Road (FM) 3351, and approximately half a mile east of Interstate Highway (IH) 10 (Figure 2.1). Camp Bullis borders CSSA on the north, east, and southeast (SE). The land on which CSSA is located was used for ranching and agriculture until the early 1900s. During 1906 and 1907, six tracts of land were purchased by the U.S. Government and designated the Leon Springs Military Reservation. The lands included campgrounds and cavalry shelters.

Contaminants were initially detected in CSSA Well CS-16, shown in Figure 2.1, during routine water supply testing in April 1991. Drinking water withdrawals at CS-16 ceased immediately. Follow-up sampling confirmed concentrations of trichloroethene (TCE) and tetrachloroethene (PCE) above drinking water maximum contaminant levels (MCLs) and the well was permanently taken out of service. Comprehensive investigation of groundwater contamination at CSSA began in 1992. The effort started with preliminary evaluations to establish the extent of the problem without invasive field techniques, namely analyzing groundwater samples from existing CSSA wells and geophysical surveys to identify potential contamination source areas. Samples from Well CS-D, located west of Well CS-16, also exhibited concentrations of PCE and TCE that exceeded MCLs. Camera surveys were also performed at CSSA wells to inspect the integrity of existing casings and to document general conditions inside the wells. Following this effort, the **Hydrogeologic Report for Evaluation of Groundwater Contamination** (ES, 1993) was submitted to the appropriate regulatory agencies for comment and approval.

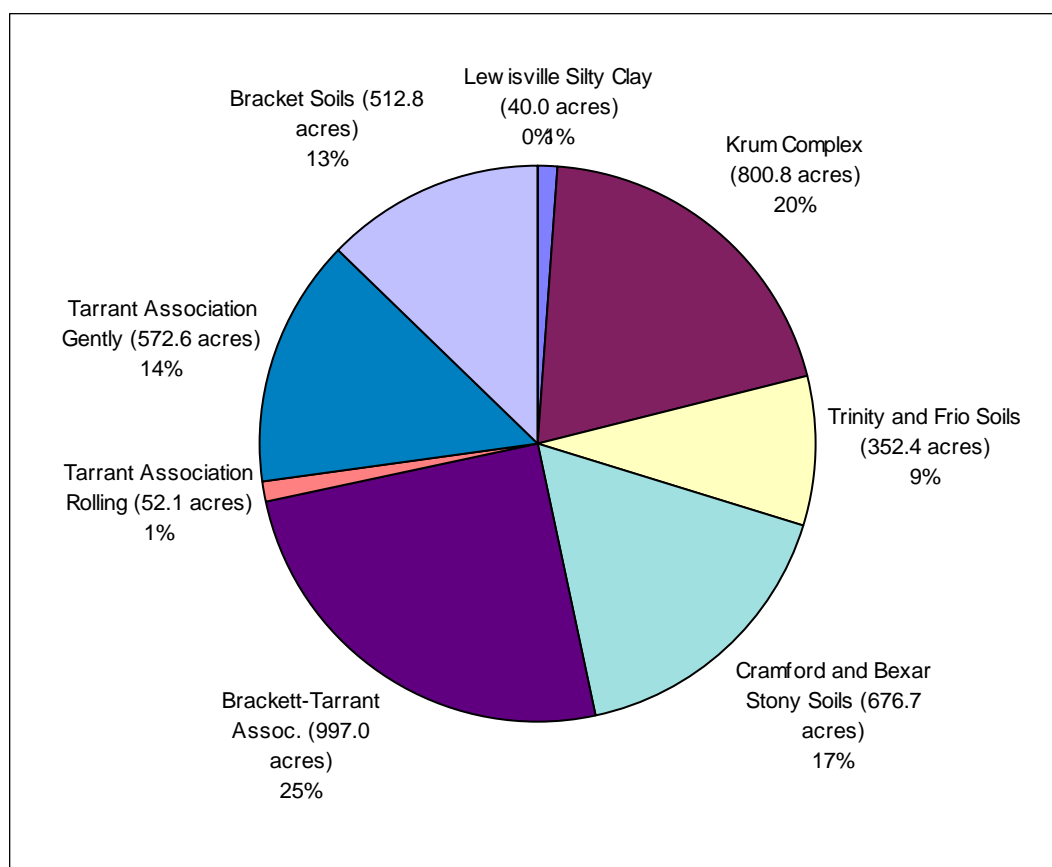
Figure 2.2 CSSA Eight Soil Types by Area Percentage

In general, soils at CSSA are thin, dark-colored, gravelly clays and loams. The soil types are strongly influenced by topography and the underlying limestone. All soil classifications used for this report are taken from the USDA Soil Conservation Service (now the Natural Resource Conservation Service (NRCS) soil survey series for Bexar County, Texas (USDA, 1991). A total of eight soil types occur at CSSA. Figure 2.2 shows the portion of CSSA each soil type covers.
